SHERMAN BOARD OF EDUCATION
MAINTENANCE MEETING
WEDNESDAY, SEPTEMBER 5, 2018
THE SHERMAN SCHOOL - LIBRARY MEDIA CENTER

PLAYGROUND SAFETY INSPECTION REPORT

SITE: Sherman Elementary School
2 Route 37 East
Sherman, CT 06784

DATE OF INSPECTION: July 5, 2018

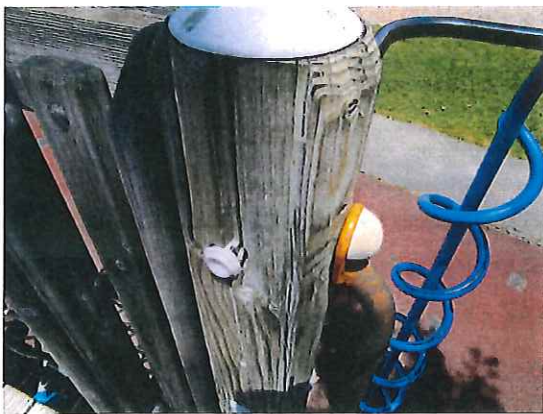
Cargo Net - One protruding bolt - CLASS B HAZARD

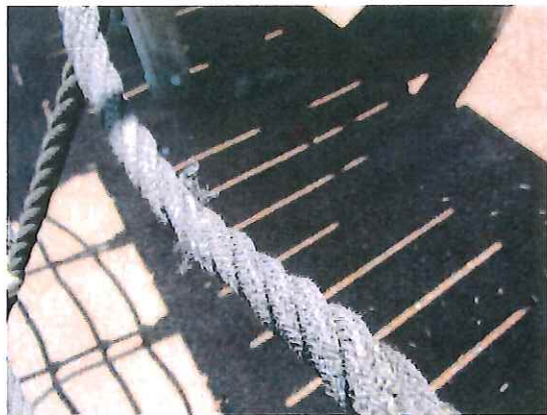
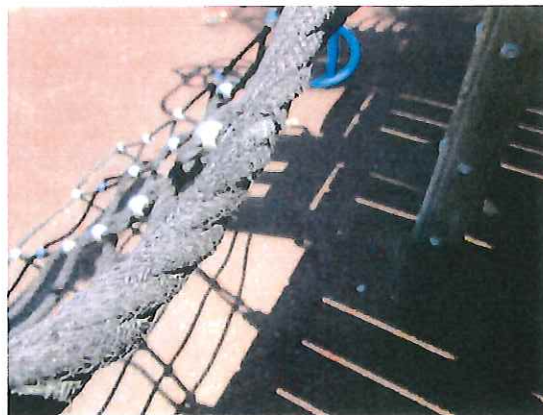
Cargo Net - Rope worn - MAINTENANCE

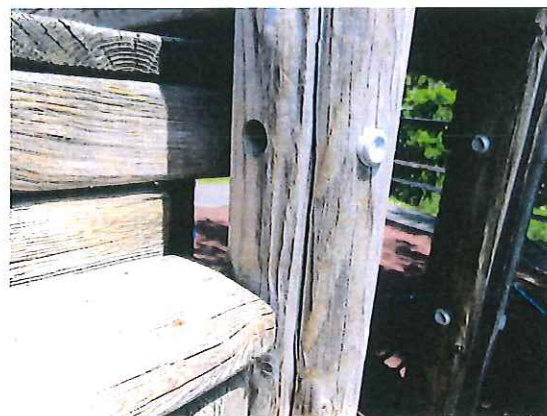
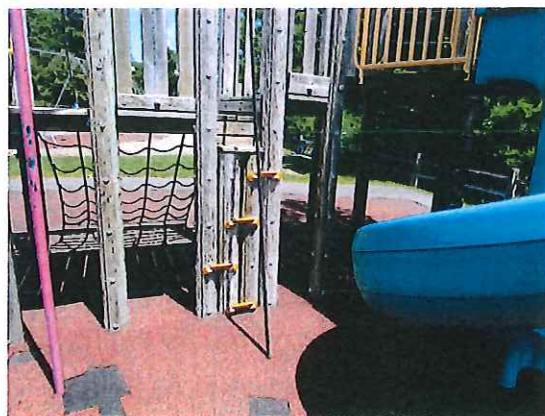
Mountain Climber - One cap missing - MAINTENANCE

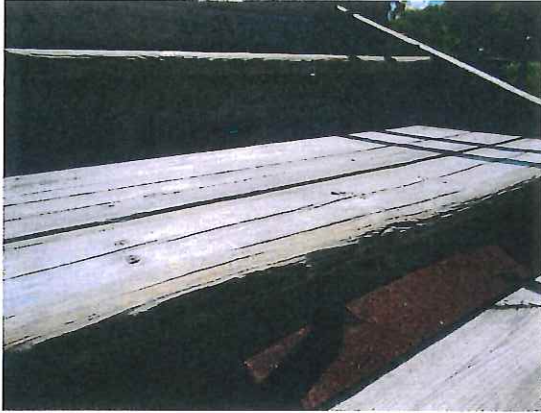
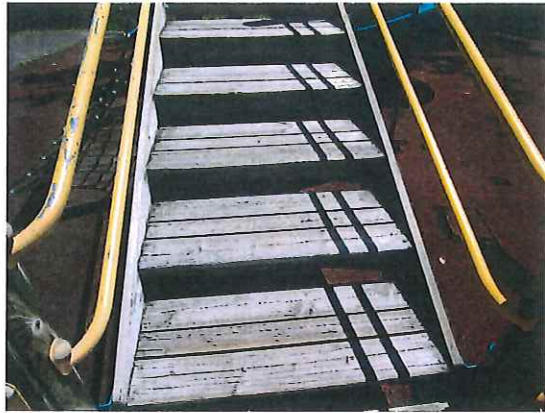
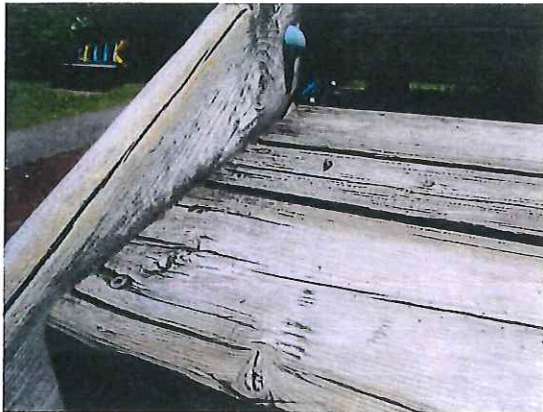
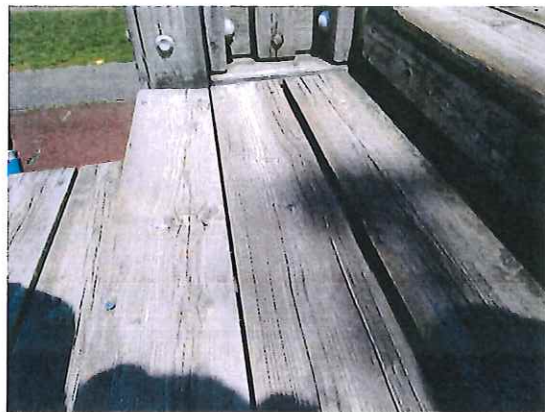
Steps - Worn, splintered, uneven, gaps & loose - MAINTENANCE

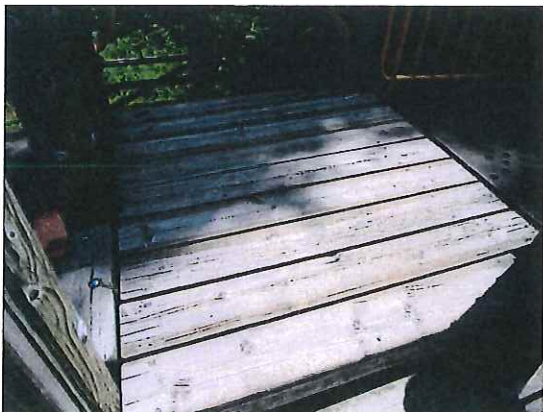
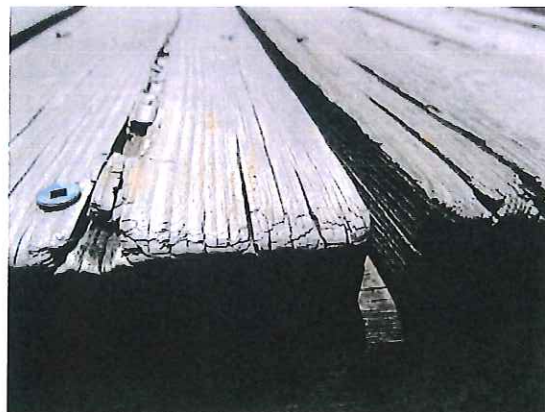
Decks (3) - Worn, splintered & loose in spots - MAINTENANCE

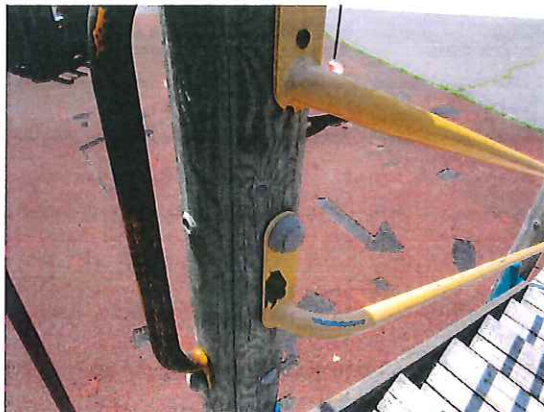
Pipe Barrier Rails - Brackets rusted & one cap cracked - MAINTENANCE

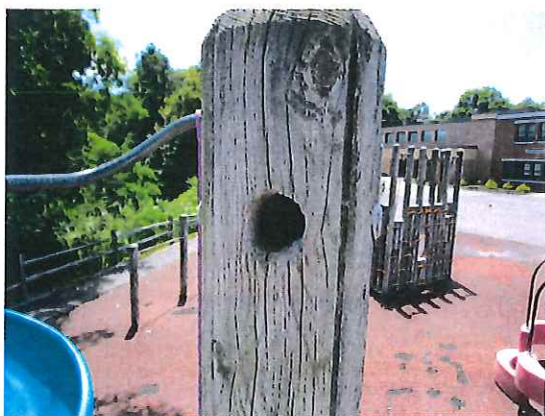
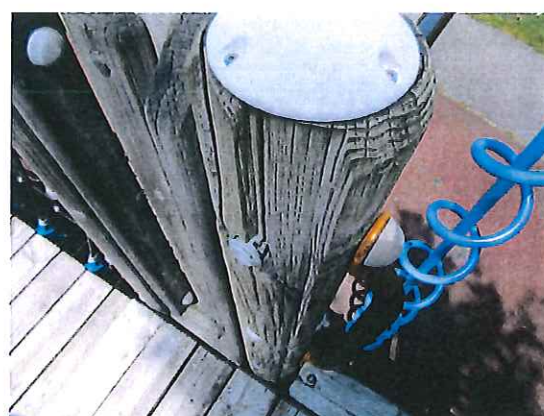
Wood Posts - One post splintered at top of Curly Climber - MAINTENANCE

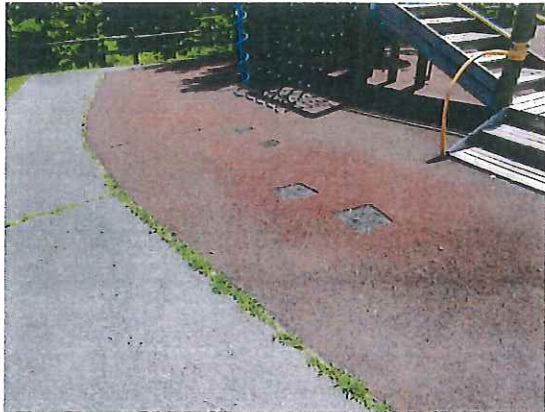
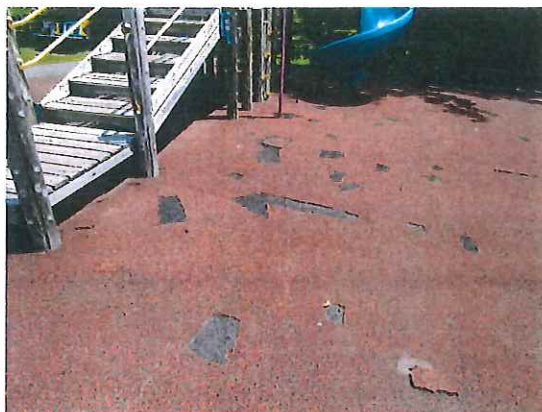
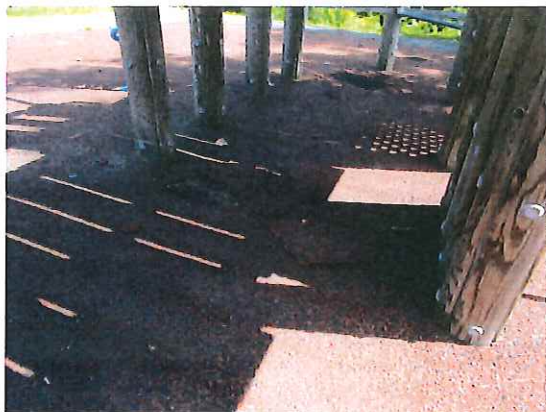
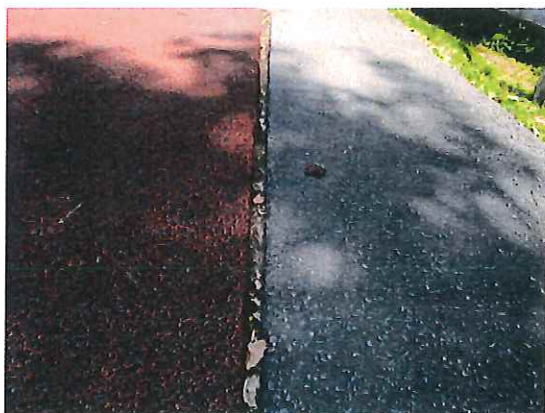
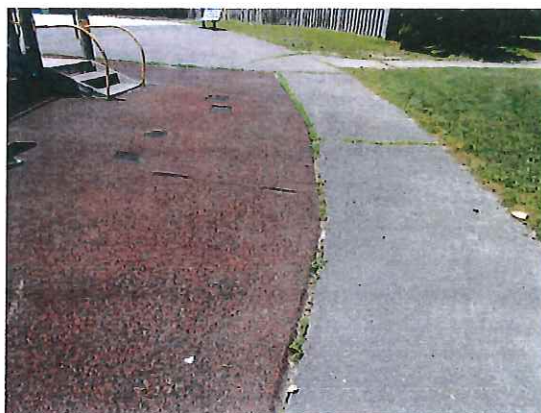
Surfacing - Shrinkage, missing, torn gaps & grass growing - CLASS B HAZARD

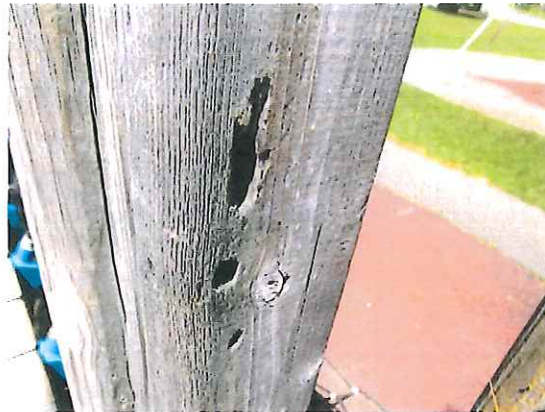
Structure - Bees, insects & bird damage - CLASS A HAZARD

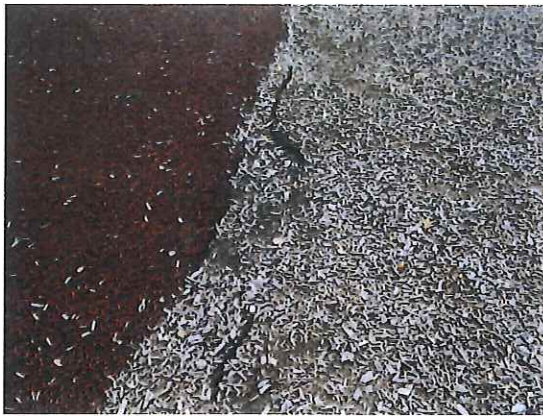
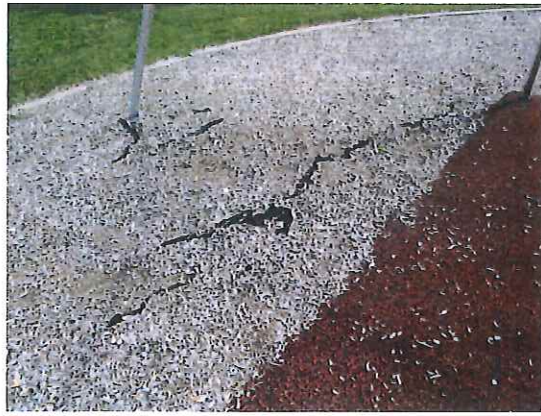
11ft. Swing Set - Fabric is exposed, trip hazard - CLASS C HAZARD

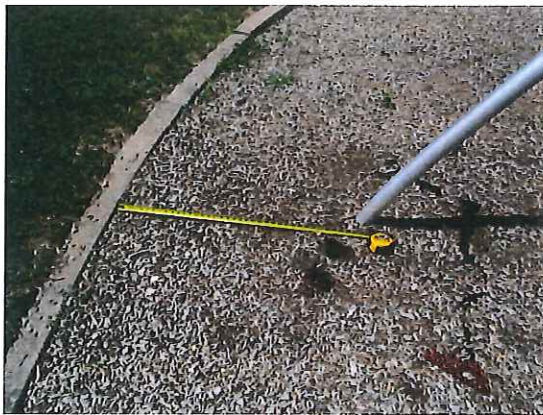
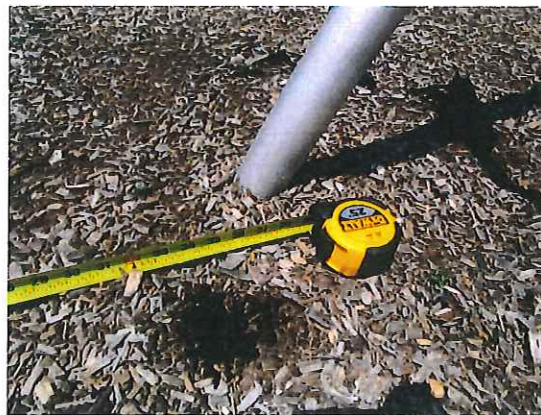
11ft. Swing Set - Use zone is inadequate at 3ft. On sides - CLASS C HAZARD

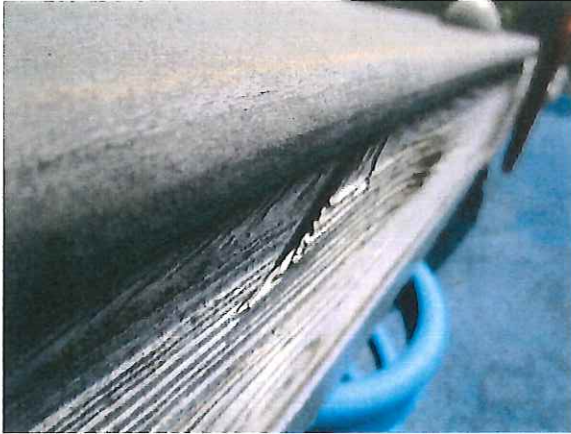
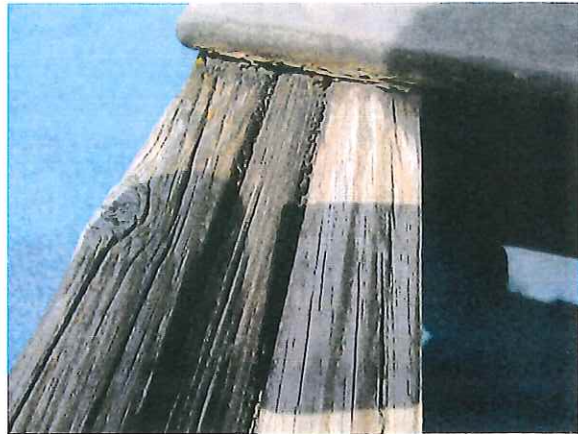
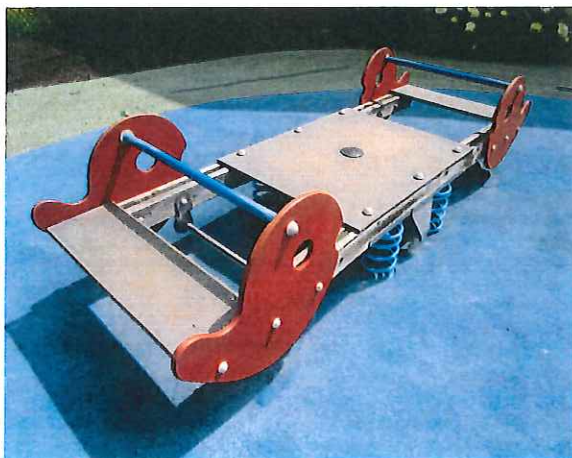
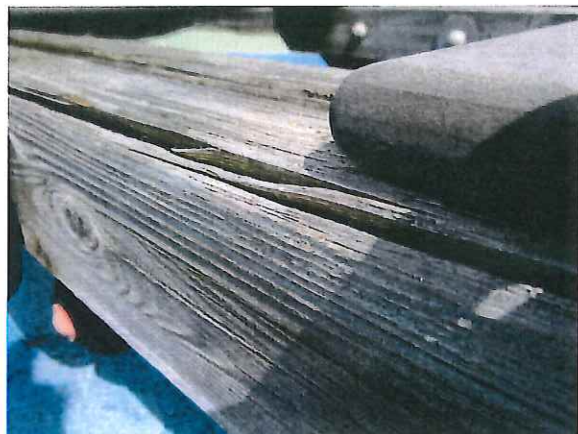
Freestanding Equipment
Multi Spring Seesaw - Wood splitting - MAINTENANCE

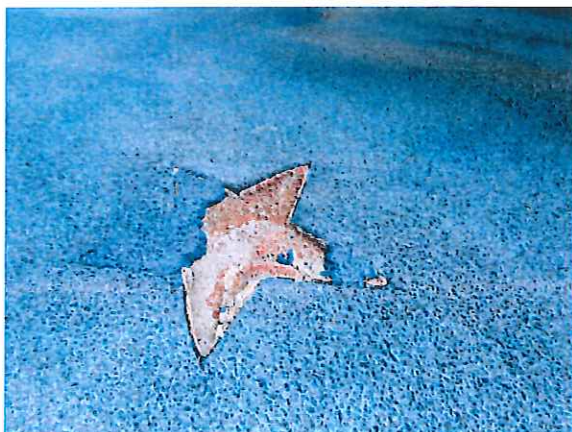
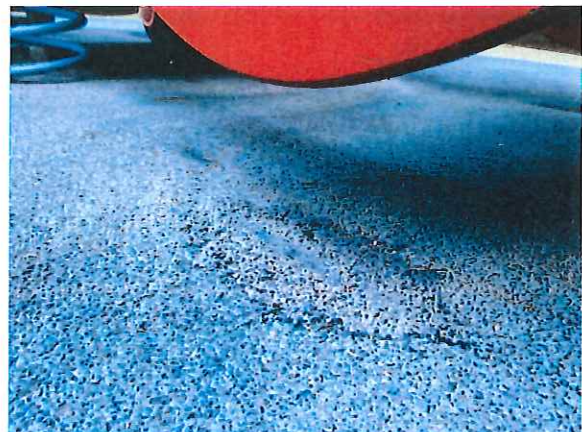
Surfacing - Poor condition - MAINTENANCE

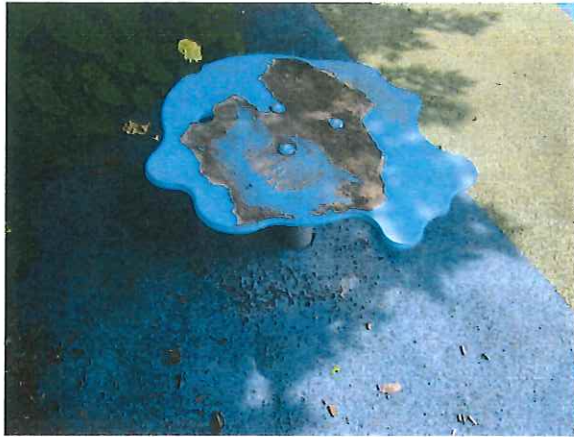
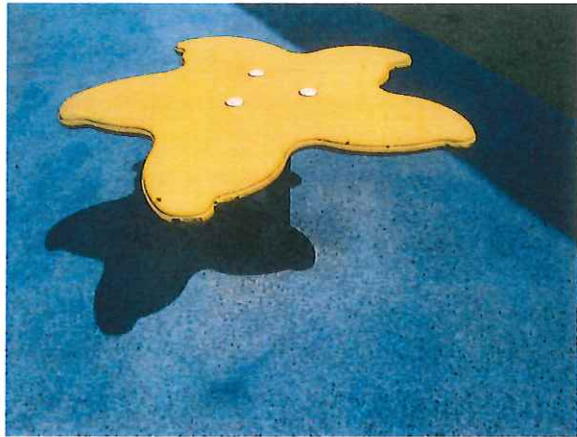
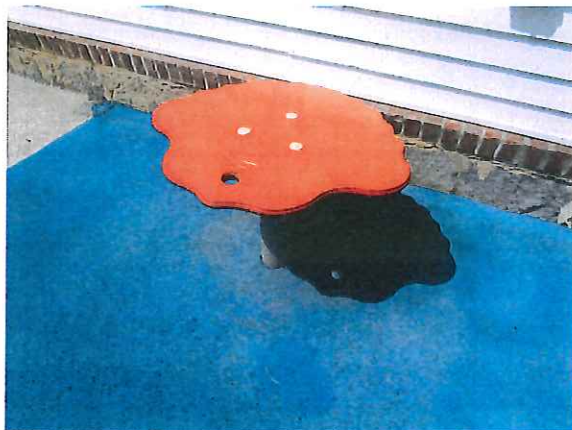
Play tables - Paint is peeling - MAINTENANCE

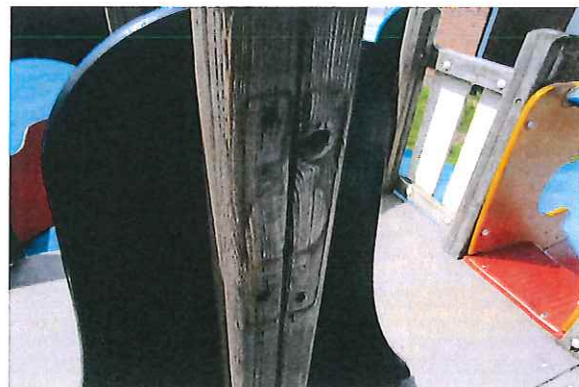
Pirate Ship - Missing component on flag post - MAINTENANCE

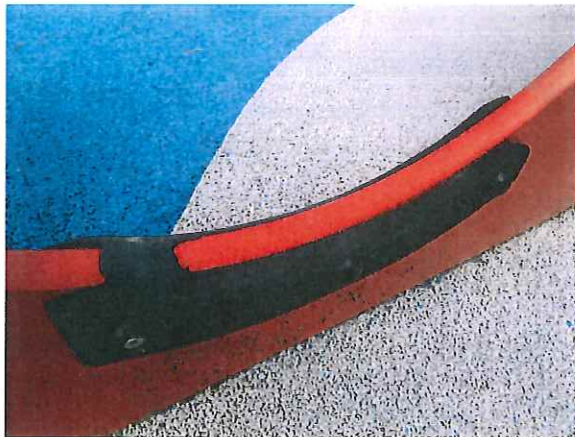
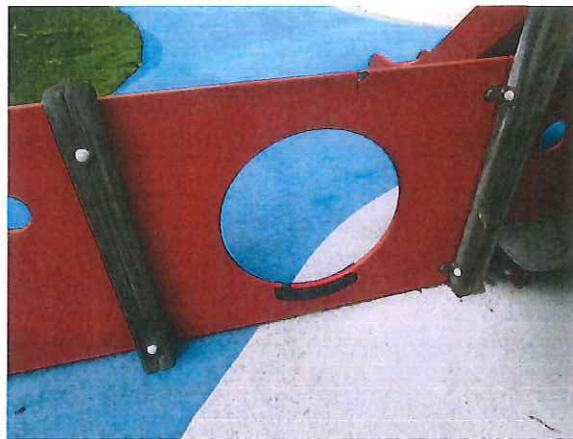
Pirate Ship - Crawl thru pad wearing & crack in crawl thru - MAINTENANCE

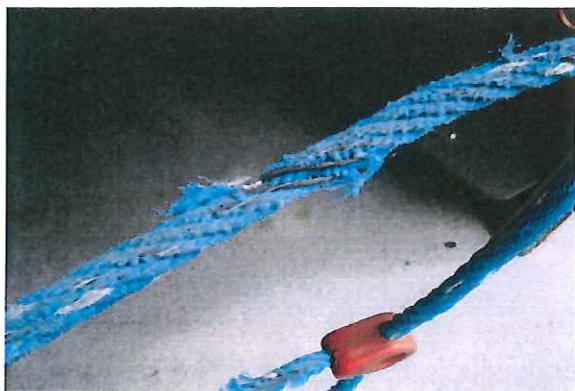
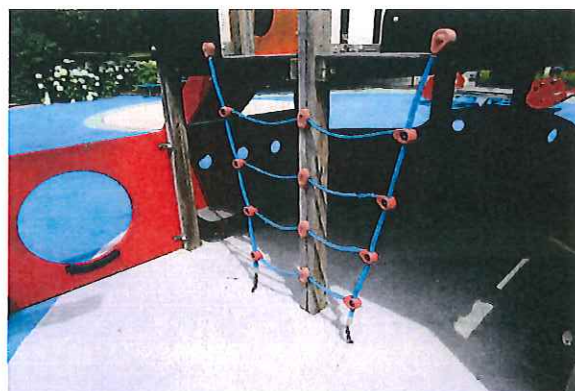
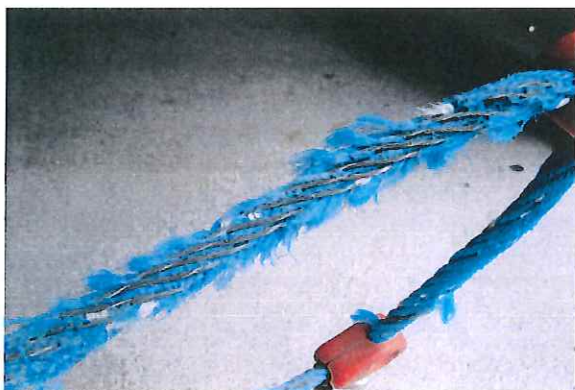
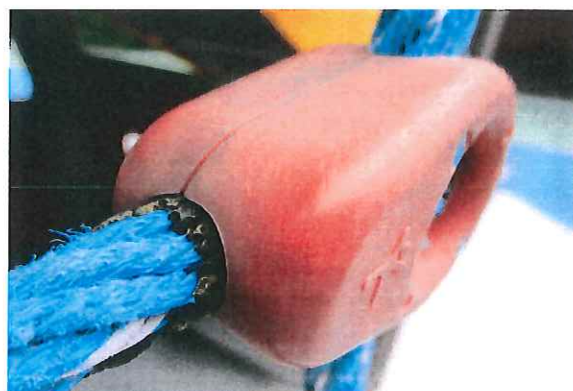
Pirate Ship - Exposed rope, worn - MAINTENANCE

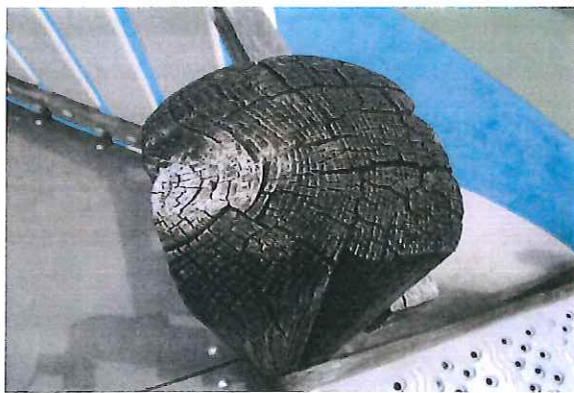
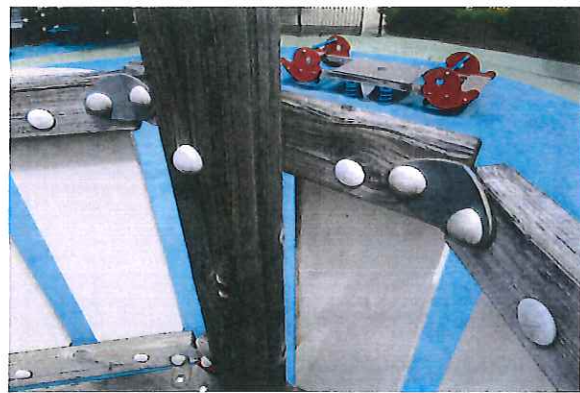
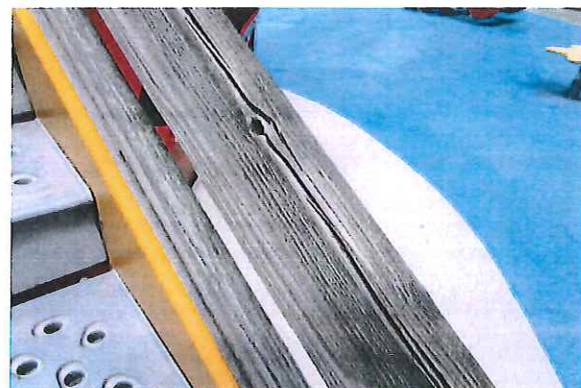
Pirate Ship - Wood worn, cracked & splintered - CLASS C HAZARD

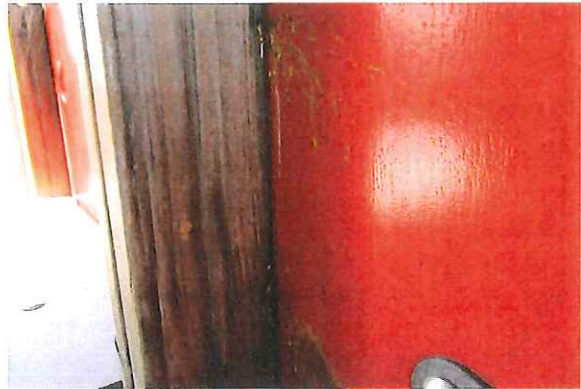
Pirate Ship - One cracked cap & insect damage - MAINTENANCE

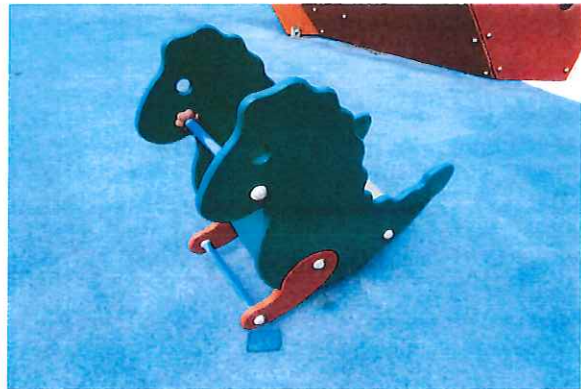
Dragon Springer (2)(Kompan) - Wood splitting on one - MAINTENANCE

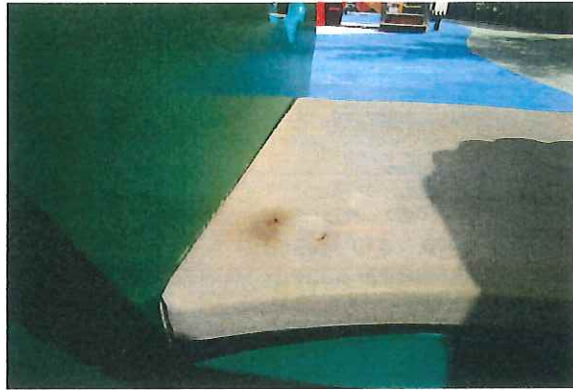
Dragon Springer (2)(Kompan) - Crack in platform on one - MAINTENANCE

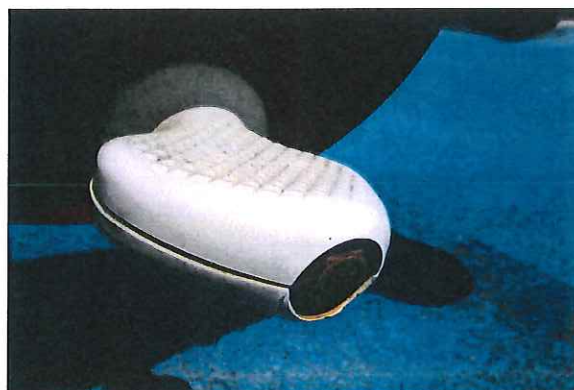
See Saw - Two caps missing - MAINTENANCE

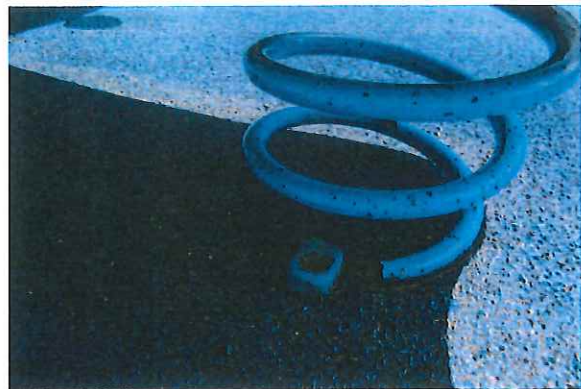
Surfacing - Cracked around springs - MAINTENANCE

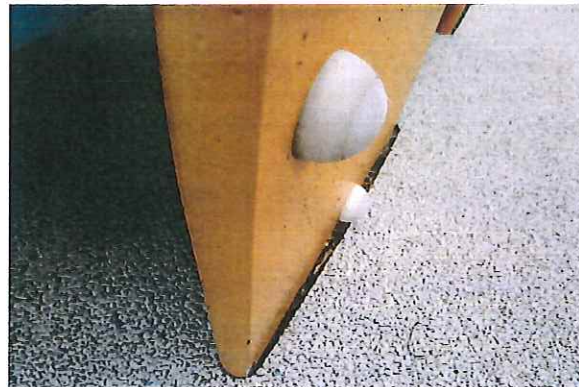
Surfacing - Shrinking - MAINTENANCE

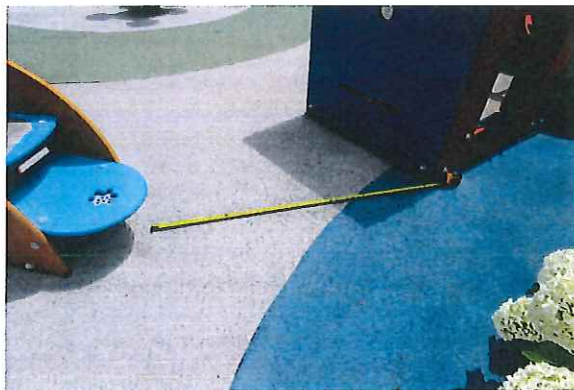
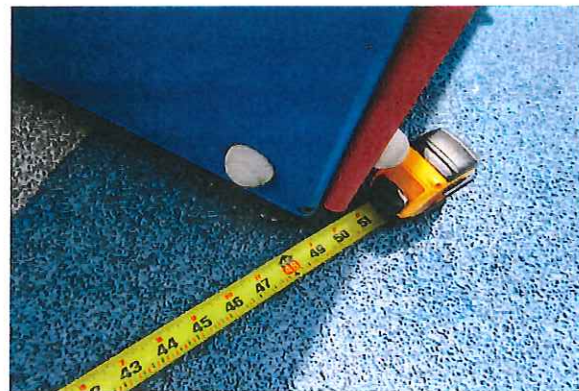
Use Zone - Inadequate at 4ft. to Labyrinth - CLASS B HAZARD

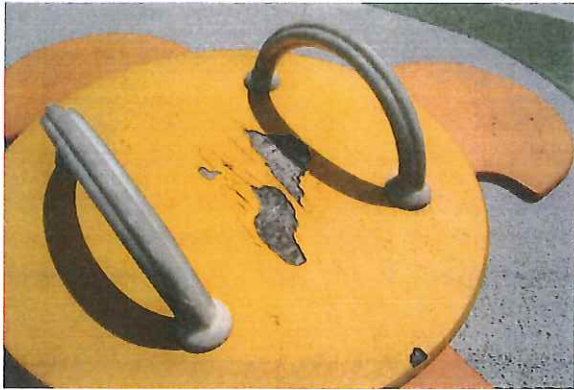
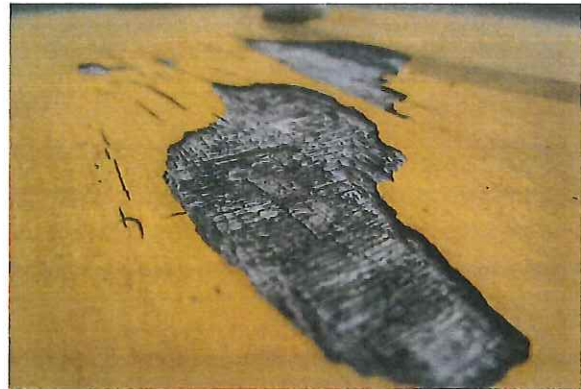
Daisy Springer (Kompan) - Wood is cracking - MAINTENANCE

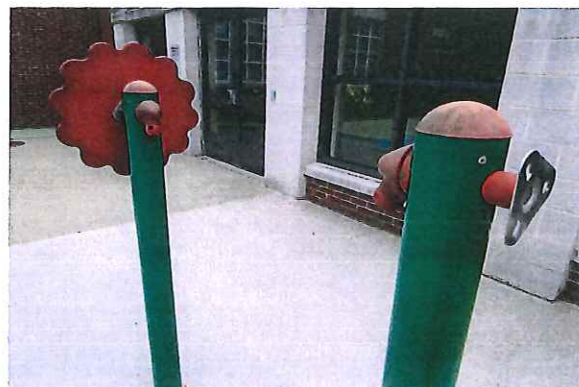
Sunflower Swing - Missing swing & chains - MAINTENANCE

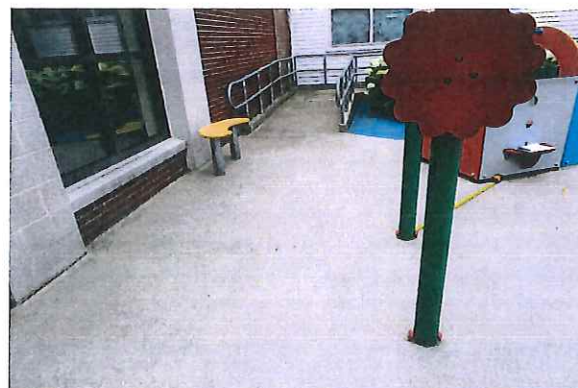
Use Zone - Inadequate at 4ft. on one side, overlaps w/ Labyrinth - CLASS B HAZARD

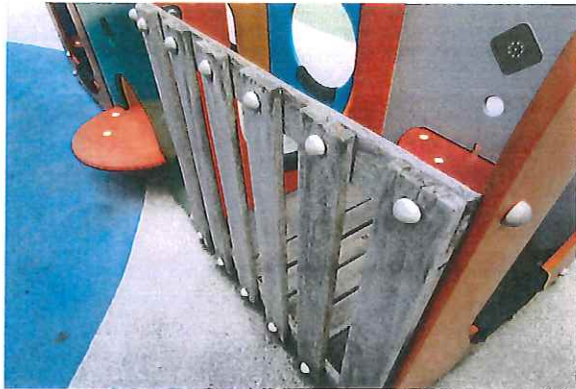
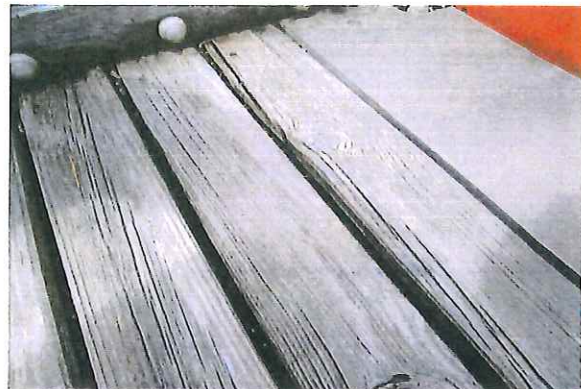
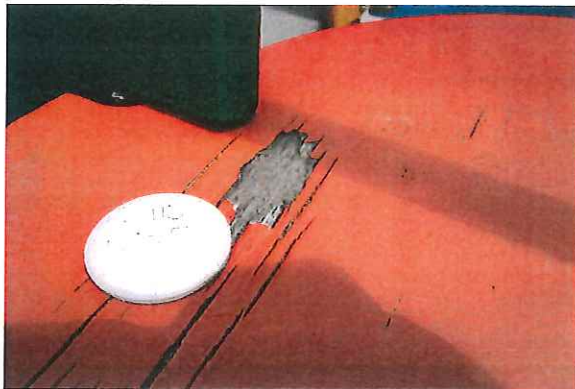
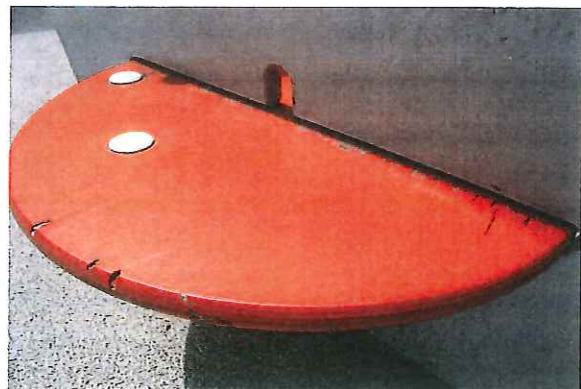
Labyrinth - Wood is cracking - MAINTENANCE

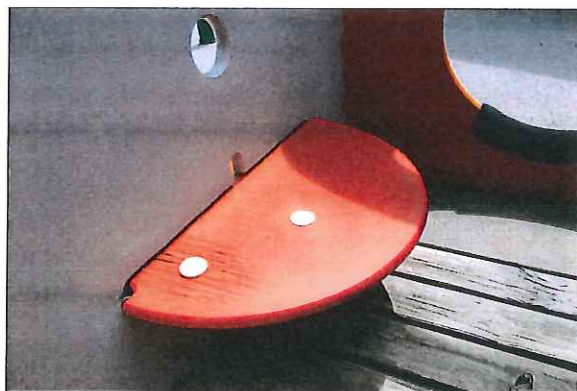
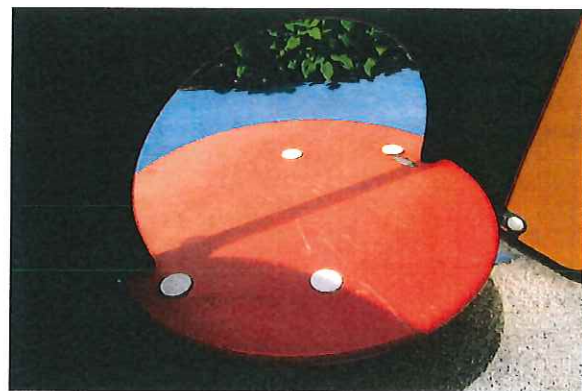
Labyrinth - Two seats loose - MAINTENANCE

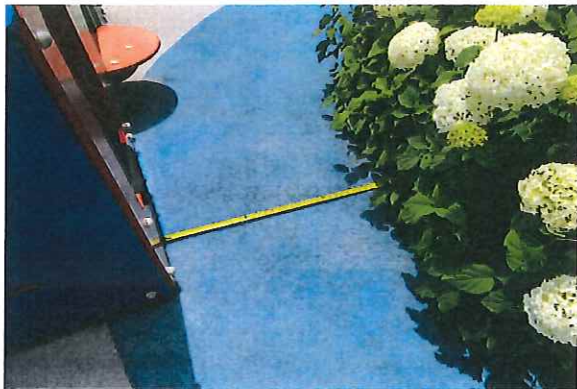
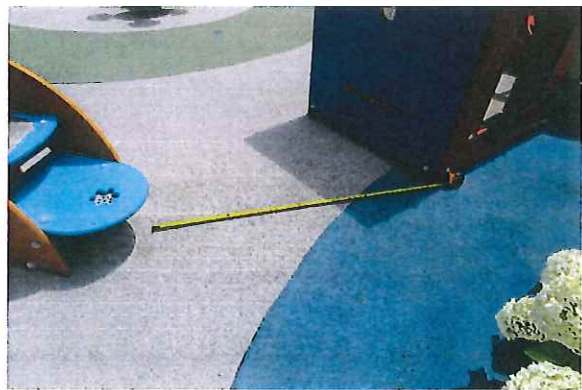
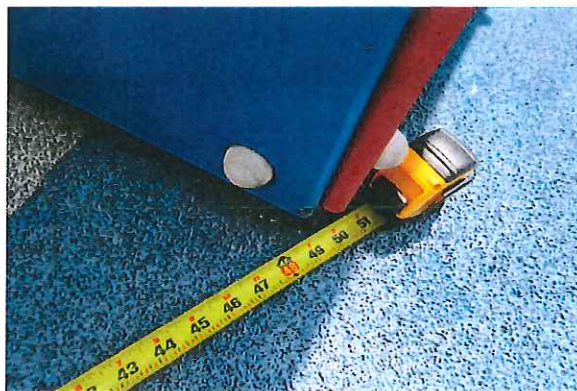
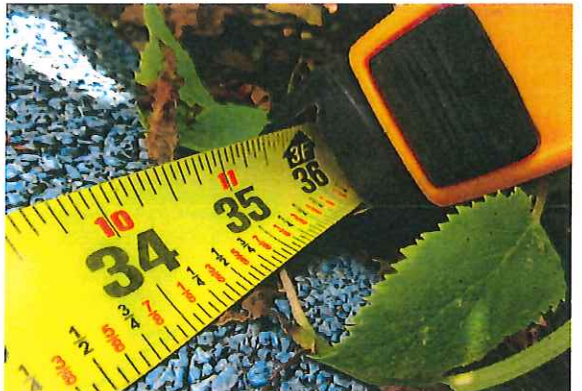
Use Zone - Overlaps with Sunflower Swing & Mighty Musketeer - CLASS B HAZARD

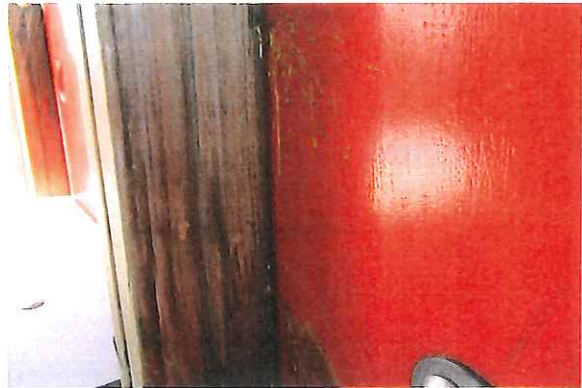
Bees or insects/animals - Infestation, insect damage to Pirate Ship - CLASS A HAZARD

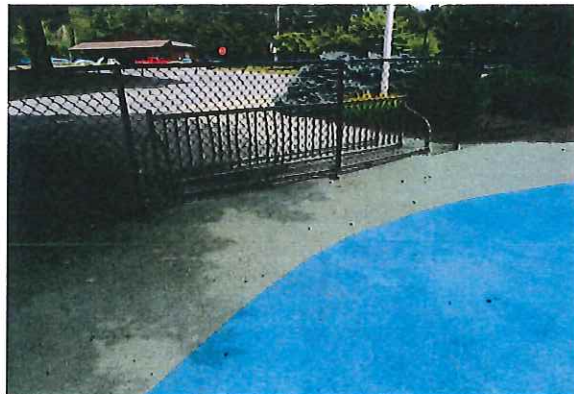
Border/Edging - Tree roots pushing up surfacing at perimeter - MAINTENANCE

Tree roots pushing surfacing up at perimeter	Maint.	Cut and remove tree roots, repair subsurface & replace PIP rubber
		Lamp post pad damaged	Maint.	Replace pad

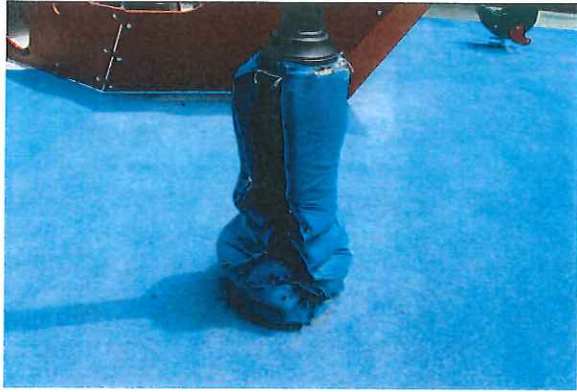
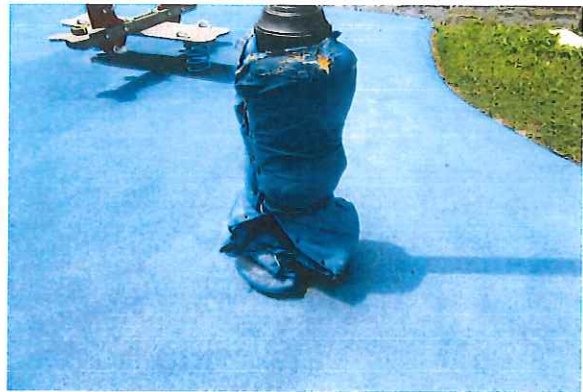
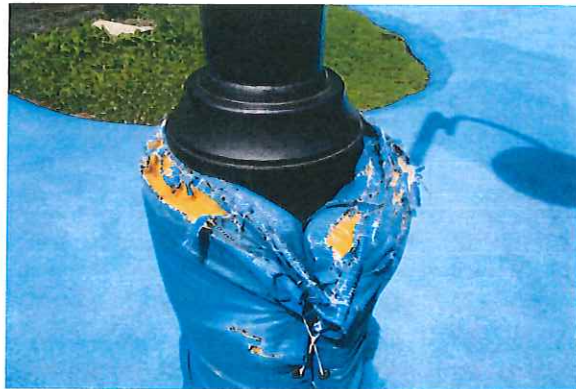
Lamp Post - Post pad damaged - MAINTENANCE
