Facility Survey, Code Analysis and Buildings & Grounds Survey & Master Plan

The Sherman School

Sherman, Connecticut

November 2018

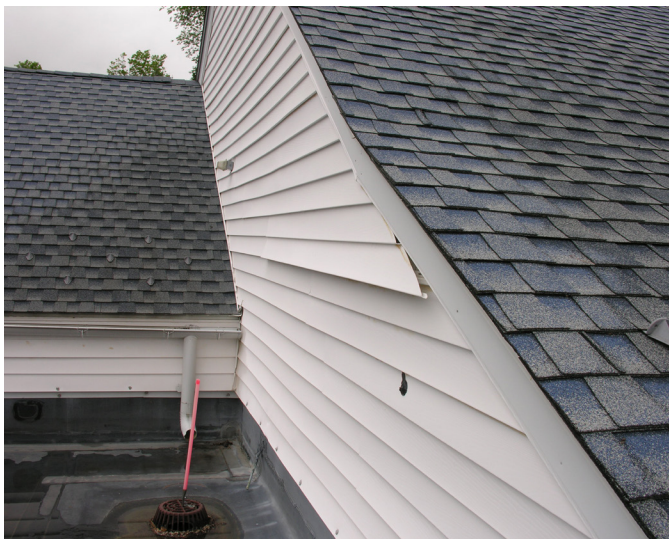
9. Location:

Damaged Vinyl Siding at Gable End Wall

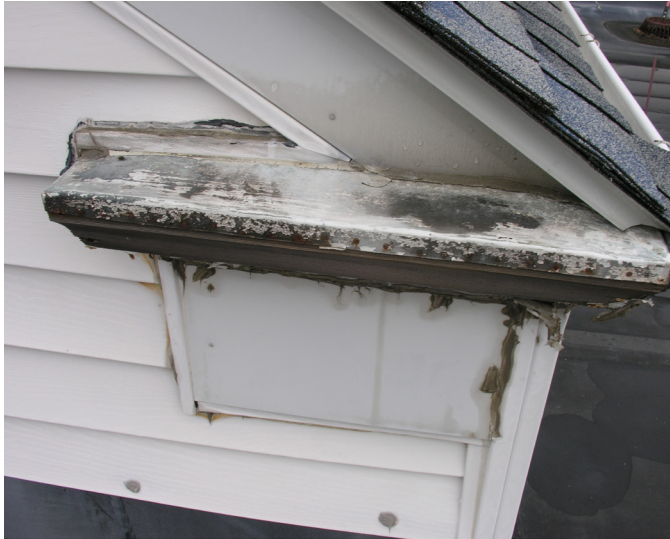
10. Location:

Damaged Gable Roof Trim

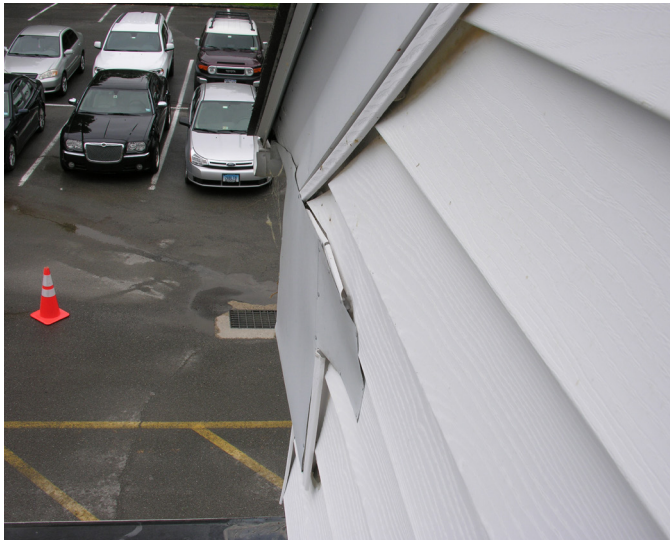
11. Location:

Damaged Gable Trim & Siding

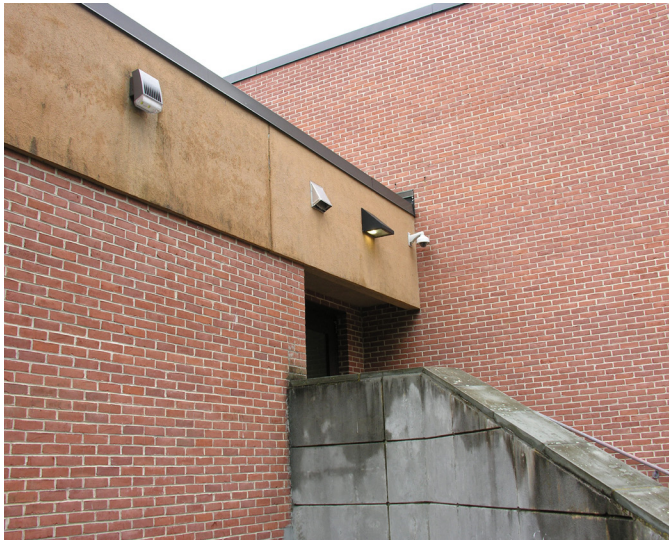
14. Location:

Damaged EIFS

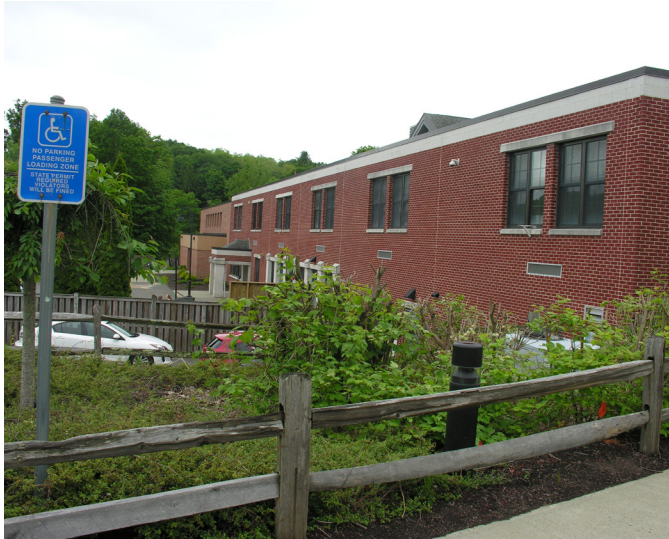
16. Location:

Library Looking East from Courtyard Playground. Playground and surfacing in need of replacement.

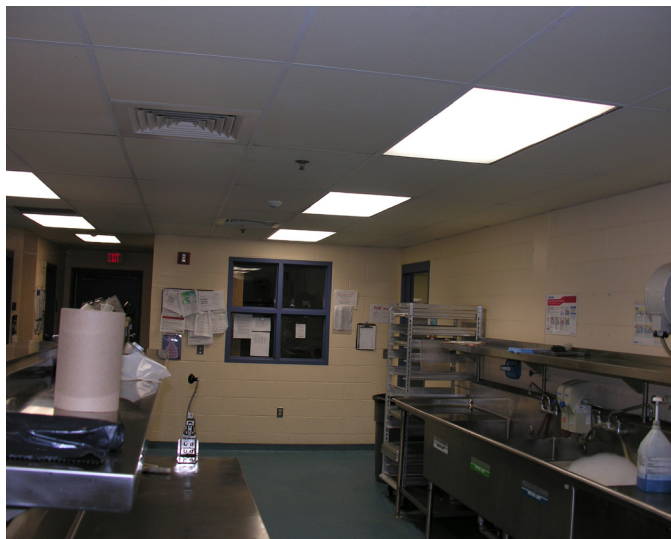
21. Location:

An overview of the Kitchen. The 3 bay Sink area is shown. The epoxy floors, painted CMU walls and acoustical tile ceiling system are all in good condition

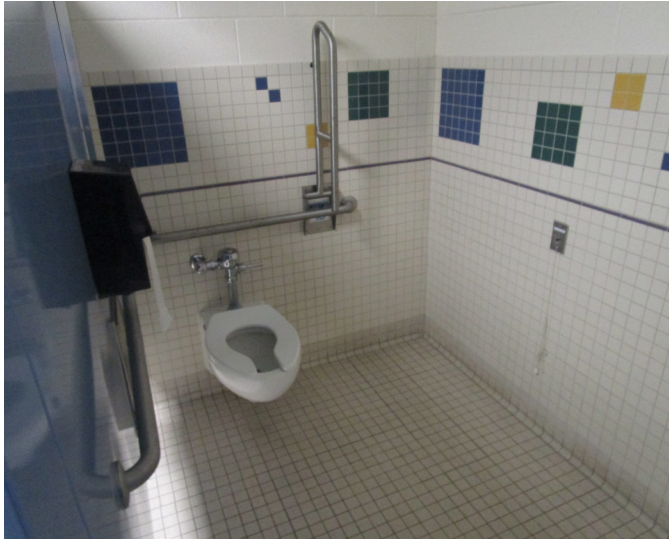
22. Location:

Vinyl Sanitary Baseboard Missing
Throughout Room

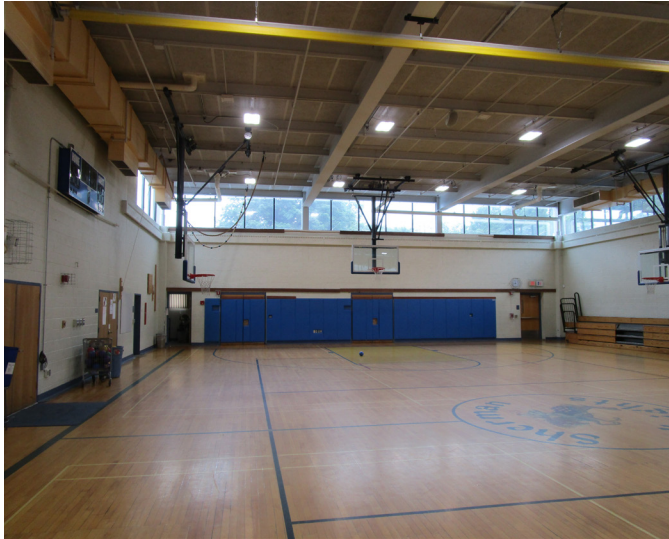
28. Location:

An overview of the Gymnasium. The wood floor, painted CMU walls and painted roof structure are all in good condition. The opening to the P.E. Office, Storage Room & Stairwell are shown at the far wall.

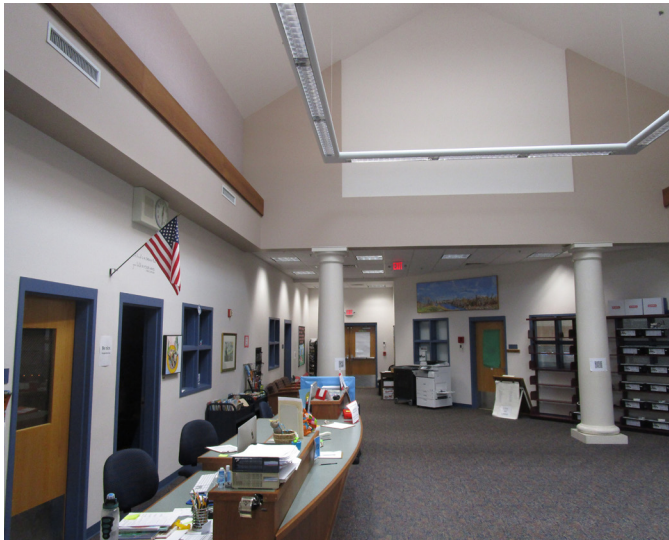
29. Location:

An overview of the Media Center. The carpeted floors, painted Gypsum walls, soffits and ceilings are in good condition.

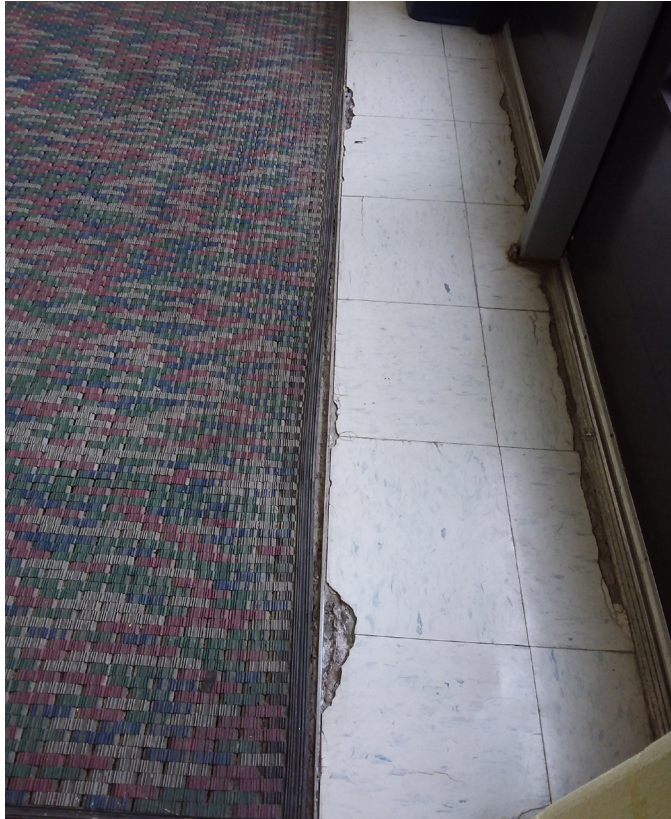
35. Location:

Areas near or around exterior doors have very heavy damage and require attention. Frames for the recessed entry grill system is popping up and poses a tripping hazard.

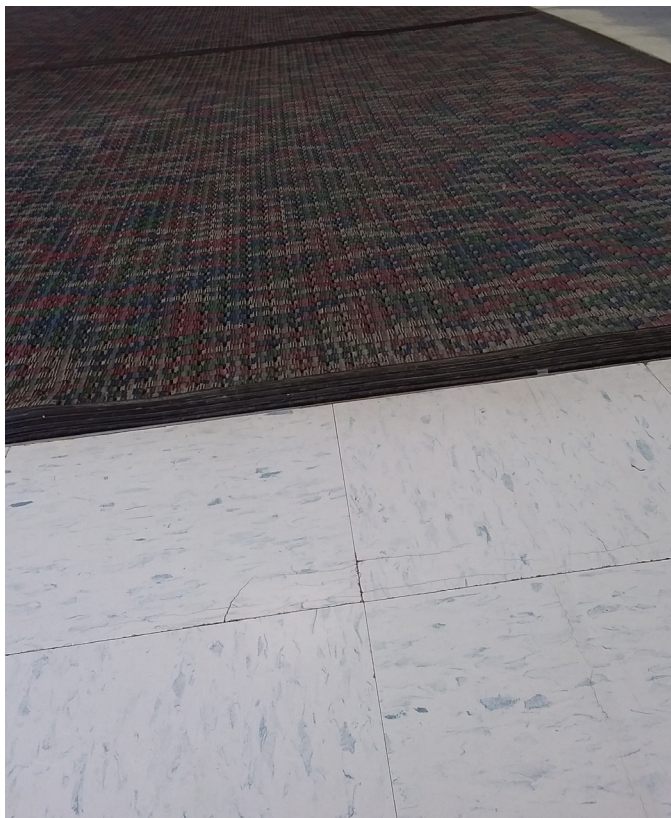
36. Location:

Areas adjacent to recessed flooring tracks in corridor areas by exterior doors show heavy damage and pose a tripping hazard.

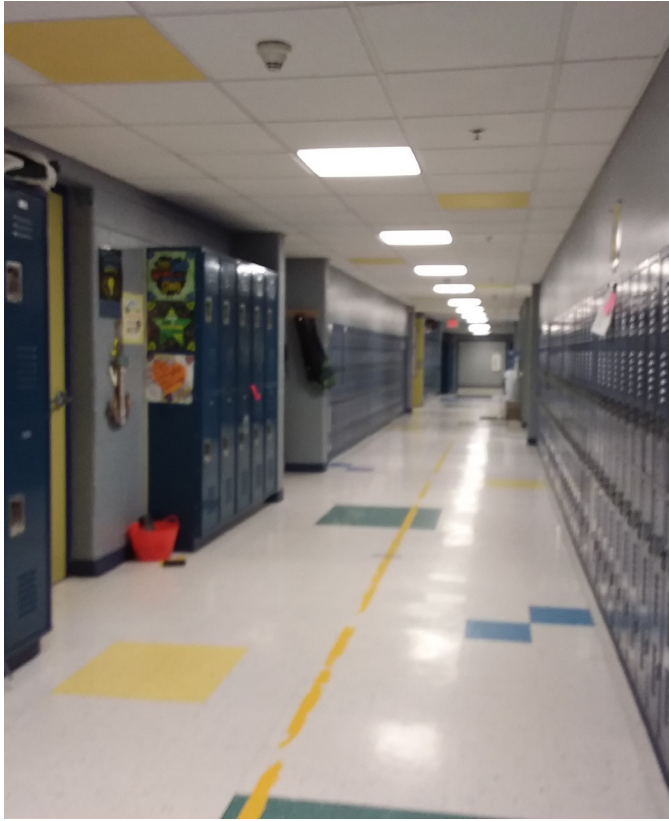
37. Location:

Yellow tape which has been applied to the center of each corridor is peeling up.

Lockers are in poor condition. Lockers are too small for required student book bags.

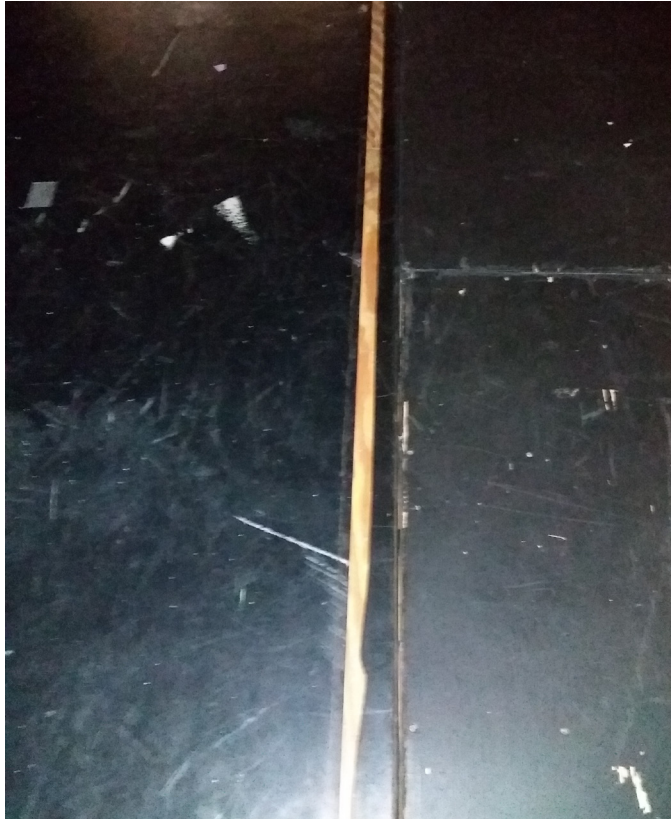
39. Location:

Stage flooring poses tripping hazard and requires repair.

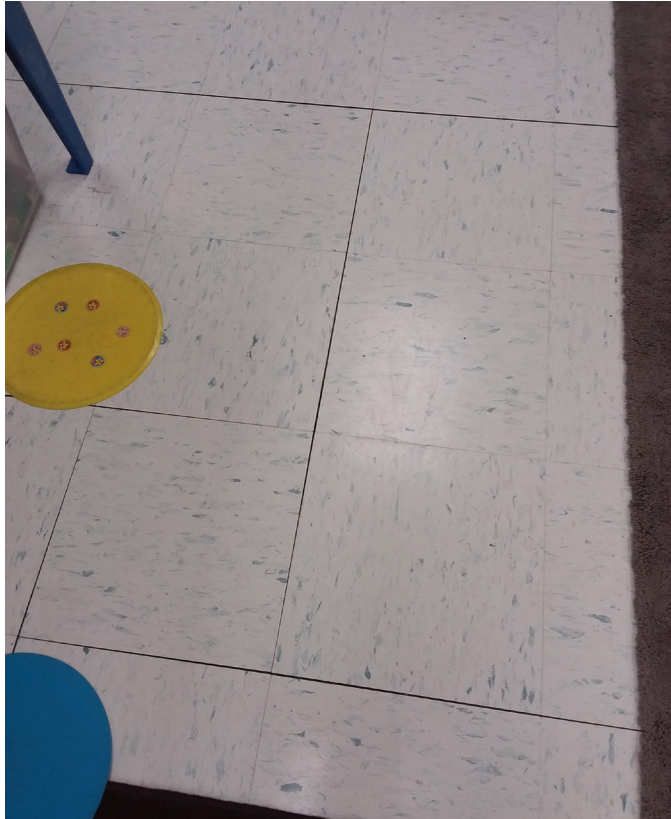
47. Location:

Cracking and tile separation is present in many classrooms

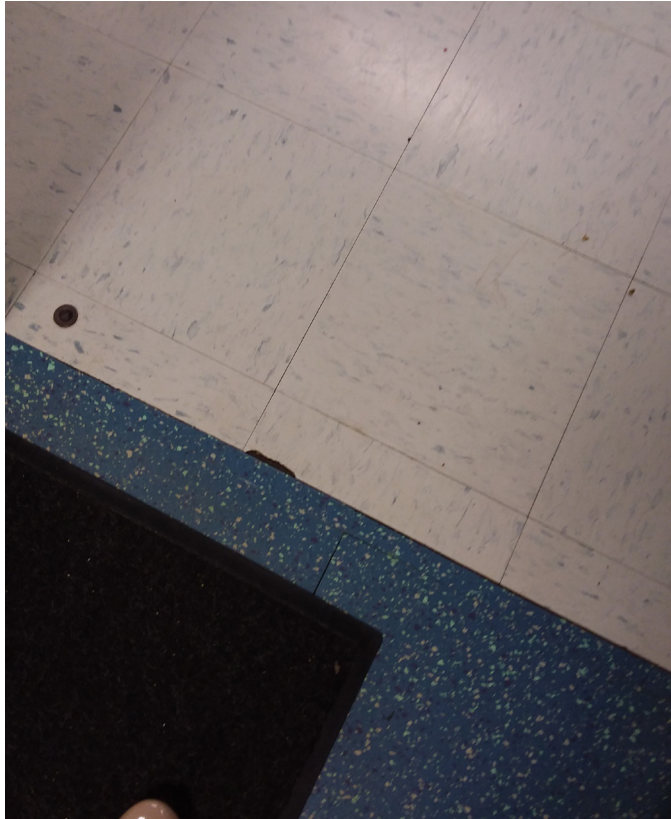
51. Location:

Majority of the floor shows minor tile separation. The transition at the entry to the cafeteria from the corridor needs a transition strip to prevent further cracking at threshold.

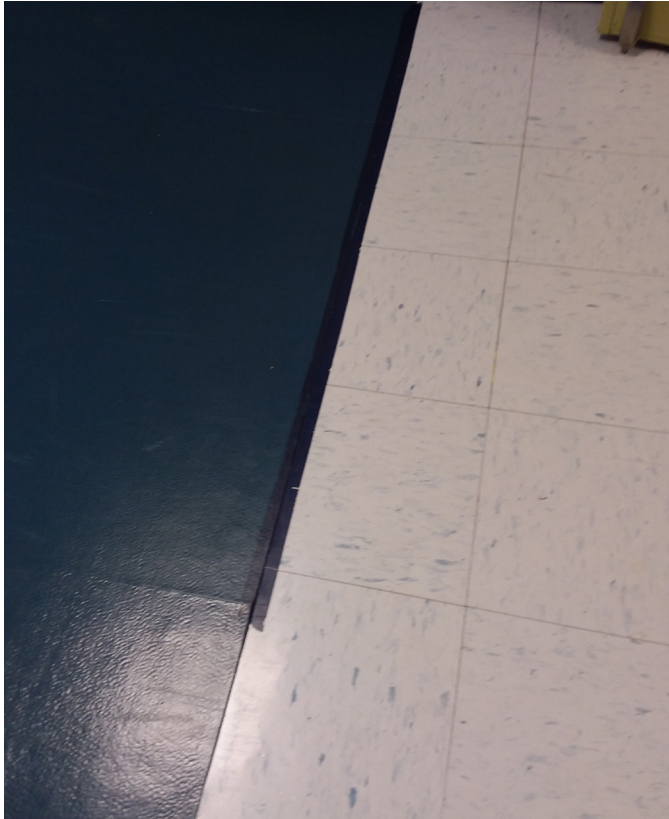
53. Location:

The rubber ramps themselves are in good condition, however where the rubber transitions to the adjacent Vinyl Composition Tile (VCT) the two flooring materials are separating. The VCT is chipping. A temporary solution of duct tape over the seams has been applied to these thresholds, however this is not a long term solution. Heat welding seams is suggested here.

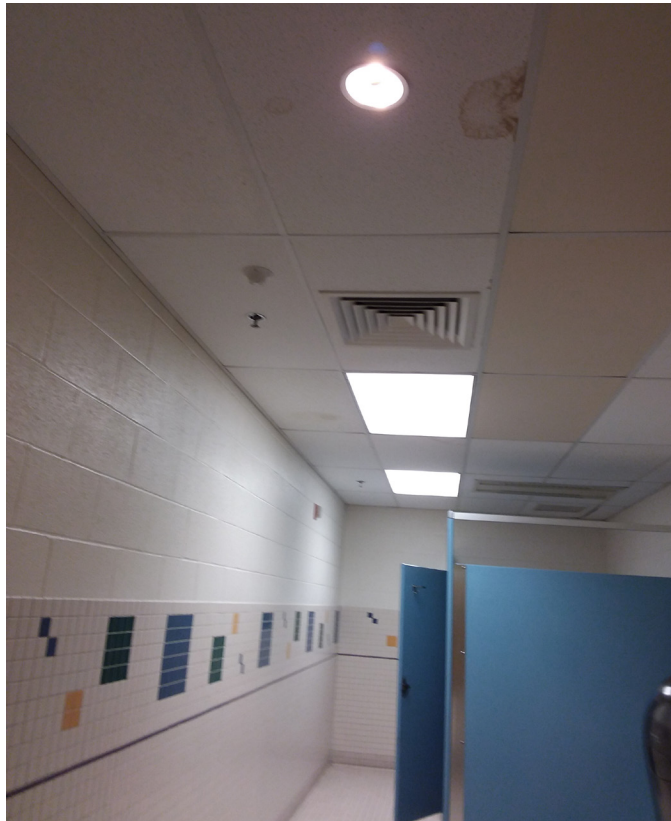
57. Location:

Areas of water damage present in some toilet rooms as well as attempted repair by infill of various types/colors of ceiling tiles.

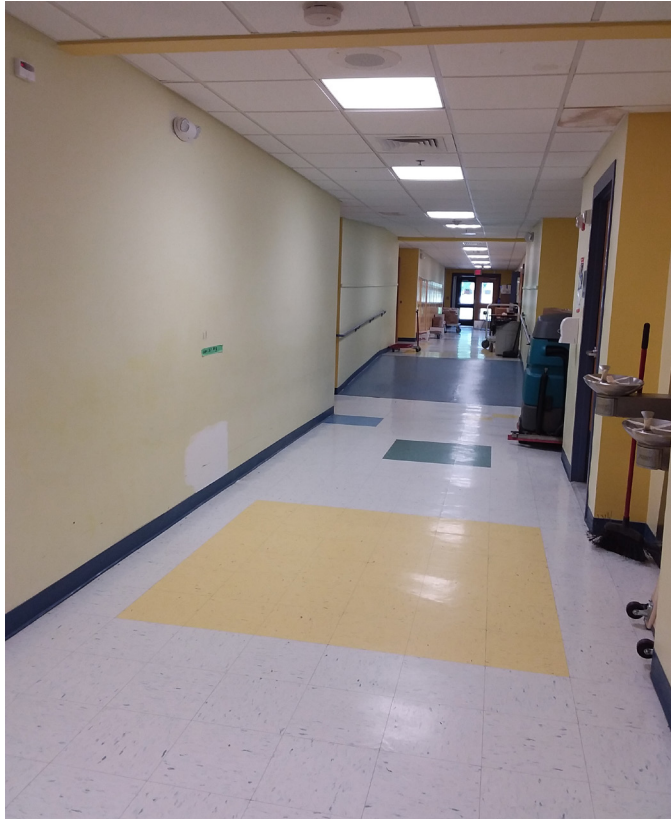
59. Location:

Walls damaged in many areas. Some have been spackled, but repair has not been completed.

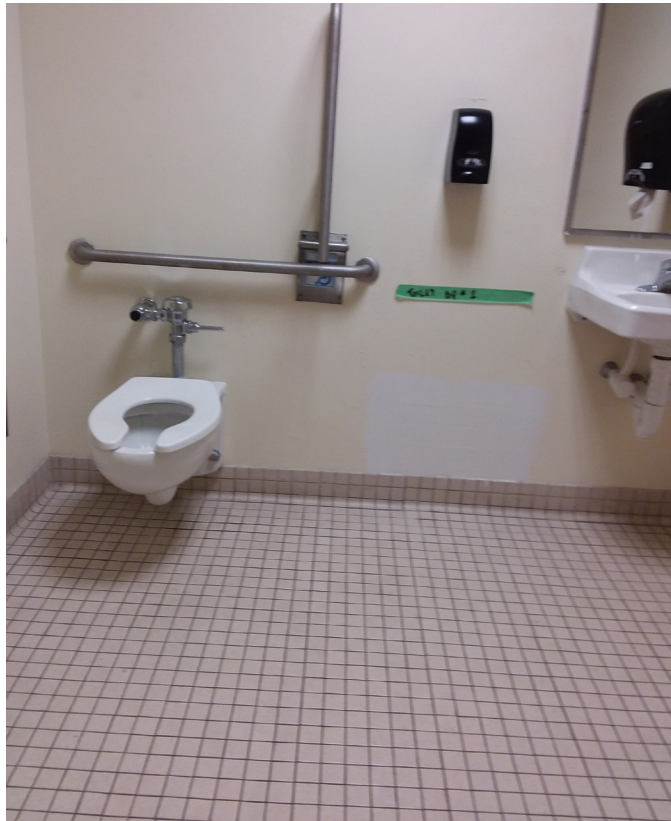
61. Location:

Most toilet rooms appear in fair condition with the exception of the ones where walls have been opened to investigate the moisture.

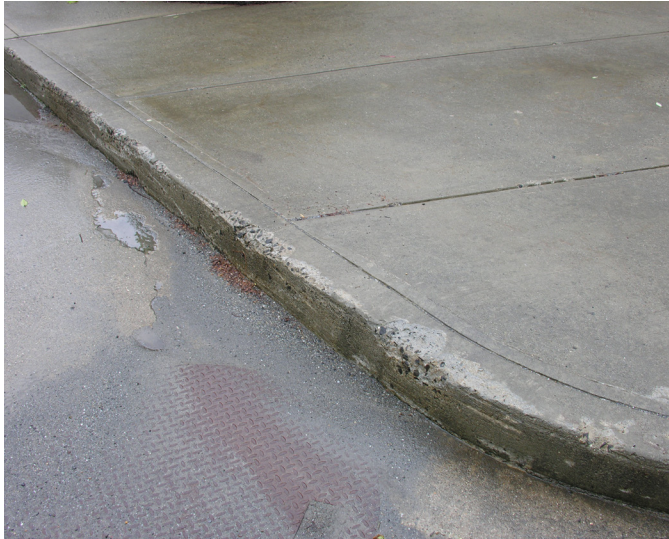
1. Location:

Damaged Concrete Curb

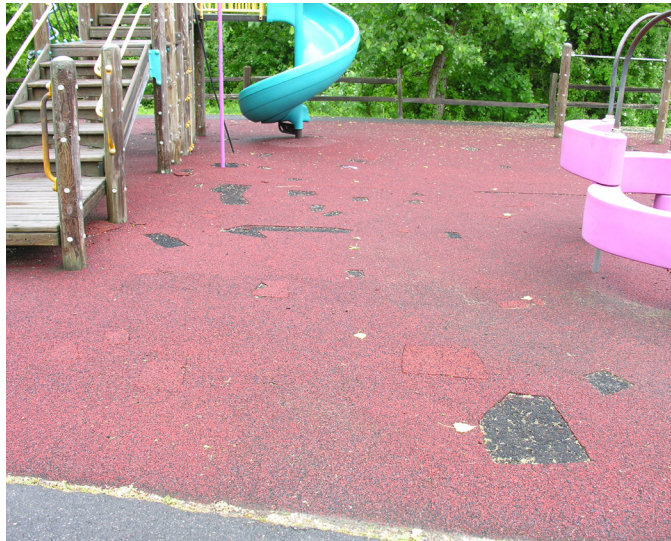
10. Location:

Wood play elements in poor condition.
