Table of Contents

Facility: Sherman School

Report Date: 04/29/2019

Roof Section: All Roof Sections except Roof Section AD & Shingle Section:

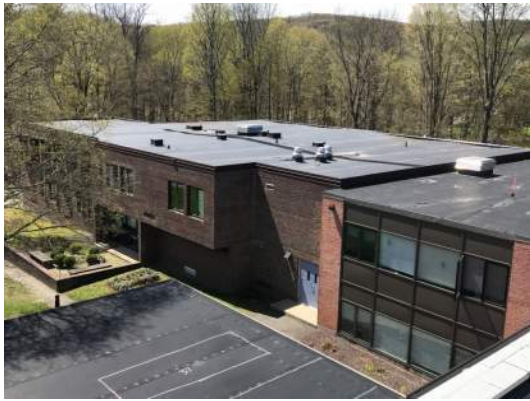
Photo 1

Overview of roof section AF - roof installed in 2011

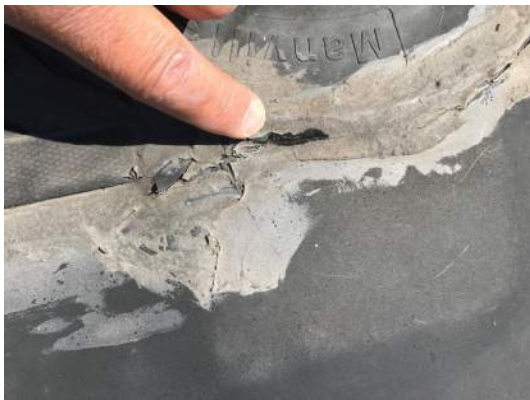
Photo 2

Splits in seams causing leaks

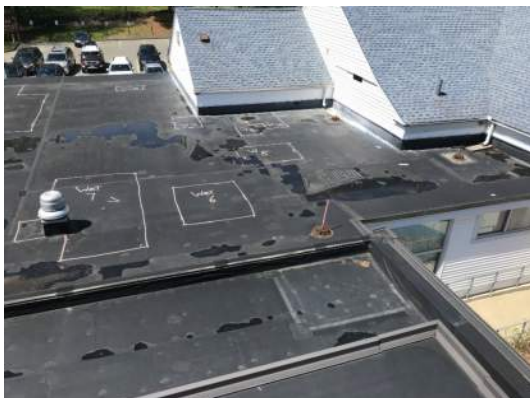
Photo 3

Overview of roof AB which was installed in 1991 and is at the end of its usable life and needs immediate attention

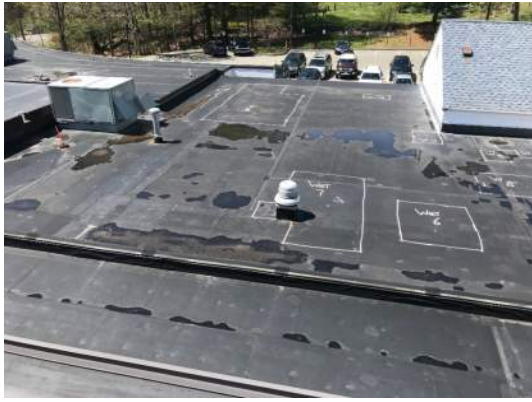
Photo 4

Another view of roof AB - installed in 1991

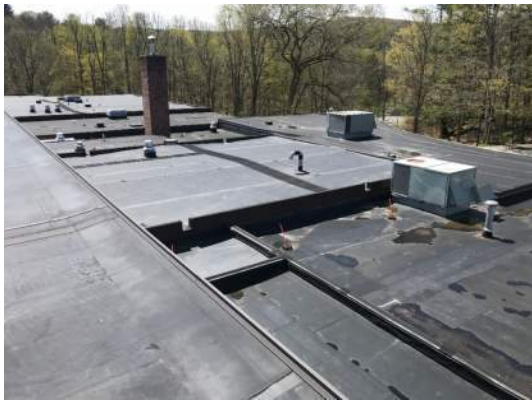
Photo 5

Overview of multiple roof sections

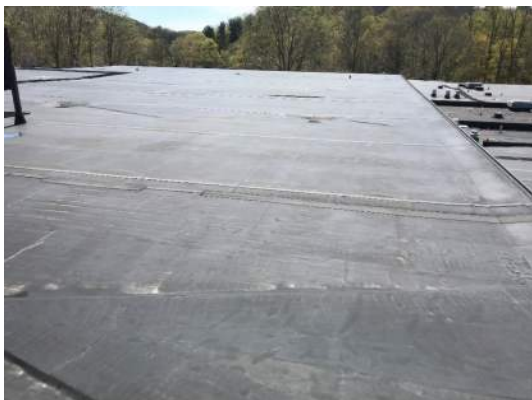
Photo 6

Overview of Roof AE

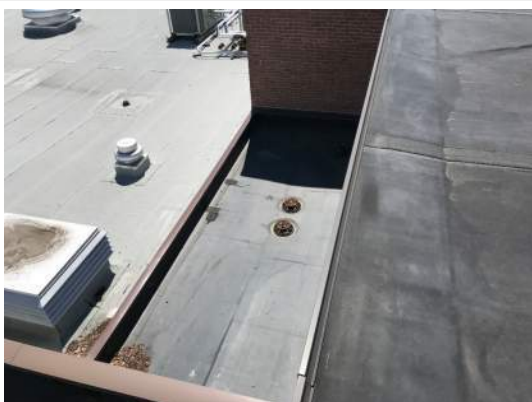
Photo 7

Overview of roof D which was installed in 2011 and is currently still under warranty until 2031

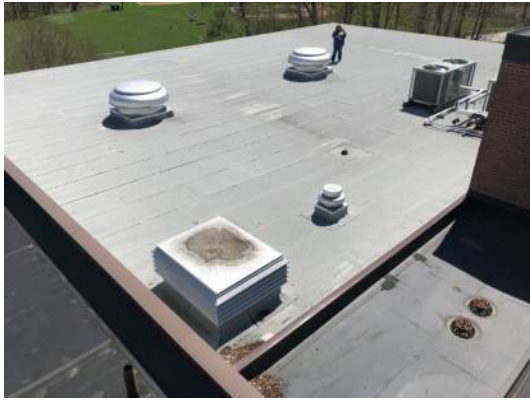
Photo 8

Overview of Roof AD which is a Garland which is a 2 ply SBS modified roof system, which was installed in 2014 and is currently under a 20 year warranty which will expire in 2034.

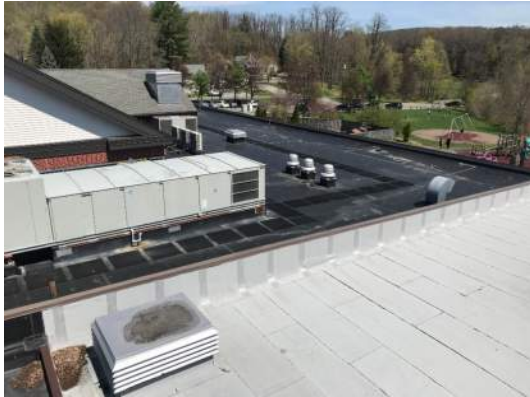
Photo 9

Overview of roof AD and AG

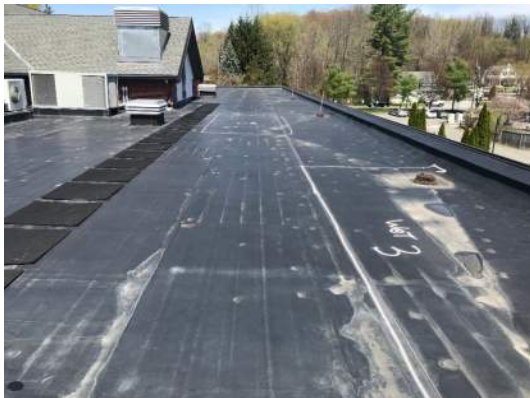
Photo 10

Overview of roof AG which was installed in 2000.

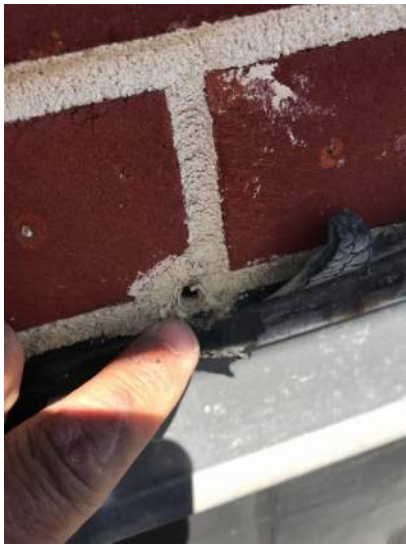
Photo 11

Photo confirmation of weep holes that needs to be cleared

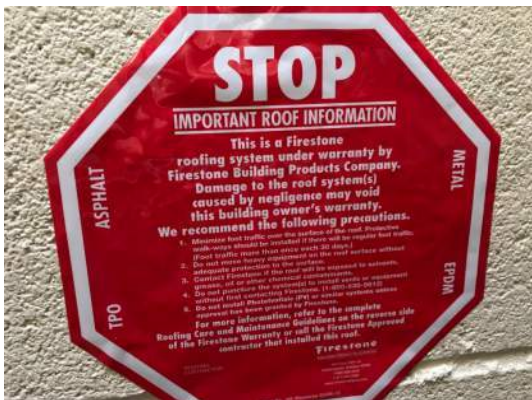
Photo 13

Photo confirmation of warranties in place on certain roof sections

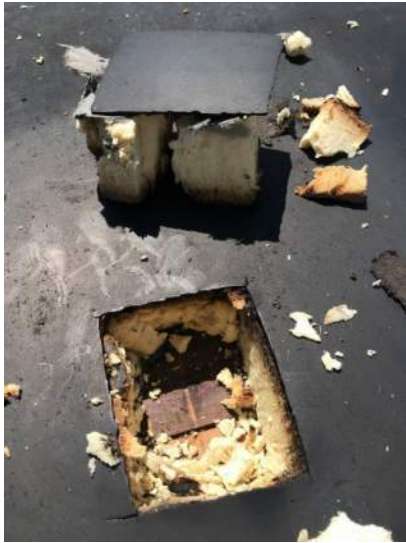
Photo 14

Core cut roof AB shows structurally sloped wood deck with 2" of ISO

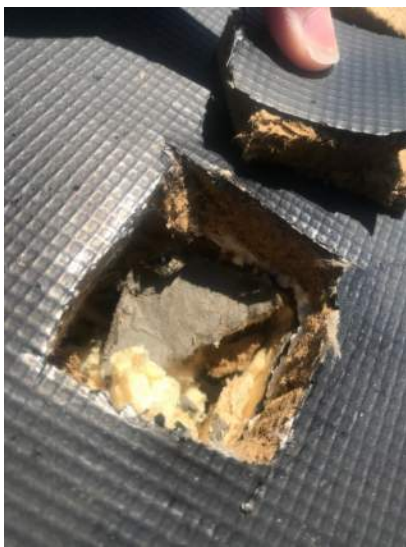
Photo 15

Core cut of one section of roof AA - Fully adhered EPDM roof with a structurally sloped metal deck. This section has 3" ISO, 1/4" of polystyrene and 1/2" wood fiber board. We did a core cut on another section of roof AA and there was no recovery board or polystyrene present, just ISO. The existing EPDM membrane is significantly worn which you can see the reinforcement showing.

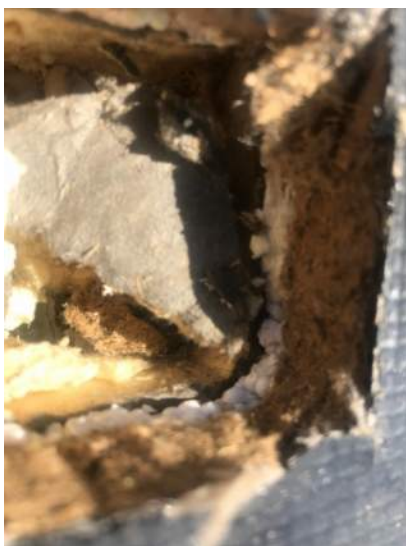
Photo 16

Another view of core cut

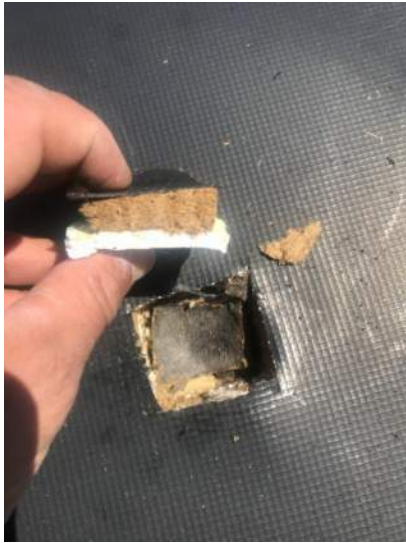
Photo 17

Another view of core cut

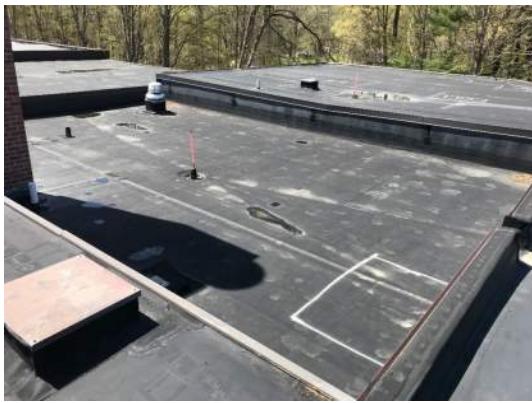
Photo 18

Overview roof section V which was installed in 1991 and is one of the sections that need immediate attention

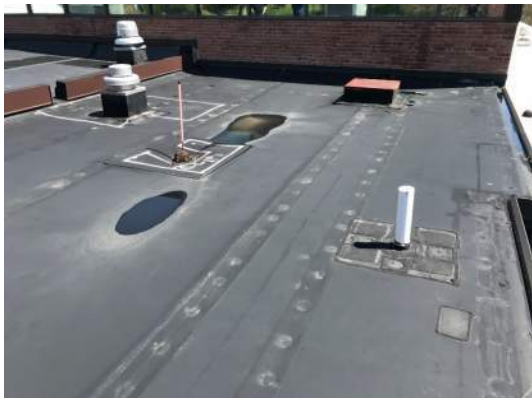
Photo 19

Overview of roof section S which was installed in 1991 and is in need of immediate attention

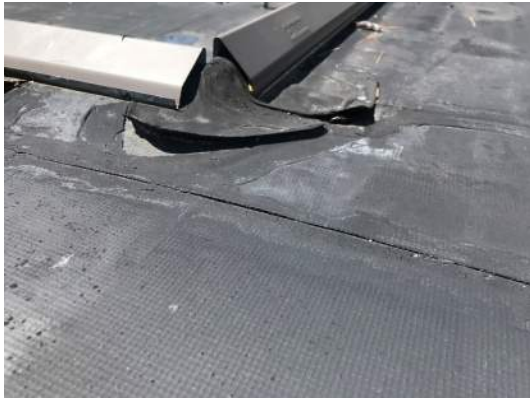
Photo 20

Photo confirmation showing the field side laps being to open up due to UV exposure

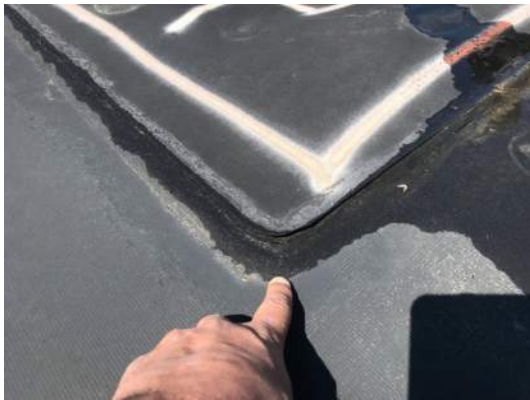
Photo 21

Photo confirmation of seam lifting and curling. The actual membrane is beginning to break down due to age and UV exposure.

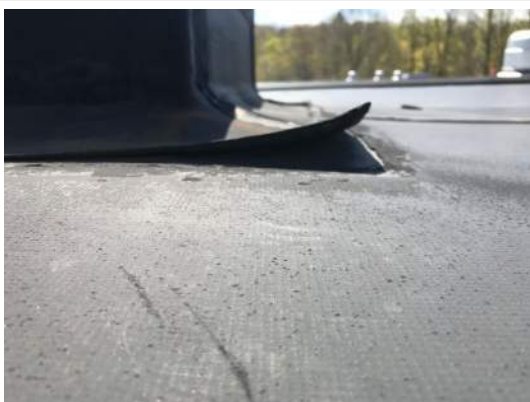
Photo 23

Photo confirmation of more seams lifting and curling due to UV exposure

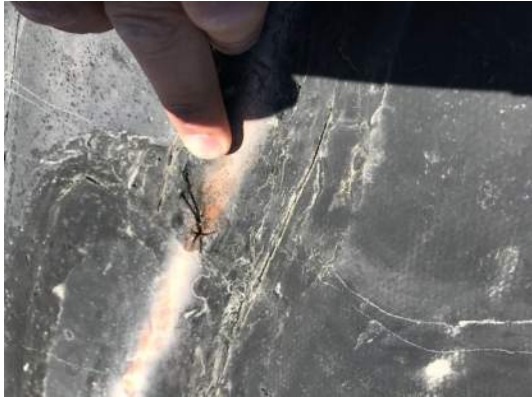
Photo 25

Photo confirmation of penetrations in the field.

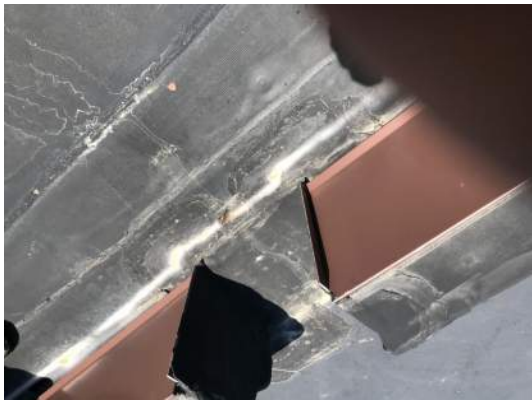
Photo 26

Unfortunately the photo is rotated but this is a roof to roof scupper.

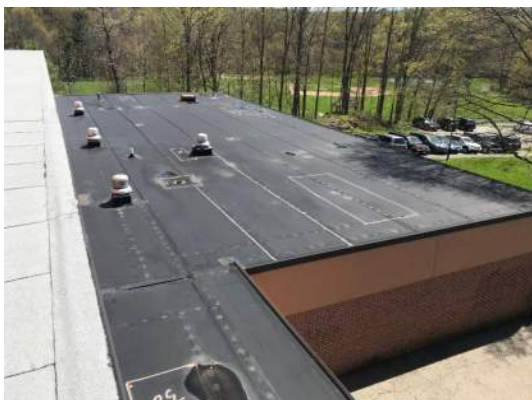
Photo 27

Overview of roof section AC which was installed in 1991 and is one of the sections that need immediate attention

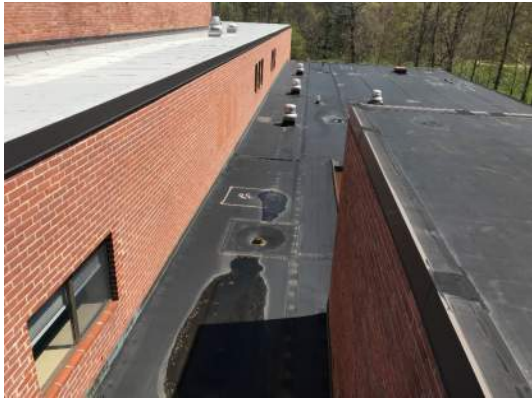
Photo 28

another view of roof section AC

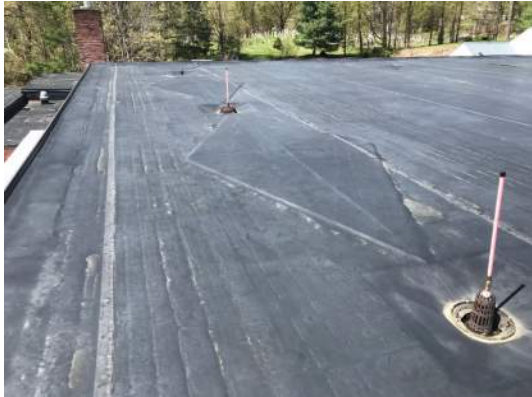
Photo 29

Overview of roof section AE which was installed in 2000

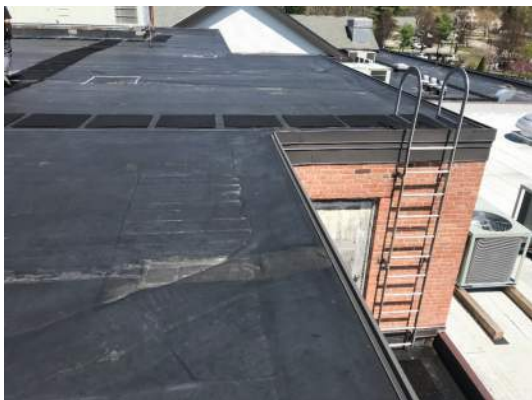
Photo 30

Another view of roof section AE

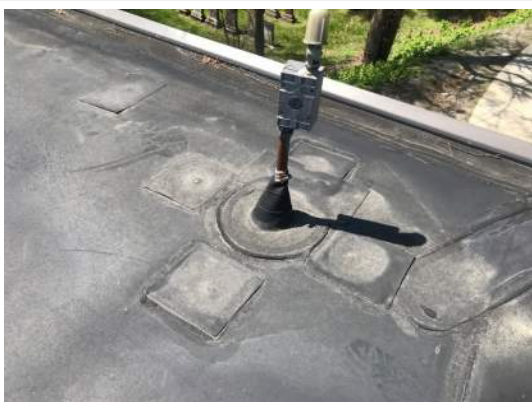
Photo 31

Electrical conduit on roof section AA - the seams are lifting and there is a tear in the pipe boot

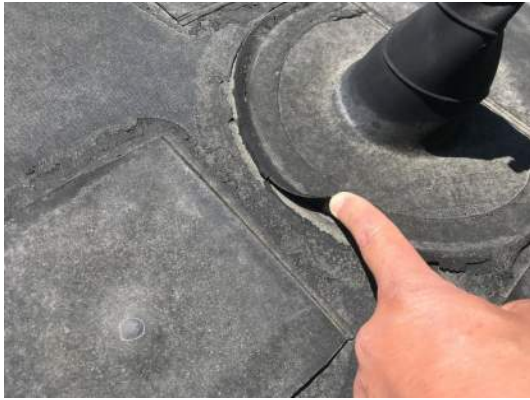
Photo 32

Photo confirmation of lifting seams around the pipe boot penetration

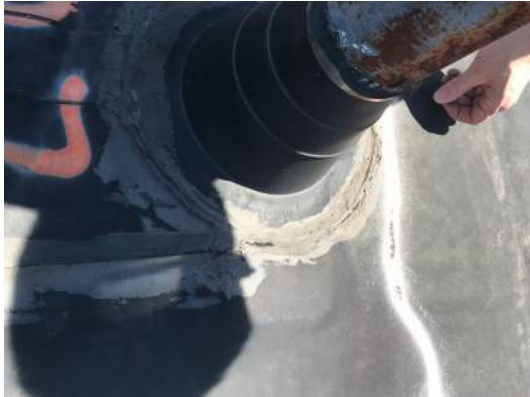
Photo 33

Pipe boot is damaged which can and may be contributing to water infiltration

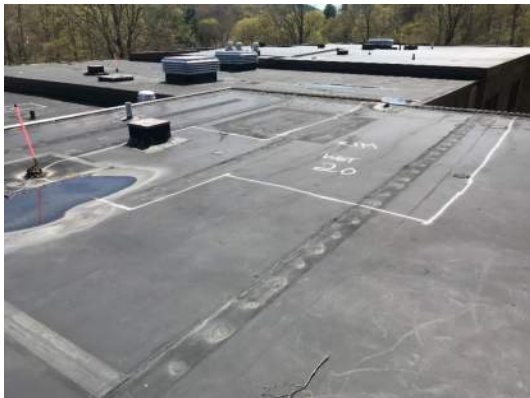
Photo 34

Overview of Roof AA which was installed in 1991 and is a roof section that needs immediate attention

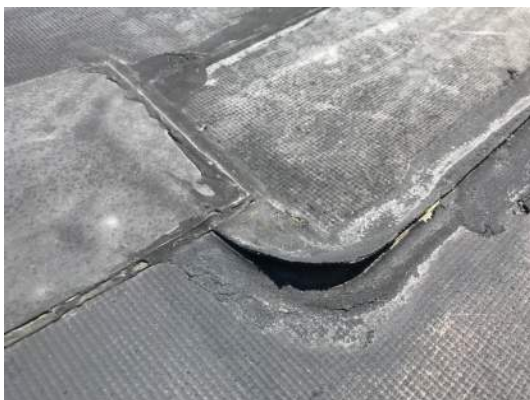
Photo 35

Photo confirmation showing where seams are lifting

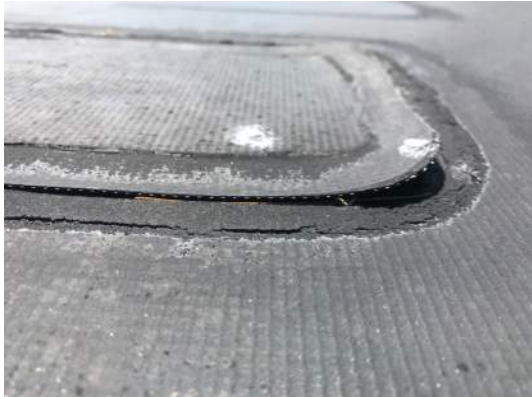
Photo 37

Photo confirmation of lifting seams

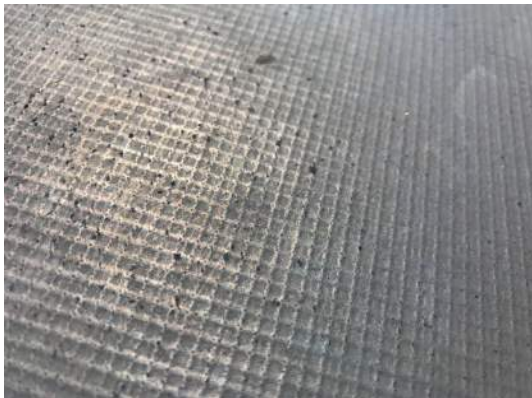
Photo 38

Photo confirmation on a 1991 roof section where the single ply roof scrim is showing. This is a common wide spread condition on all of the 1991 roof sections which happens based on age and UV exposure and once this happens the roof is failed.

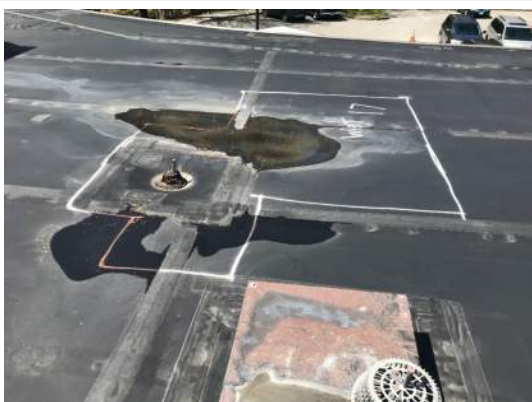
Photo 39

Overview of Roof AA which shows some ponding/bird bathing.

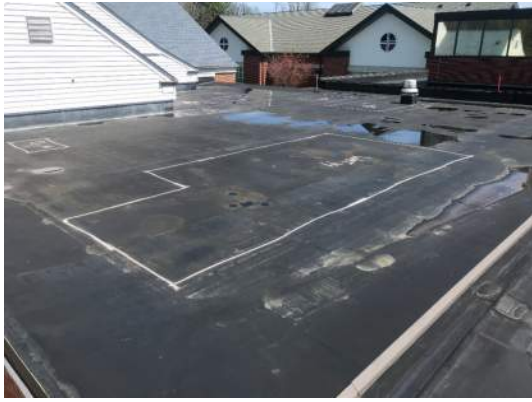
Photo 40

Overview of roof AB which was installed in 1991 and is another roof section that is in need of immediate attention.

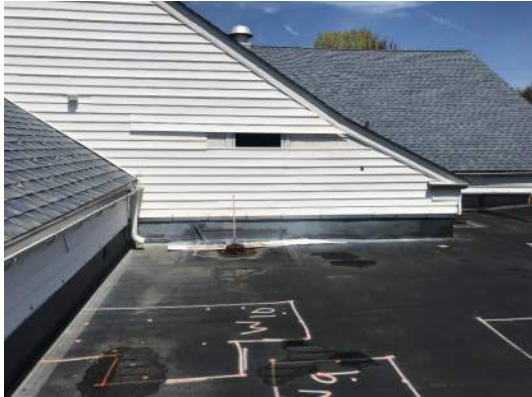
Photo 41

Another view of roof AB

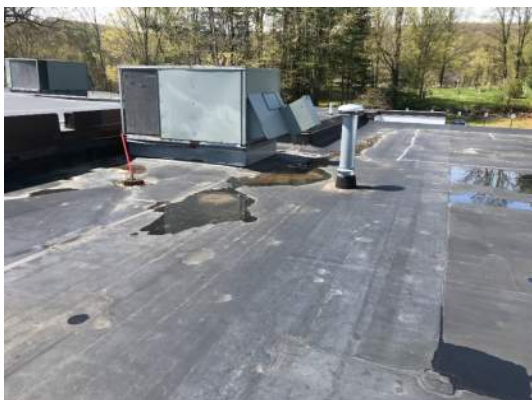
Photo 43

Another view of roof AB

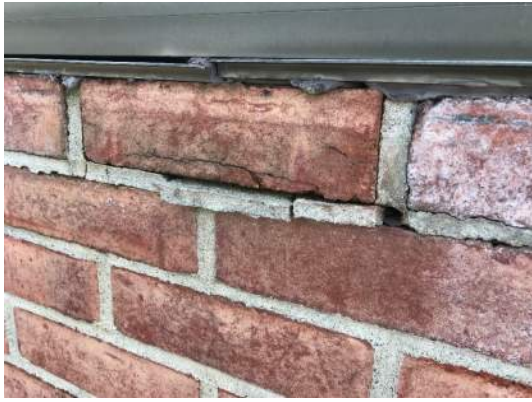
Photo 44

Photo confirmation of cracks in the masonry walls

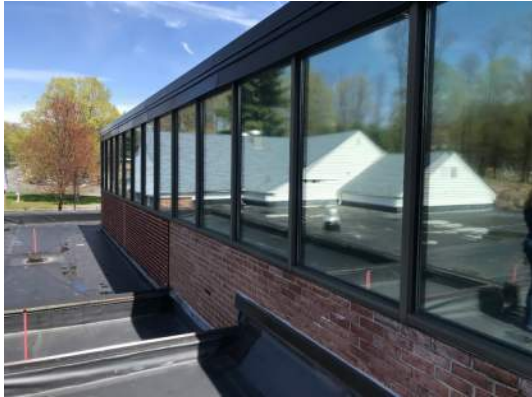
Photo 45

Based on past experience over the last several years the windows have been troublesome, which was caused when there was no metal or waterproofing membrane installed under the sill during the installation process.
