SHERMAN BOARD OF EDUCATION
MAINTENANCE MEETING
WEDNESDAY, SEPTEMBER 5, 2018
THE SHERMAN SCHOOL - LIBRARY MEDIA CENTER

PLAYGROUND SAFETY INSPECTION REPORT

SITE: Sherman Elementary School
2 Route 37 East
Sherman, CT 06784

DATE OF INSPECTION: July 5, 2018

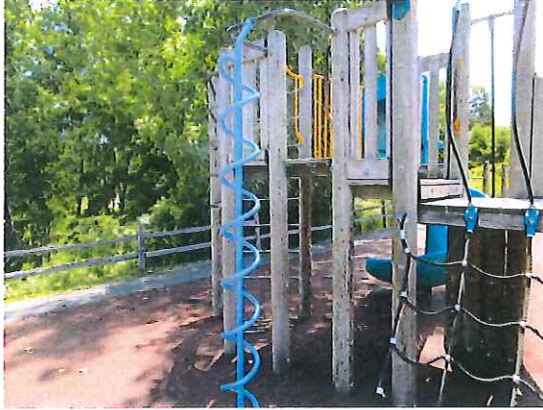
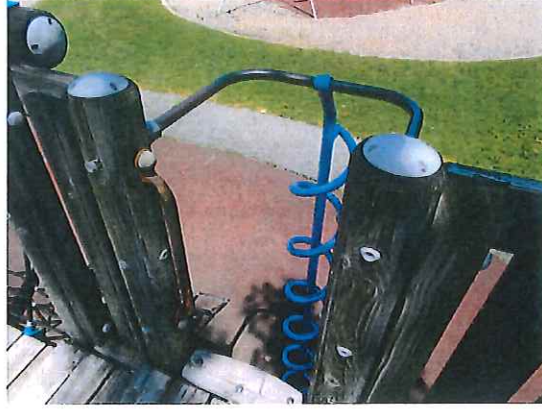
Small Composite Structure (Kompan)
Curly Climber - Loose at wood posts - MAINTENANCE

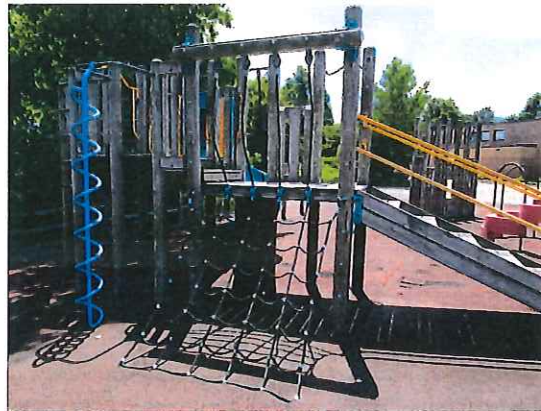
Cargo Net - One protruding bolt - CLASS B HAZARD

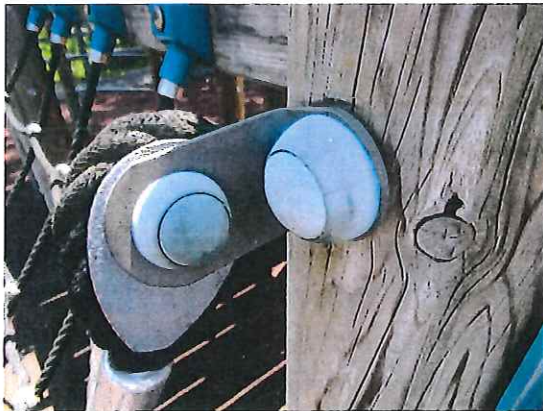
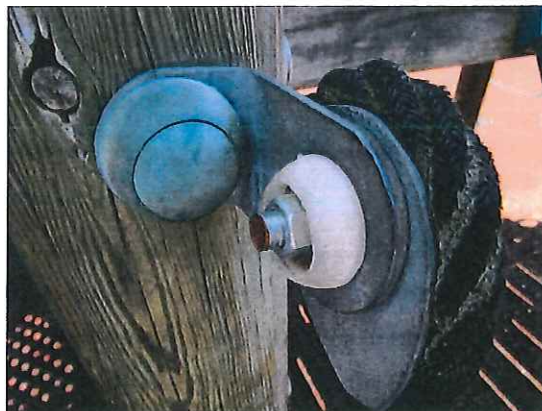
Cargo Net - One missing cap - MAINTENANCE

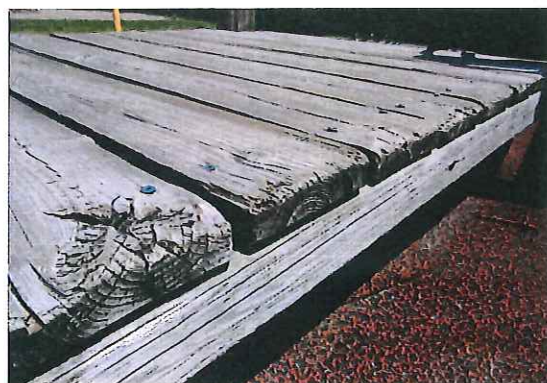
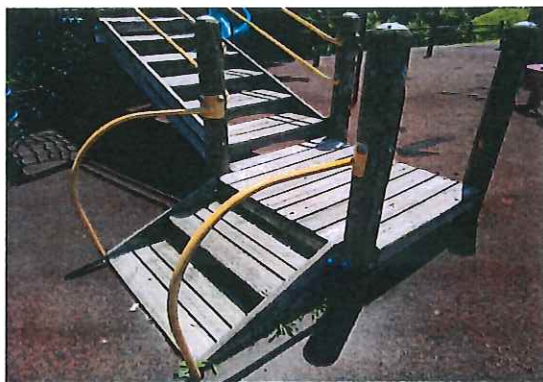
Transfer platform - Wood worn and splintered - MAINTENANCE

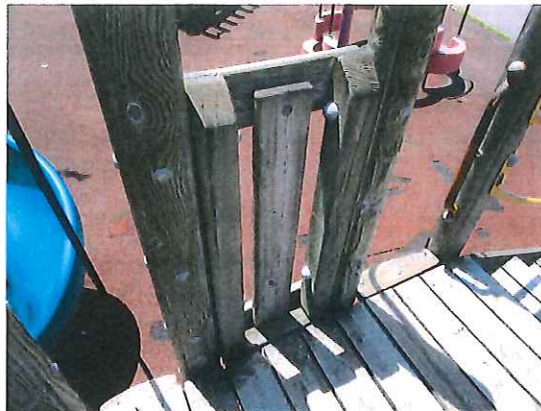
Wood Barriers - Loose - MAINTENANCE

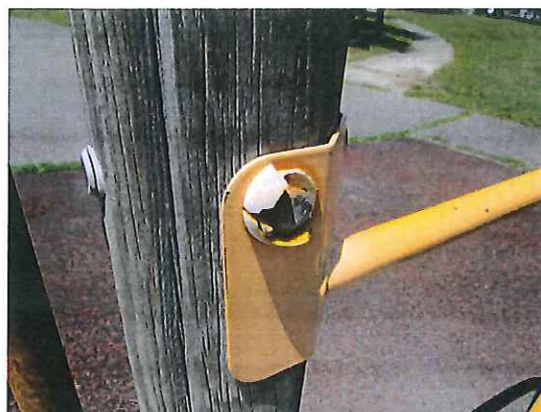
Pipe Barrier Rails - Brackets rusted & one cap cracked - MAINTENANCE

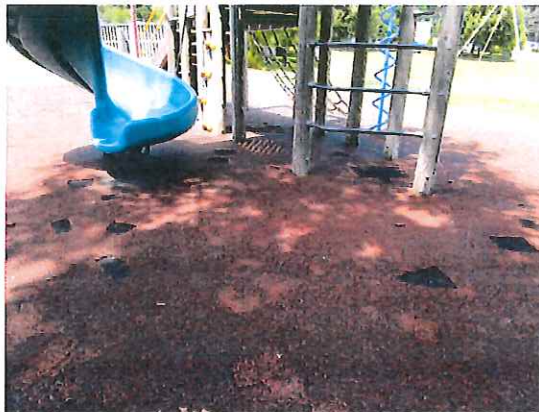
Surfacing - Shrinkage, missing, torn gaps & grass growing - CLASS B HAZARD

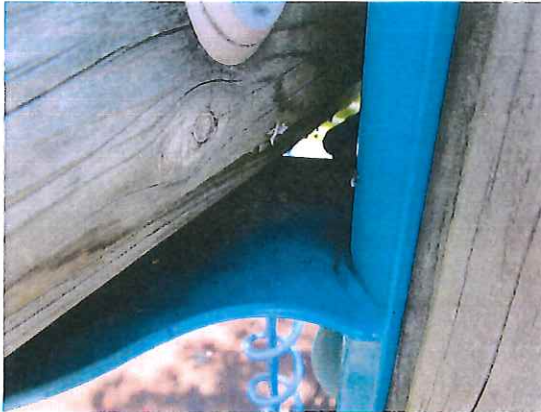
Structure - Bees, insects & bird damage - CLASS A HAZARD

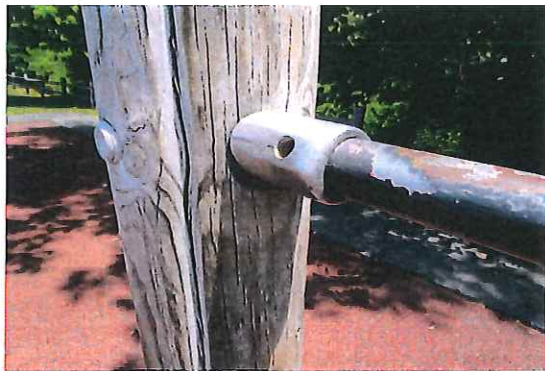
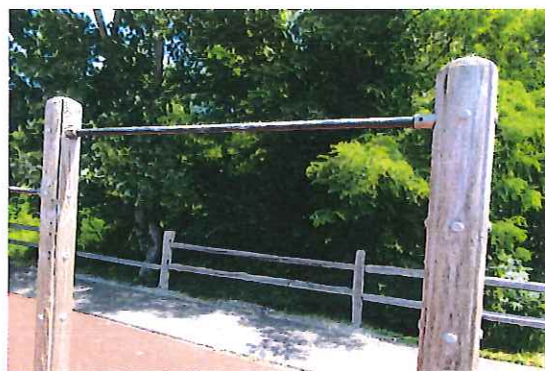
**Freestanding Equipment
Turning Bars - Two bars loose - MAINTENANCE**

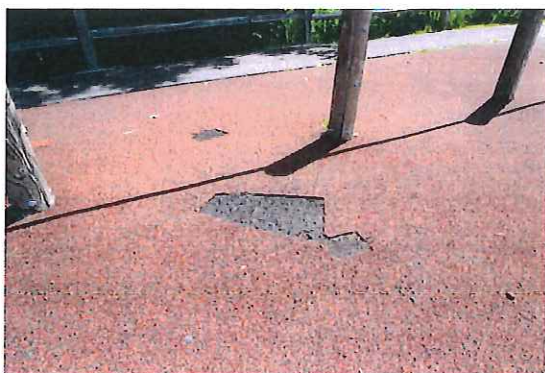
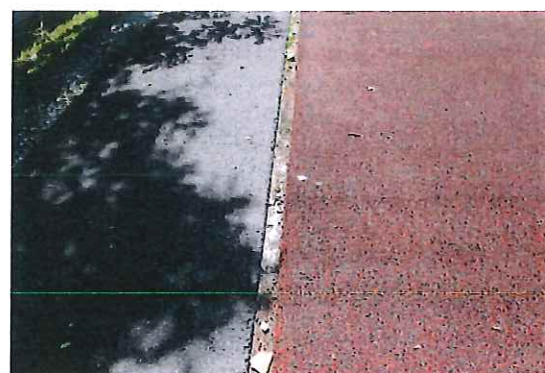
Surfacing - Shrinkage, torn & missing pieces - CLASS C HAZARD

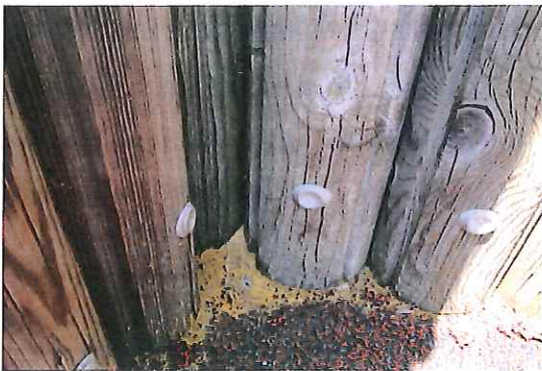
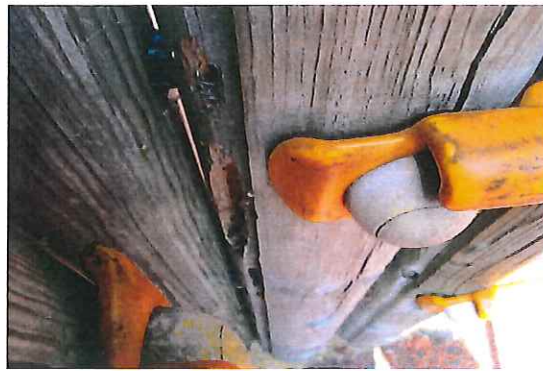
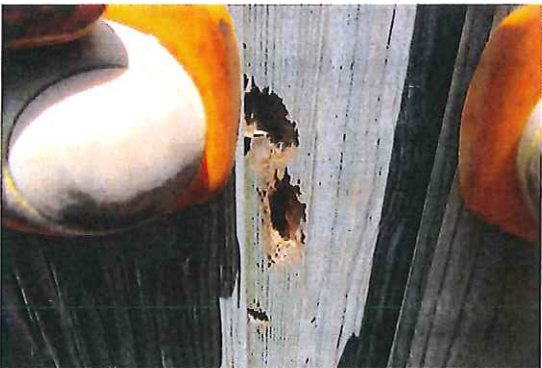
Climbing Wall - Insects, bees & birds present - CLASS A HAZARD

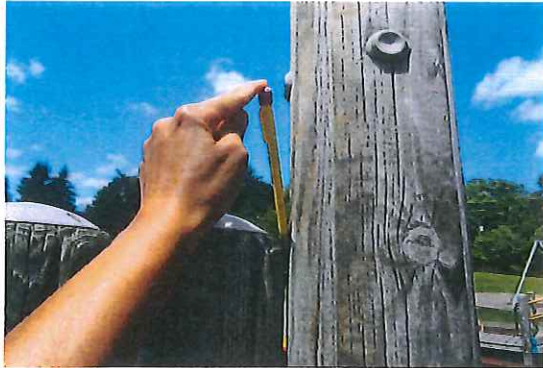
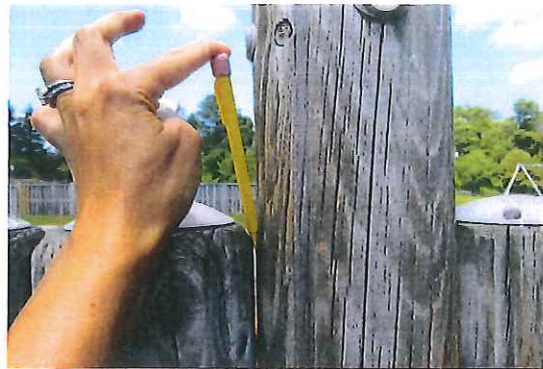
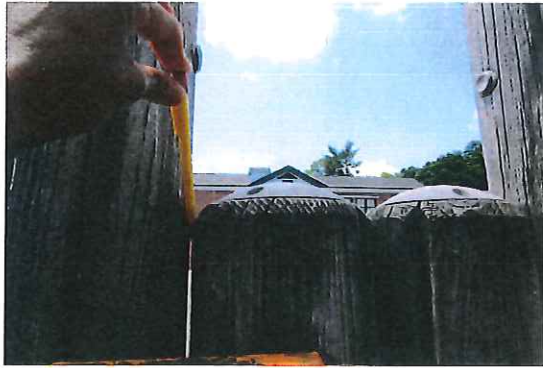
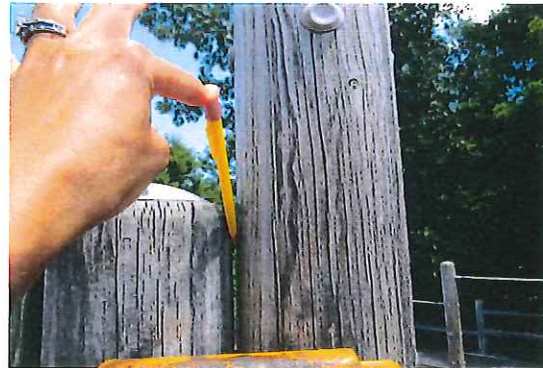
Climbing Wall - Eight drawstring entanglements at gaps in wood posts - CLASS A HAZARD

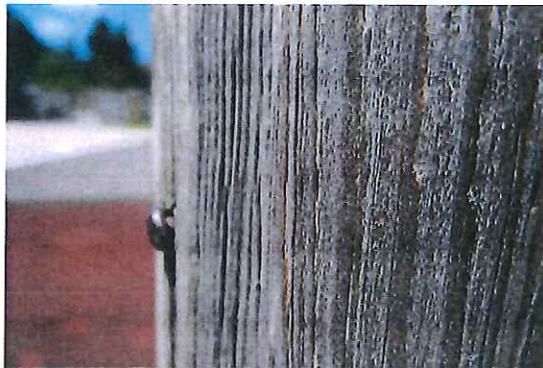
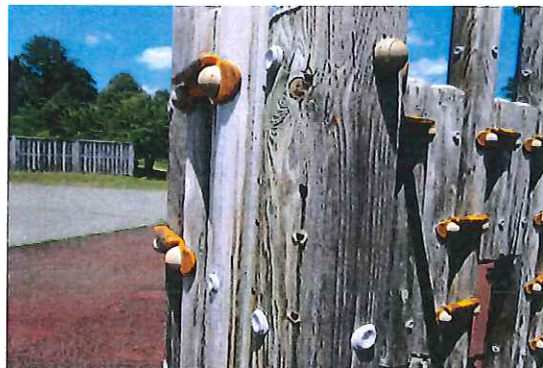
Climbing Wall - Screws exposed - CLASS C HAZARD

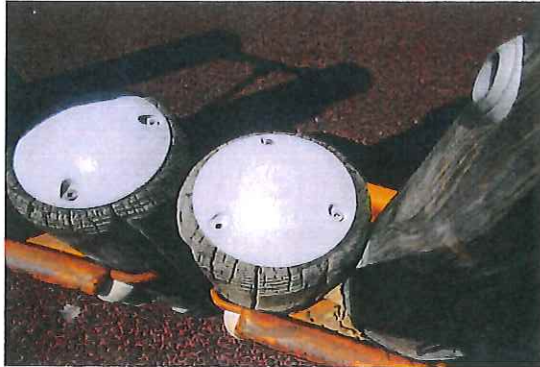
Climbing Wall - One bolt missing - MAINTENANCE

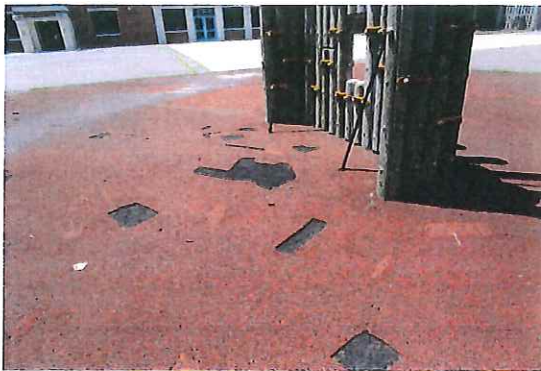
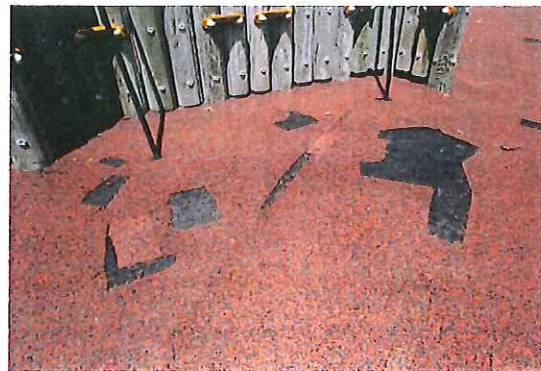
Surfacing - Areas missing, torn & sloped - CLASS B HAZARD

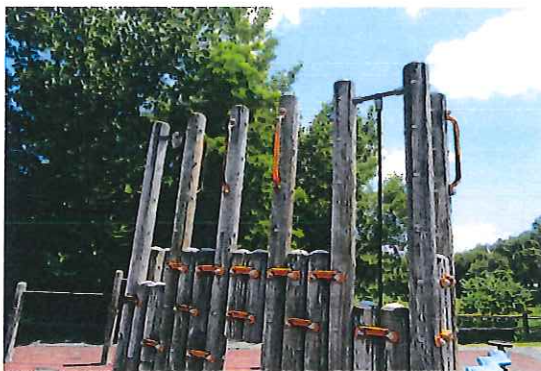
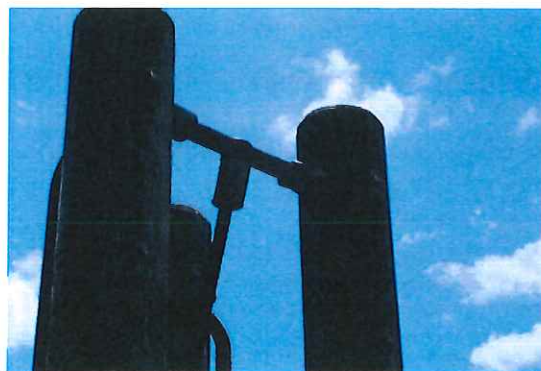
Structural Stability - Loose at Rope Bar posts - MAINTENANCE

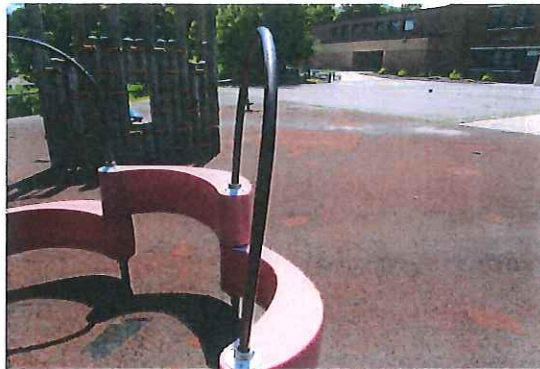
Playshell Climber - One bar bent - MAINTENANCE

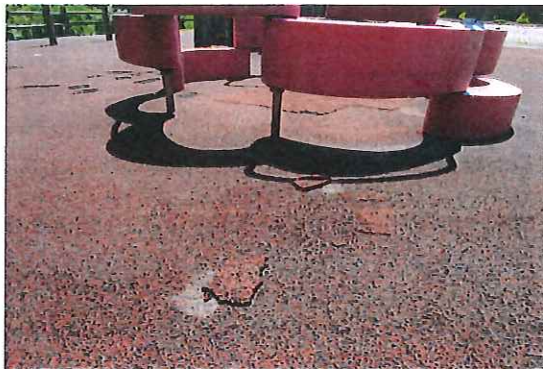
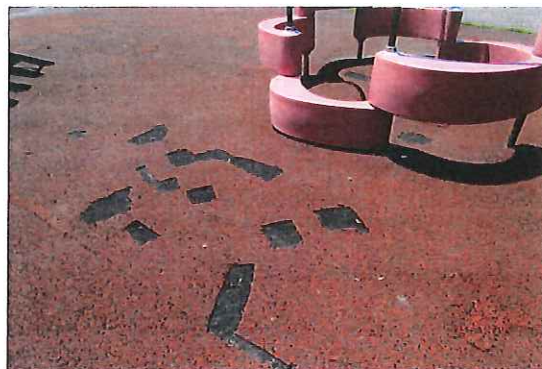
Playshell Climber -Surfacing areas peeling, torn & missing - CLASS B HAZARD

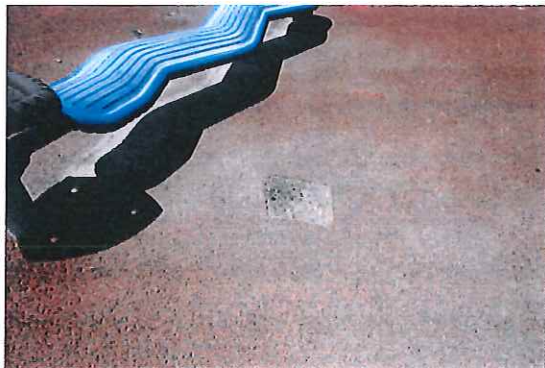
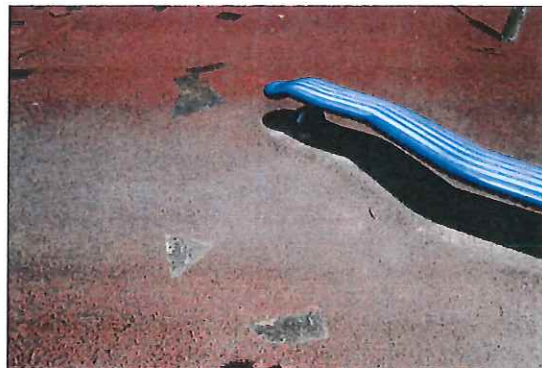
Argo GXY 8019 - Surfacing is peeling, missing & torn - CLASS B HAZARD

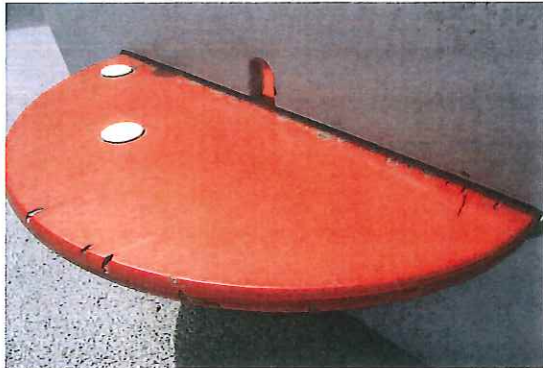
Spica GXY 8015 - Foot stand is cracking - MAINTENANCE

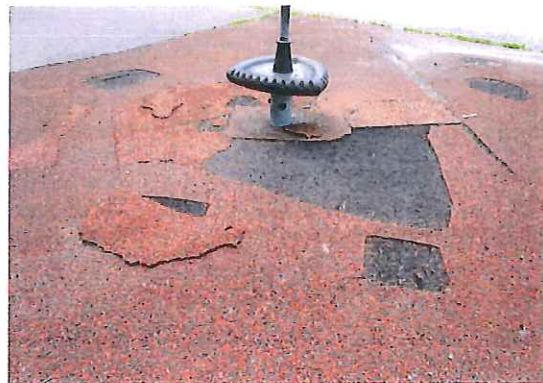
Spica GXY 8015 - Surfacing is peeling - MAINTENANCE

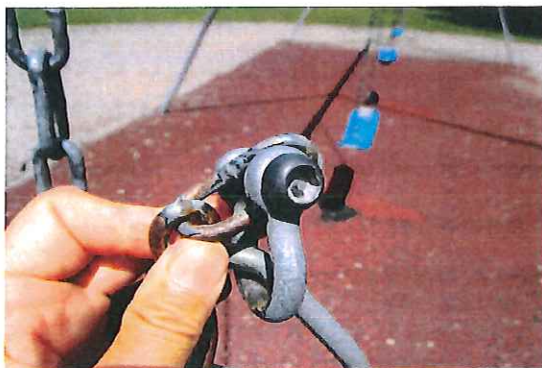
11ft. Swing Set (Unknown) - All chains worn - CLASS A HAZARD

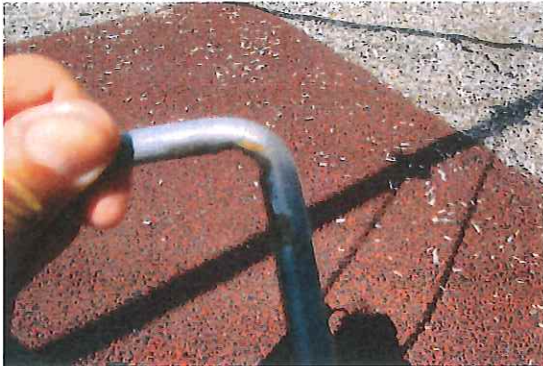
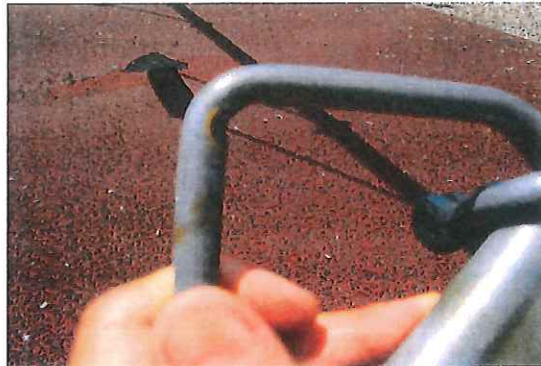
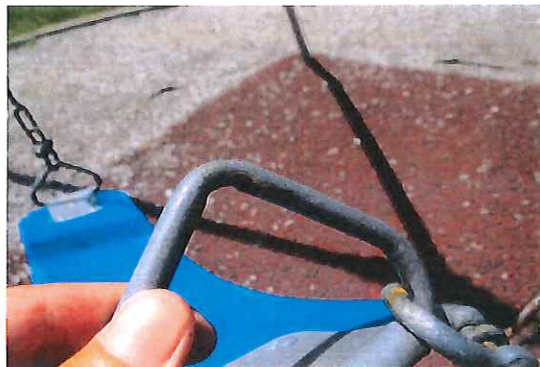
11ft. Swing Set - Four belt seats worn - CLASS A HAZARD

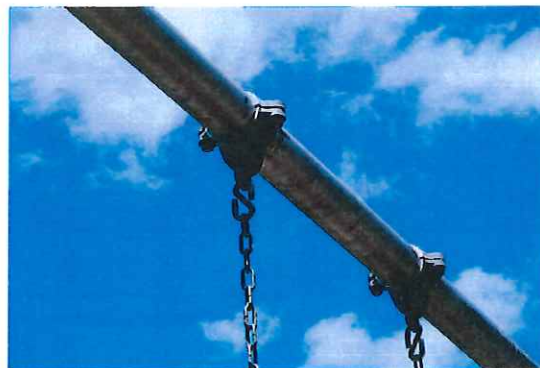
11ft. Swing Set - Eight "S" - Hooks starting to wear - MAINTENANCE

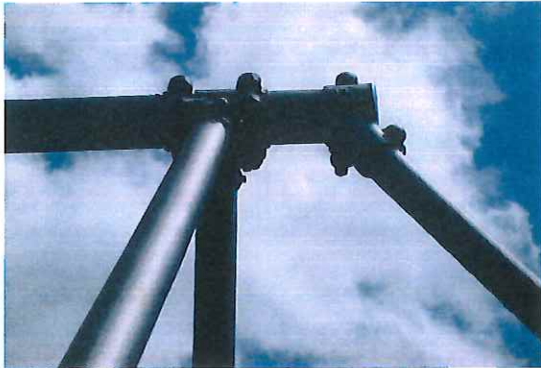
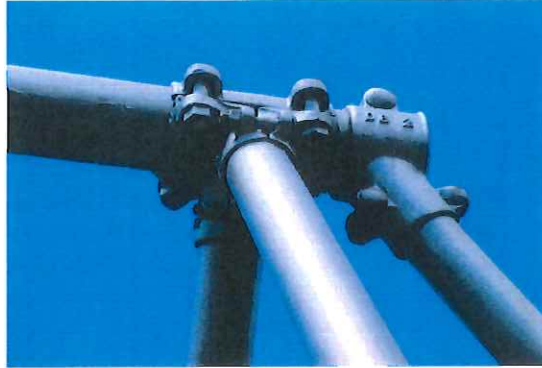
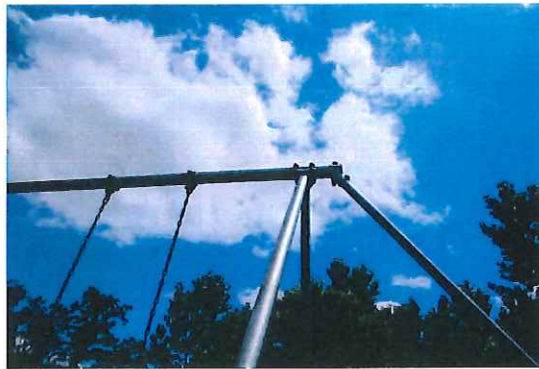
11ft. Swing Set - Four protruding bolts, drawstring entanglement at top hardware - CLASS A HAZARD

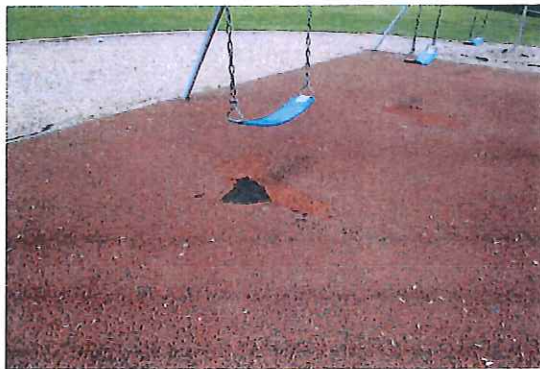
11ft. Swing Set - Surfacing is peeling - MAINTENANCE

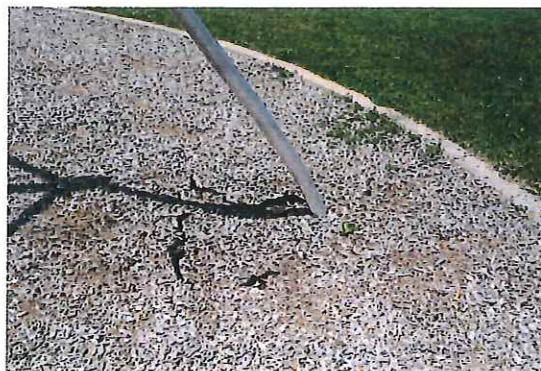
11ft. Swing Set - Four posts bent - MAINTENANCE

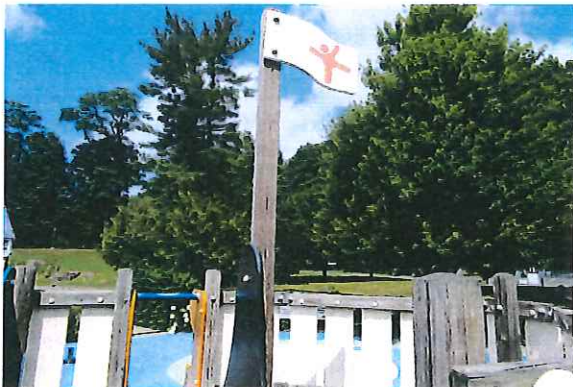
Pirate Ship - Crawl thru pad wearing & crack in crawl thru - MAINTENANCE

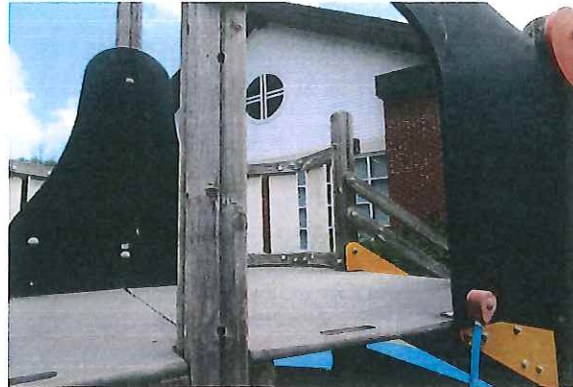
Pirate Ship - Wood worn, cracked & splintered - CLASS C HAZARD

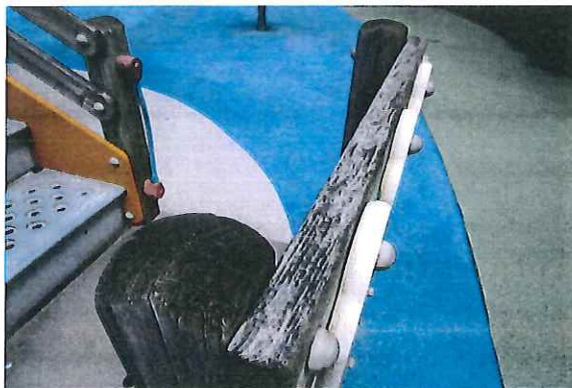
Pirate Ship - One cracked cap & insect damage - MAINTENANCE

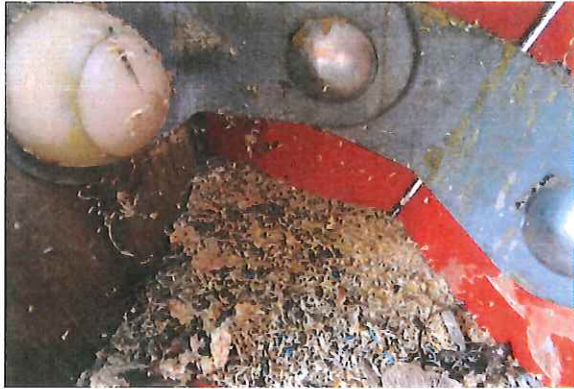
Dragon Springer (2)(Kompan) - Wood splitting on one - MAINTENANCE

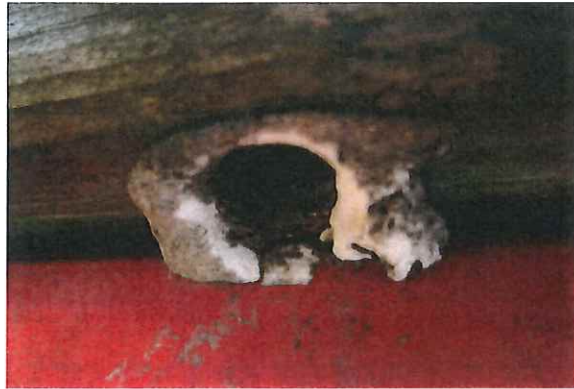
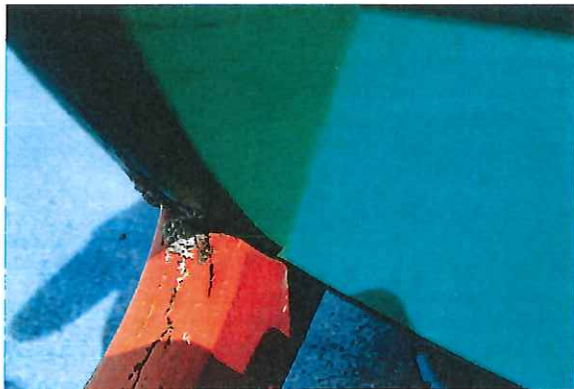
Dragon Springer (2)(Kompan) - Crack in platform on one - MAINTENANCE

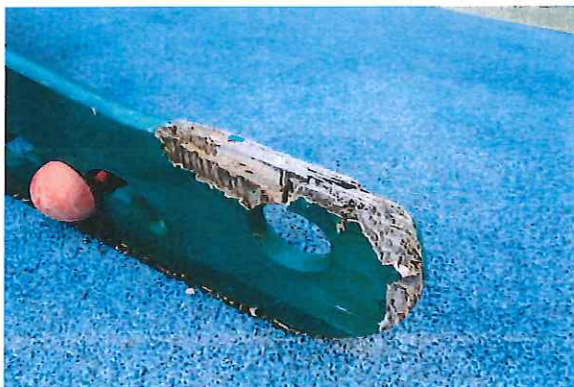
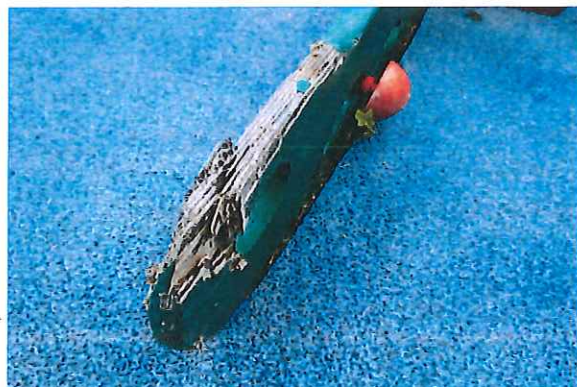
See Saw (Kompan) - Wood is cracking - MAINTENANCE

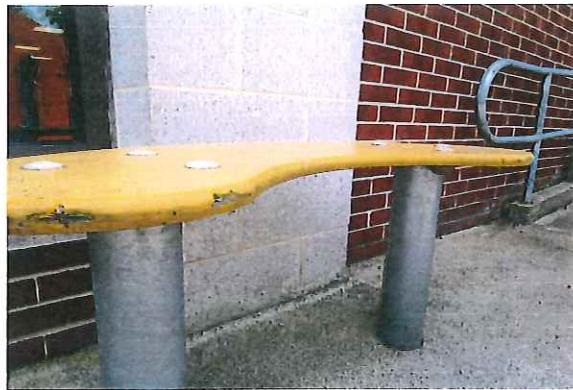
Mighty Musketeer (Kompan) - Wood splintered & paint peeling - MAINTENANCE

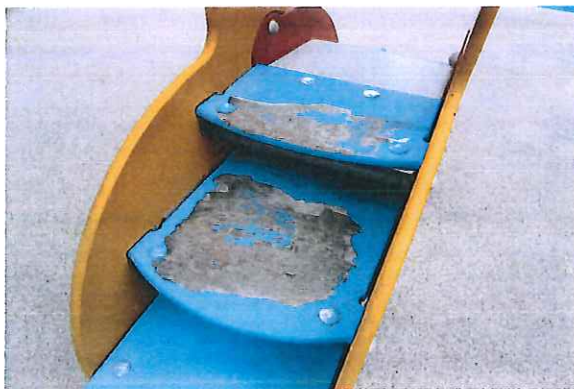
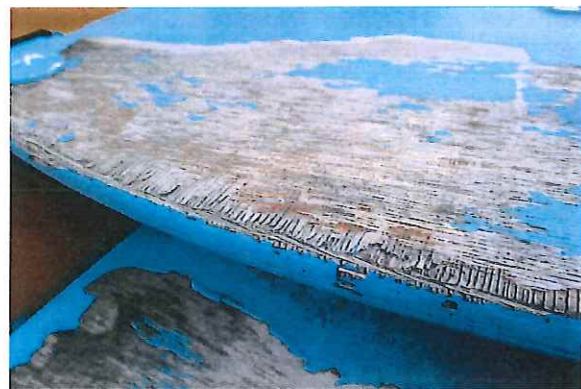
Mighty Musketeer (Kompan) - Wood splintered & paint peeling - MAINTENANCE

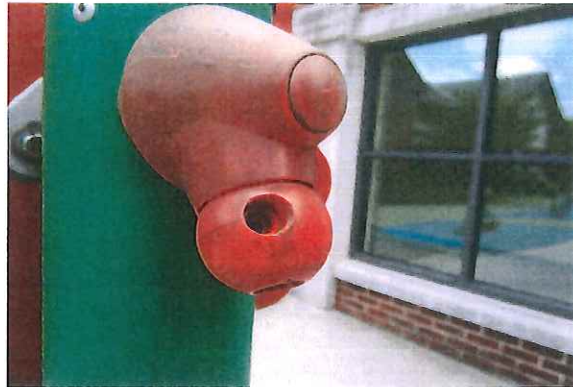
Sunflower Swing (Kompan) - Rusted hardware - MAINTENANCE

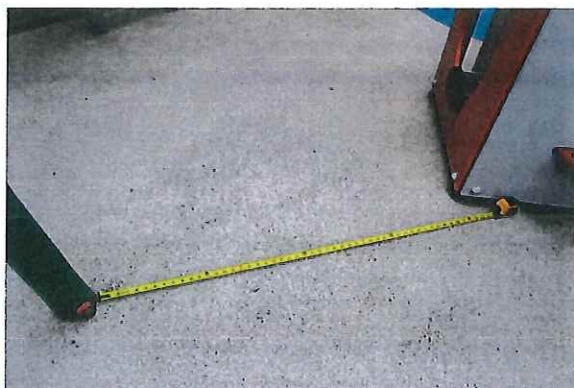
Labyrinth - Wood is cracking - MAINTENANCE

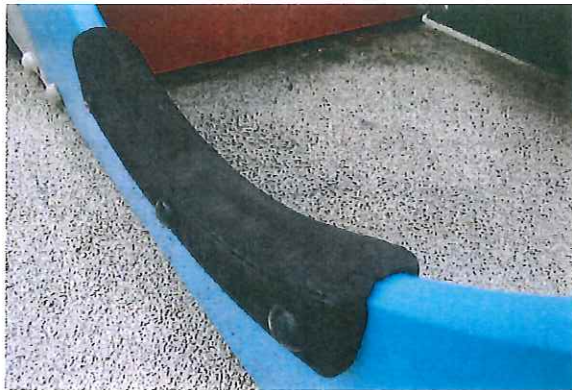
Use Zone - Overlaps with Sunflower Swing & Mighty Musketeer - CLASS B HAZARD

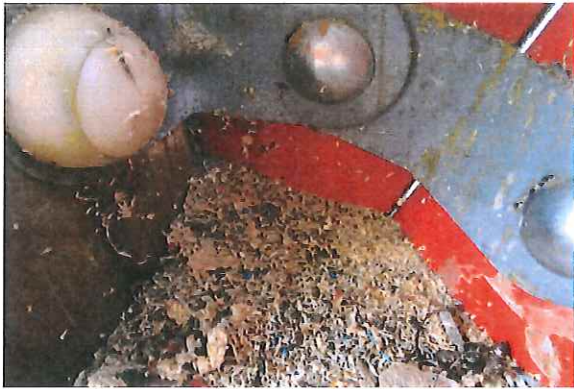
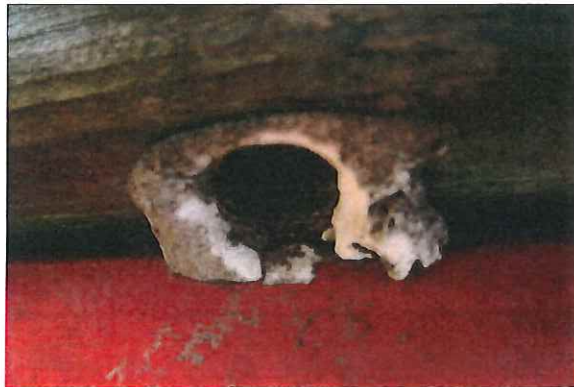
Tree roots pushing surfacing up at perimeter	Maint.	Cut and remove tree roots, repair subsurface & replace PIP rubber
		Lamp post pad damaged	Maint.	Replace pad

Border/Edging - Tree roots pushing up surfacing at perimeter - MAINTENANCE
