Facility Survey, Code Analysis and Buildings & Grounds Survey & Master Plan

The Sherman School

Sherman, Connecticut

November 2018

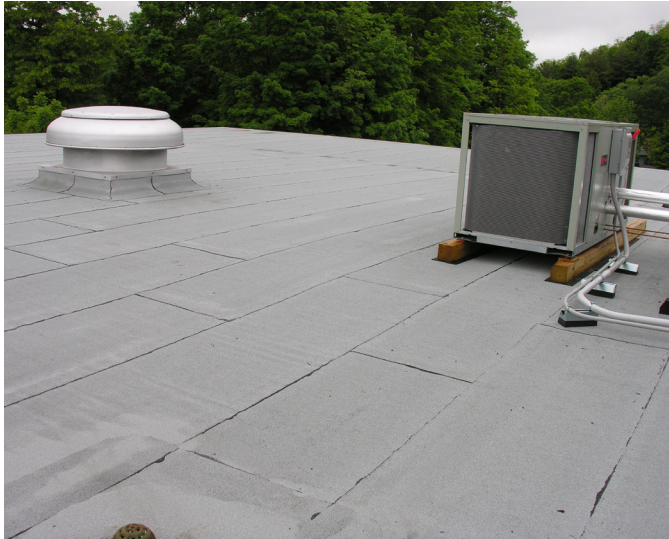
1. Location:

New Condensing Unit / Exhaust Fan on Bituminous Roof Looking Southeast.

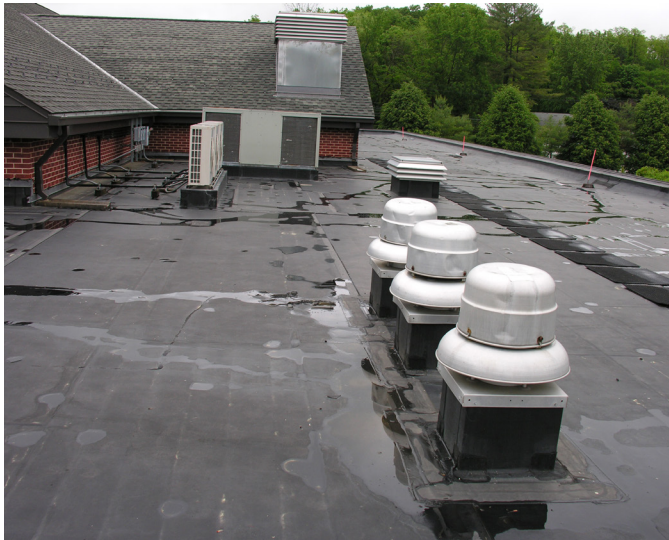
2. Location:

Existing Condensing Units / Exhaust Fan on EPDM Roof Looking North. The roof is nearing its 20-year mark.

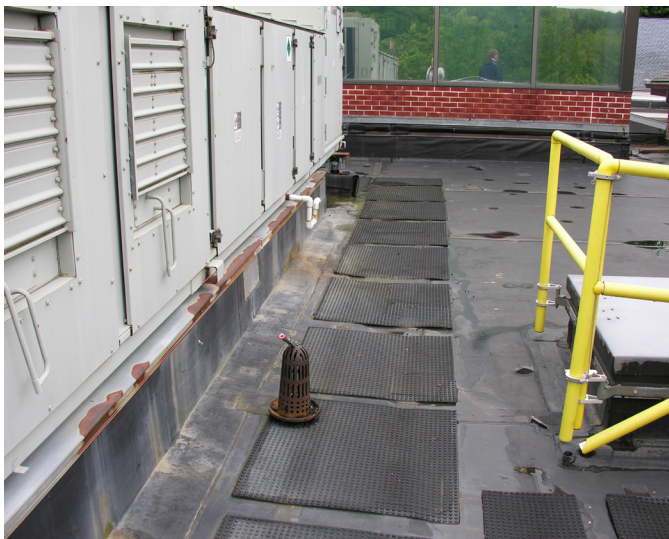
3. Location:

Equipment Walkway on EPDM Roof. The roof is nearing its 20-year mark.

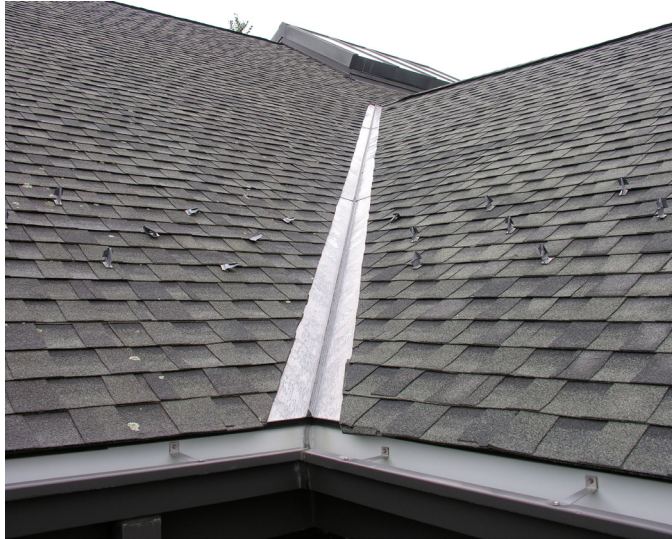
4. Location:

Typical Gable Valley Flashing

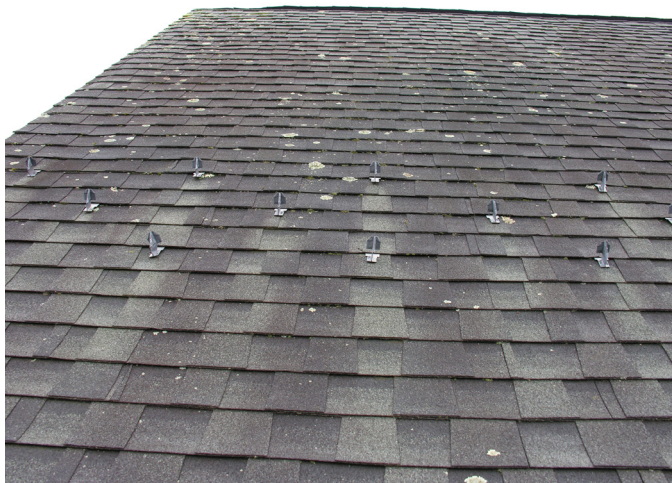
5. Location:

Asphalt Shingle Roof - Roof is nearing the 20 year mark.

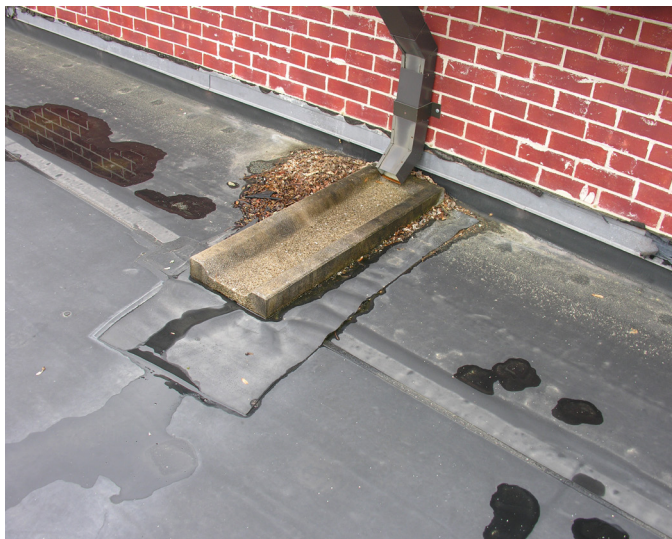
6. Location:

Typical Downspout to Splash Block for Gable Roof to EPDM Roof.

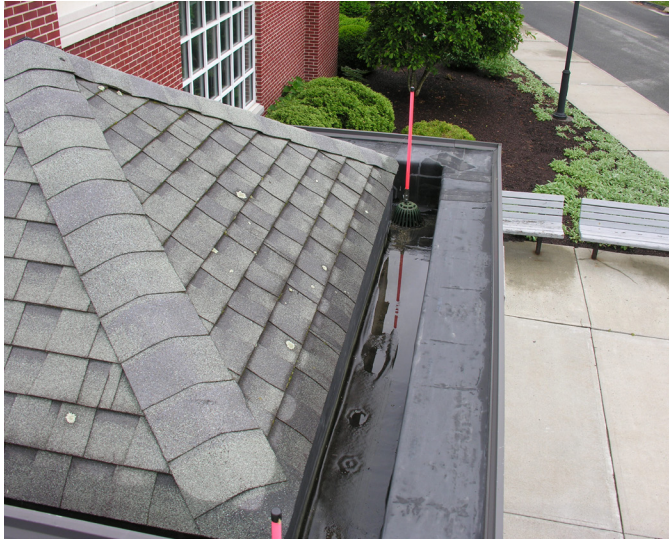
7. Location:

Drainage around Hip Roof at "A" Wing Entrance.

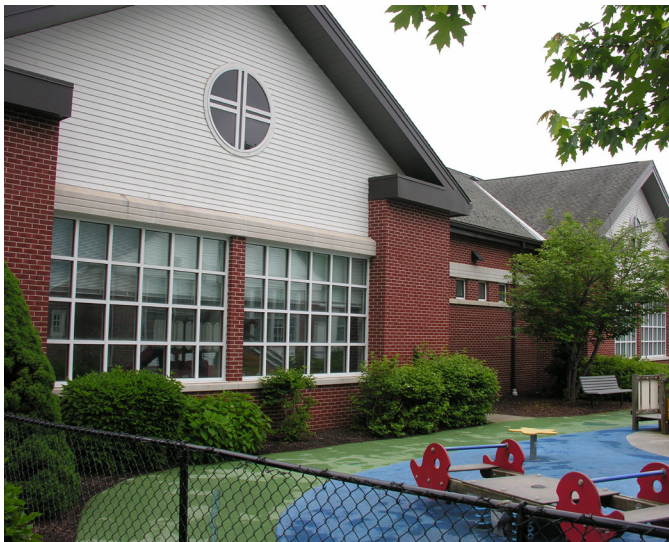
17. Location:

Library Looking East from Courtyard Playground. Playground and surfacing in need of replacement.

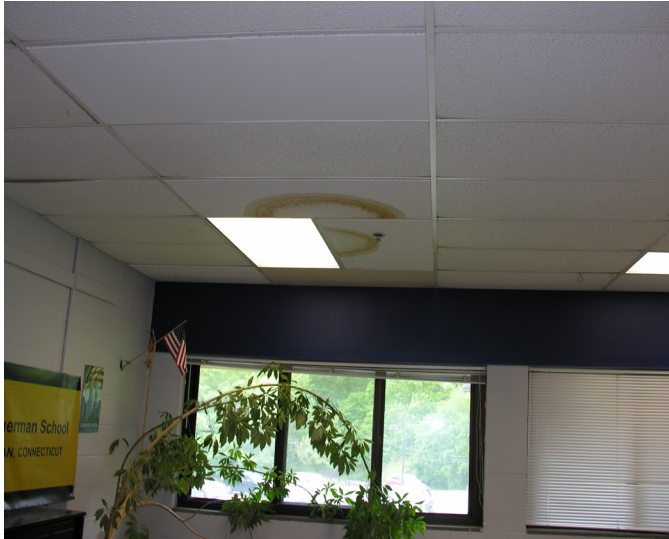
26. Location:

Typical Damaged Ceiling Tile

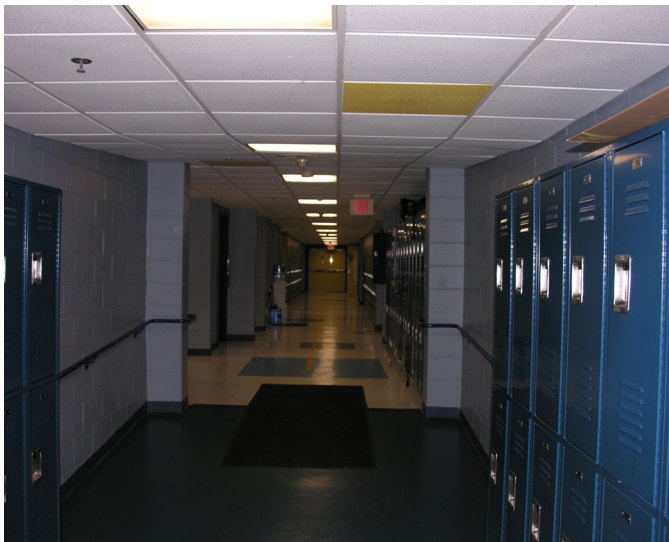
26. Location:

An overview of the ramp/corridor in the "D" Wing looking South. Non compliant ramp area due to protrusion of lockers into landing area.

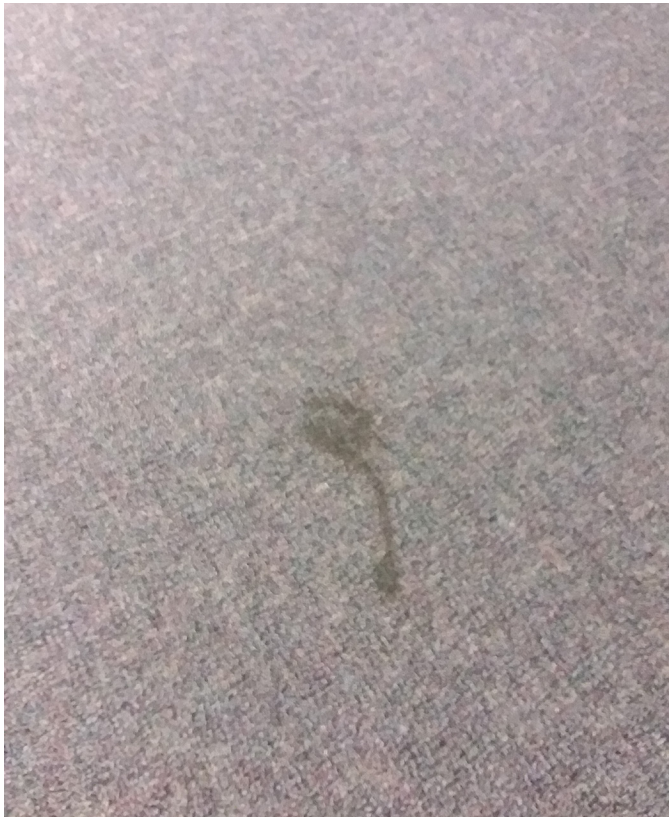
38. Location:

Stage flooring poses tripping hazard and requires repair.

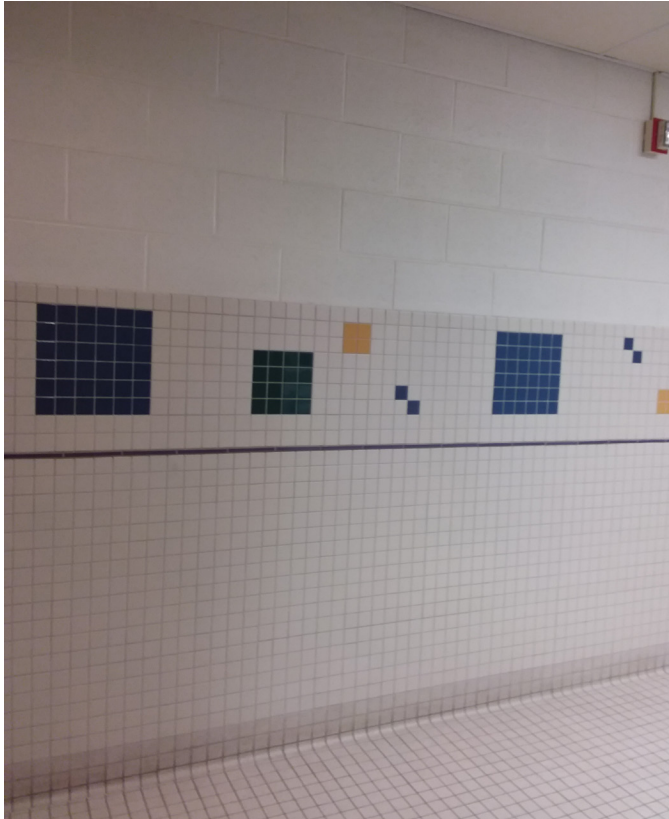
41. Location:

Toilet Rooms

2"x2" Ceramic tile and CMU

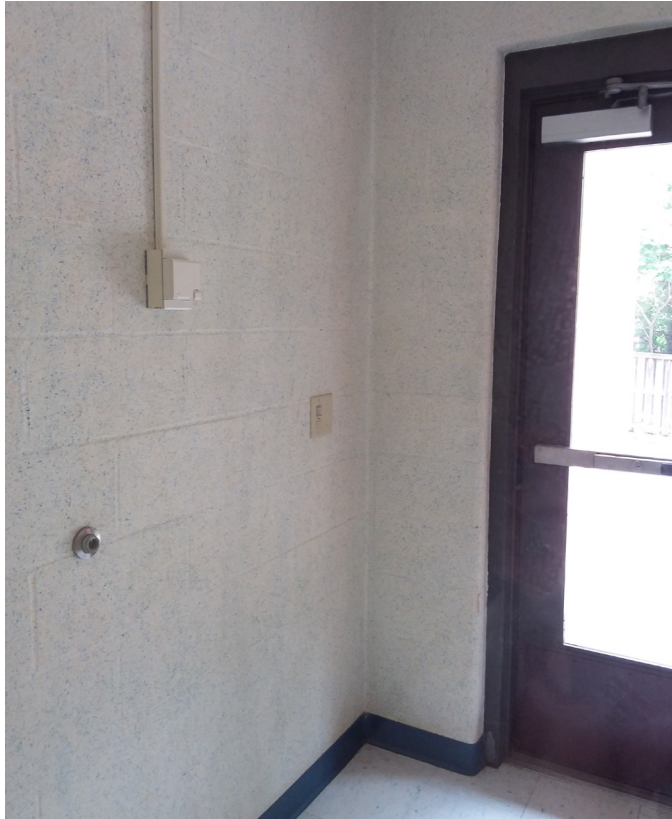
43. Location:

Entry Vestibules

Zolatone paint on Gypsum Board & CMU

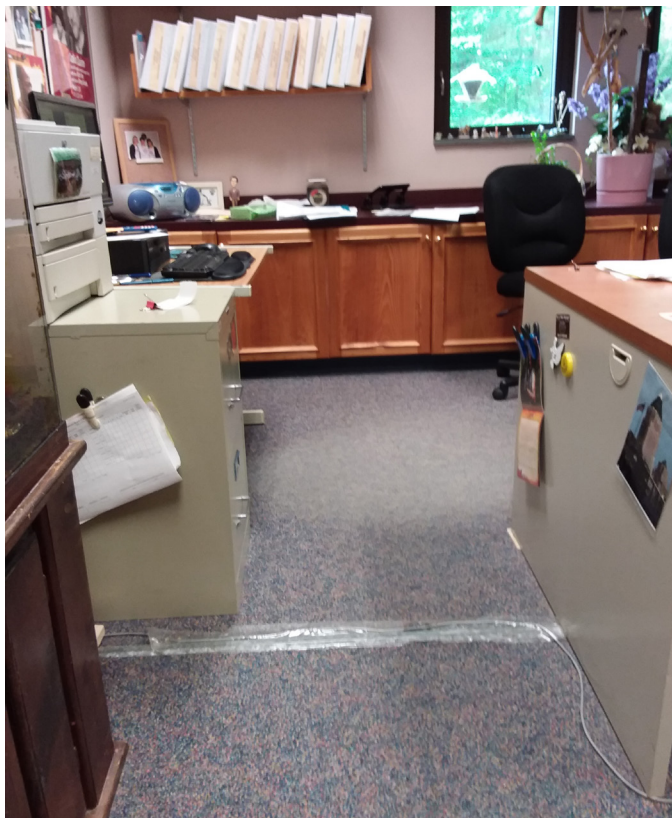
44. Location:

Offices

Staining and traffic pattern wear is visible on carpet.

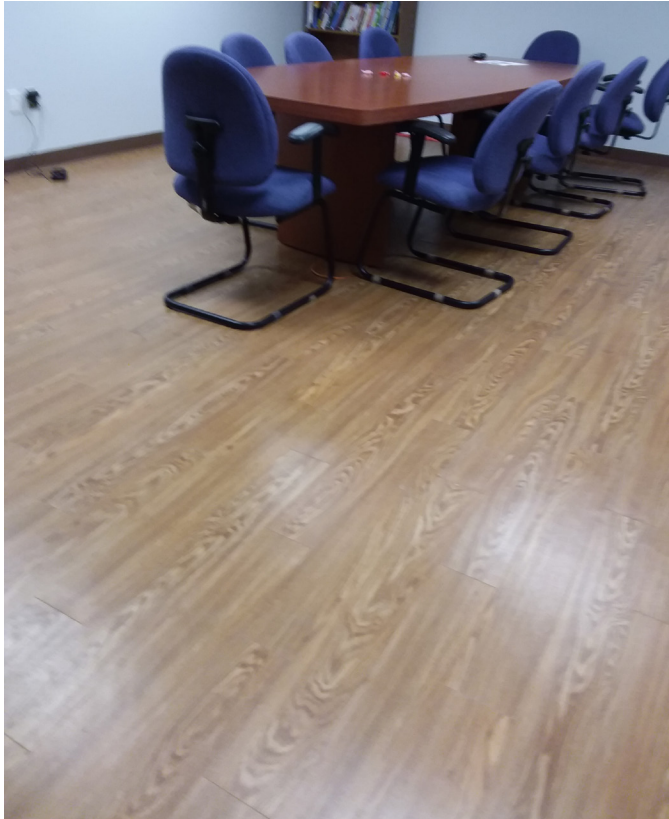
45. Location:

Offices / Conference

Vinyl appears in good condition.

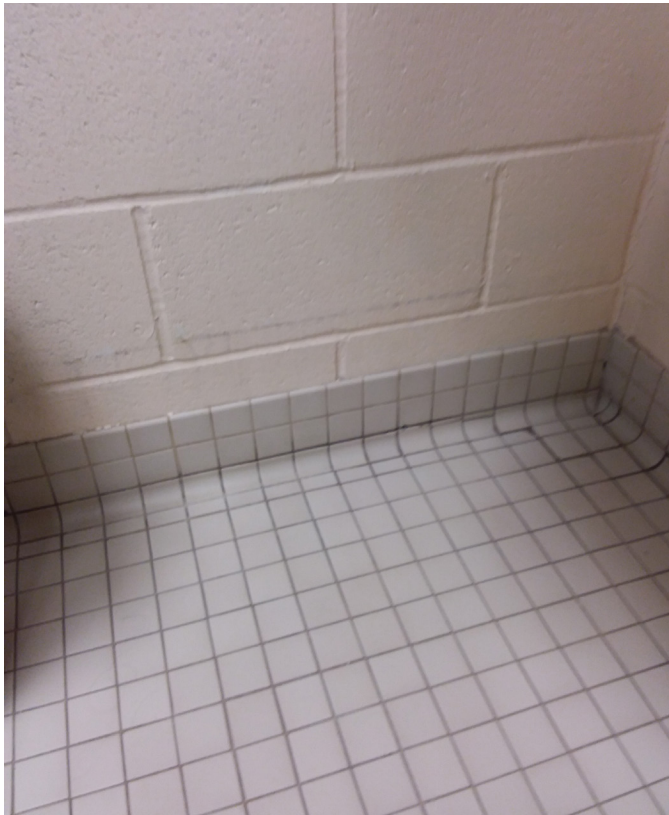
46. Location:

Toilet Rooms

Tile base cracking or broken in areas.

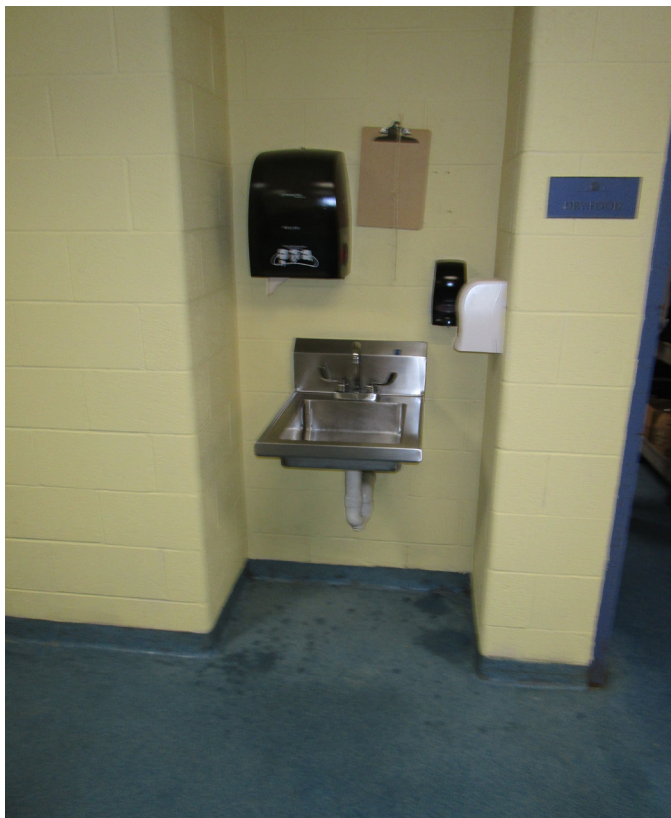
48. Location:

Kitchen

Area needs significant cleaning.

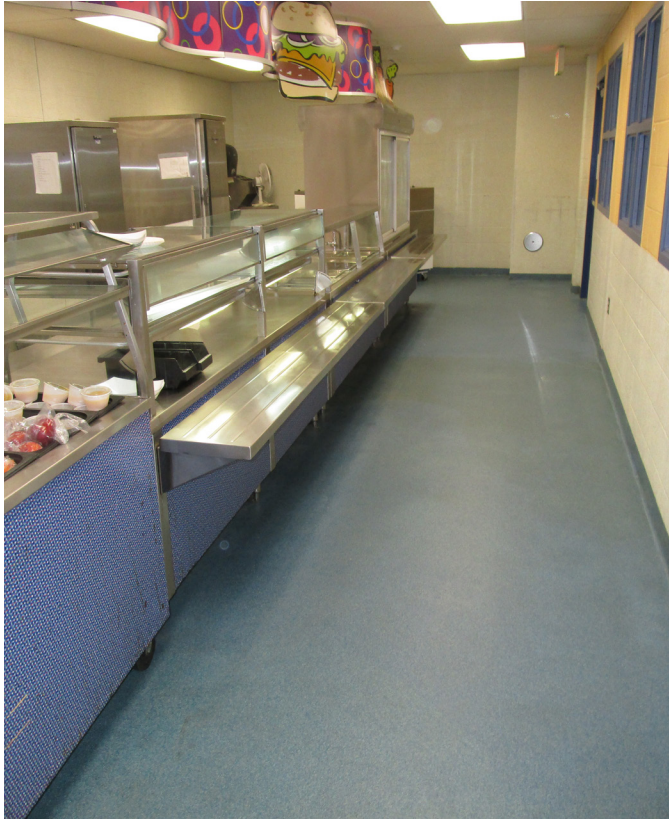
49. Location:

Servery

Some staining present, floor needs deep cleaning.

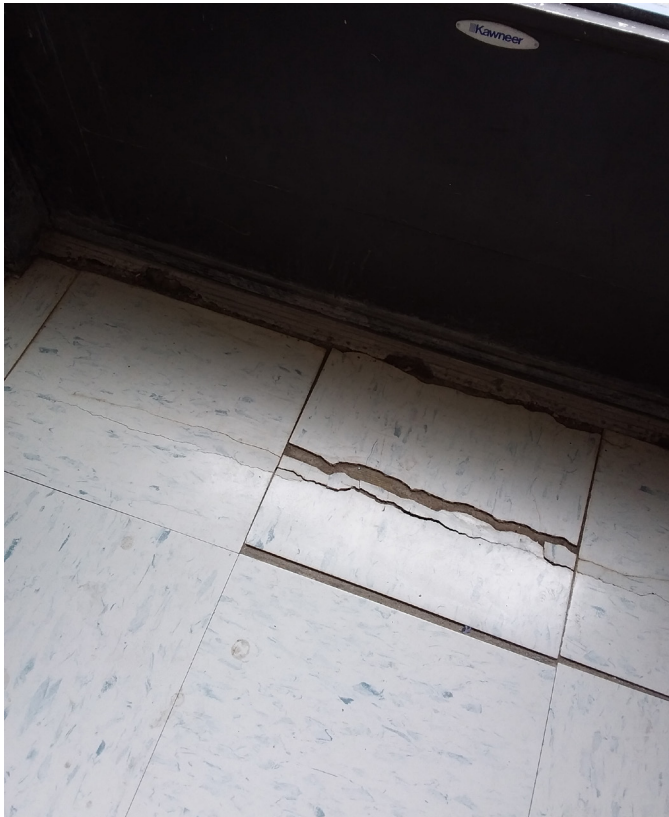
50. Location:

Art Classrooms

Heavy cracking present. Area directly in front of the exterior door requires immediate attention.

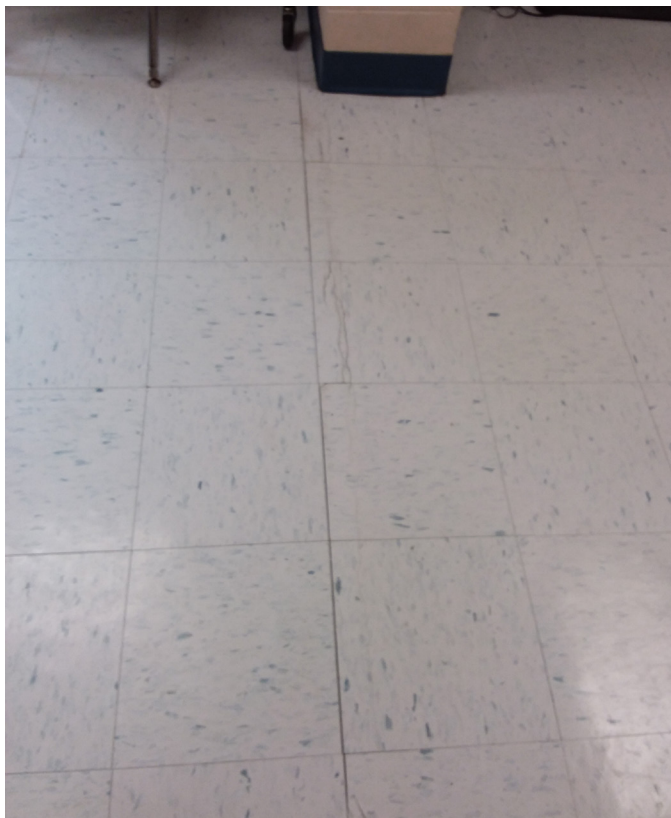
52. Location:

Nurse

Heavy cracking visible.

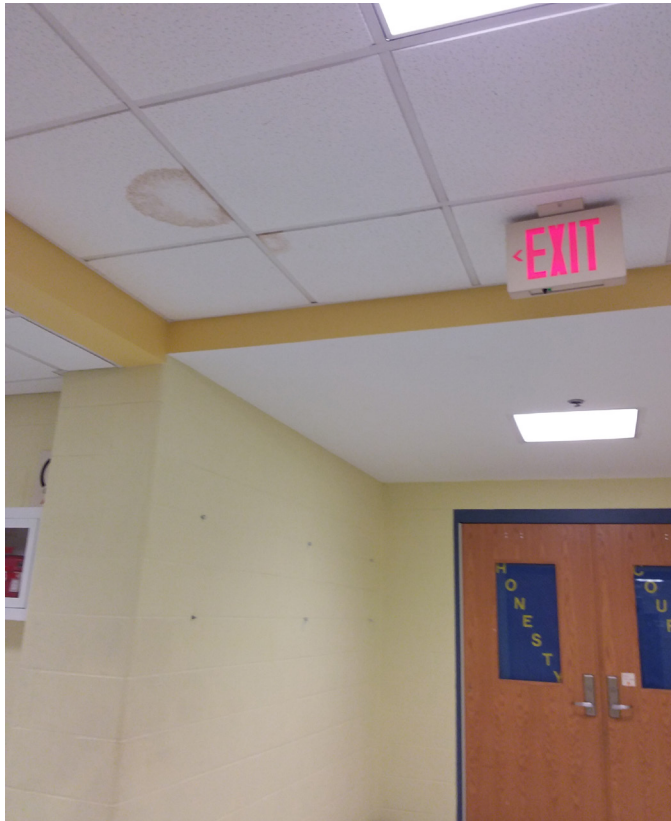
55. Location:

Corridors

Many areas of water damage present throughout.

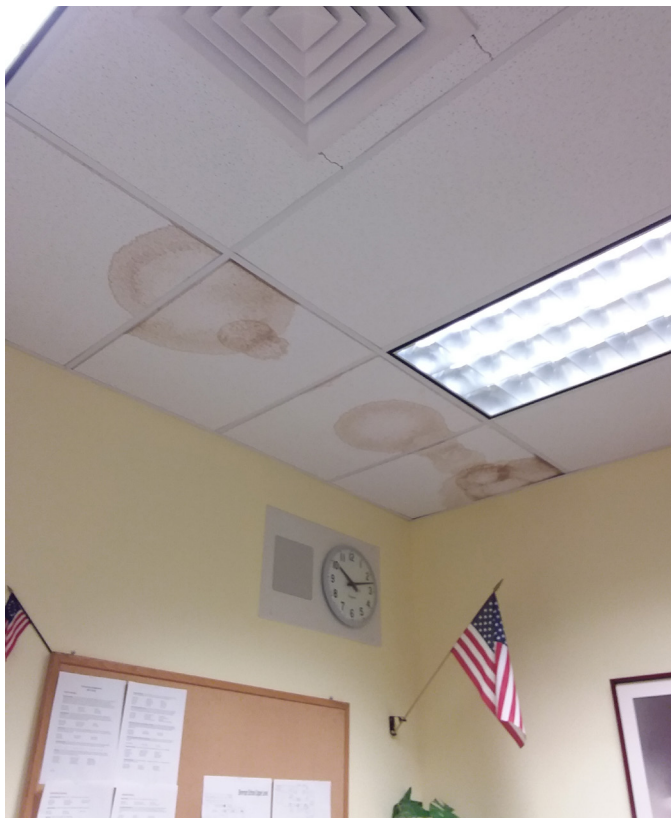
56. Location:

Offices

Few areas of water damage present in some offices.

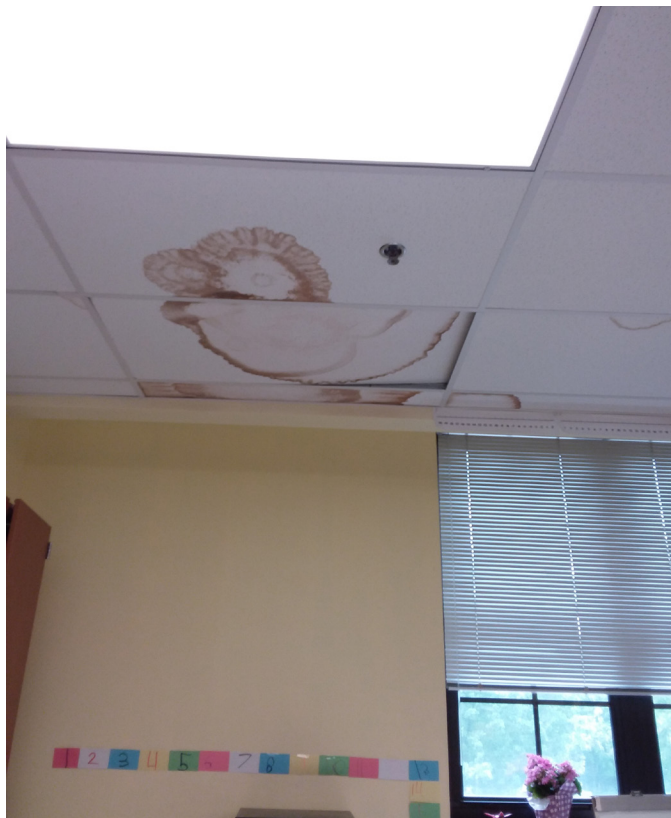
58. Location:

Classrooms

Areas of water damage appear frequently.

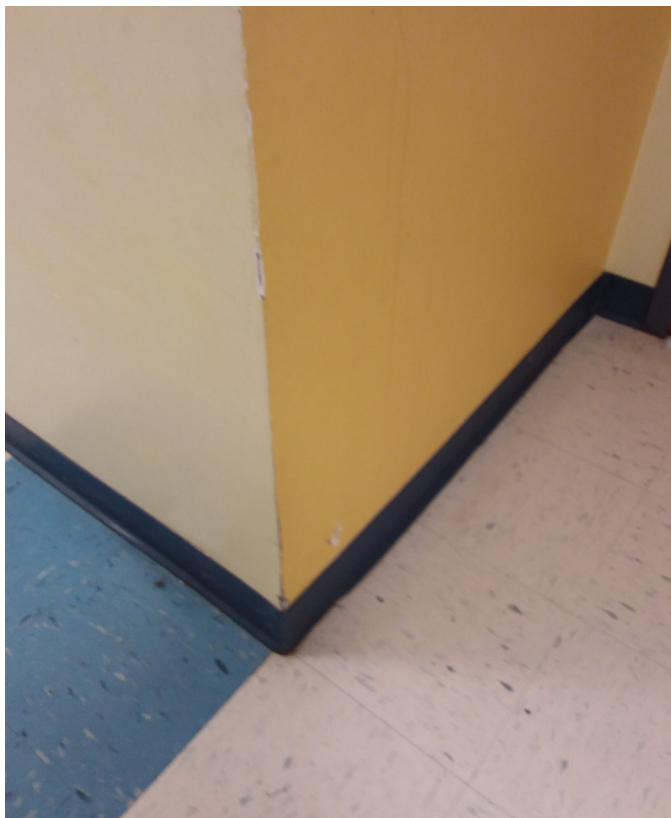
60. Location:

Pre-K / Kindergarten Wing - Corridors

Walls damaged in many areas, especially outside corners. Some have been spackled, but repair has not been completed.

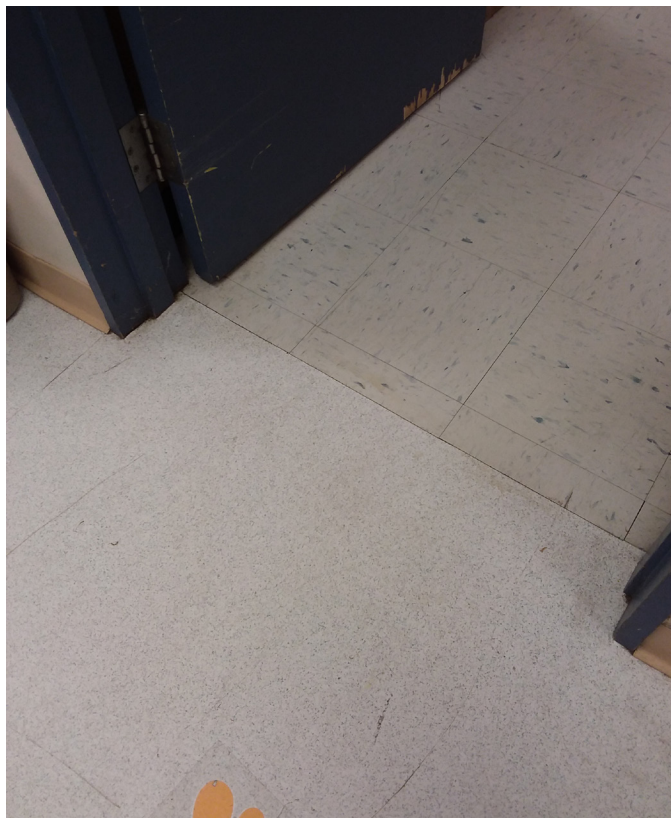
62. Location:

Pre-K / Kindergarten Wing - Main Corridors

No heat welding at transition between vinyl floor and VCT will pose issue if left as is.

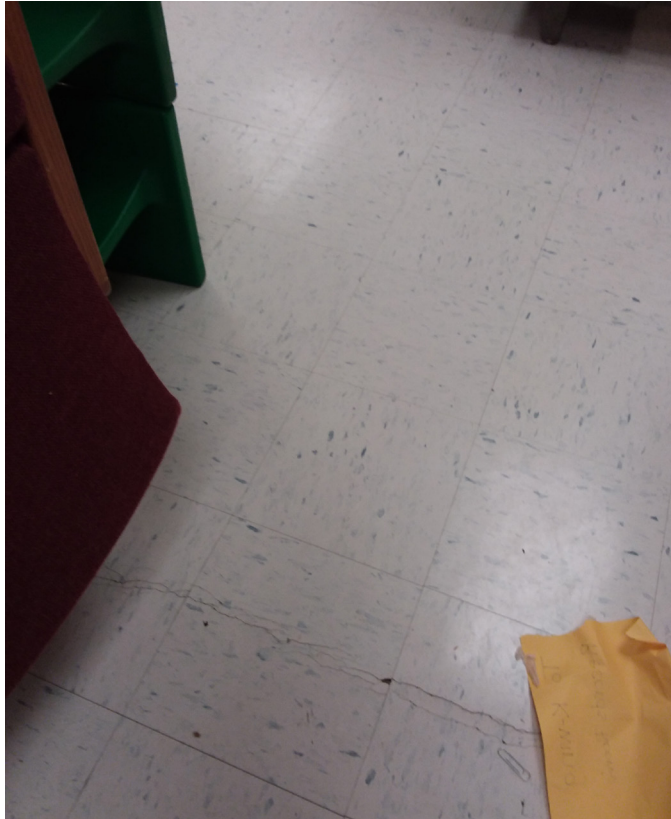
63. Location:

Pre-K / Kindergarten Wing - Classrooms

Heavy cracking, cupping from moisture and separation of tiles present in VCT.

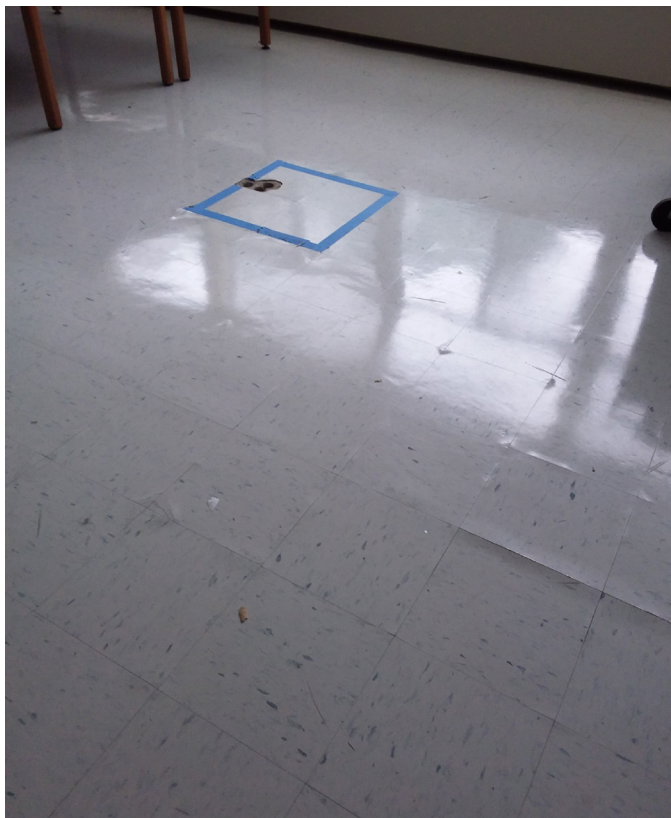
64. Location:

Pre-K / Kindergarten Wing - Classrooms

VCT shows signs of lifting.

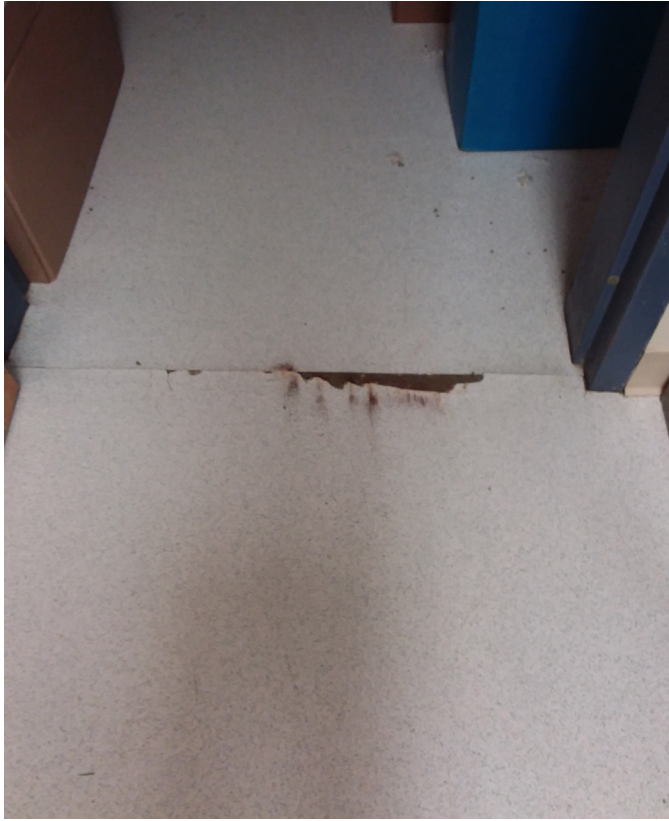
65. Location:

Pre-K / Kindergarten Wing - Classrooms

No transition strips were used between different materials at doorways.

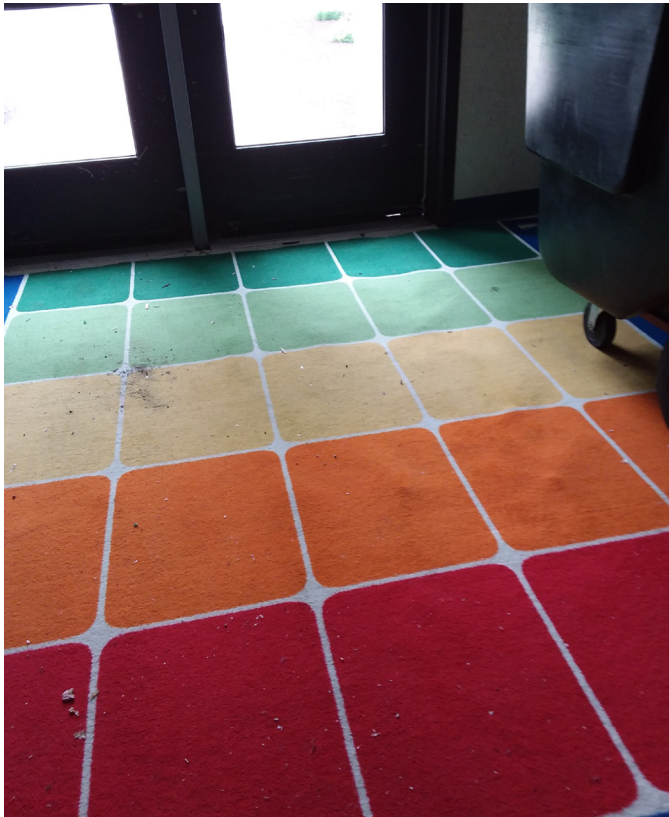
66. Location:

Pre-K / Kindergarten Wing - Entry Vestibule

Recessed entry grill system cover with area rug.

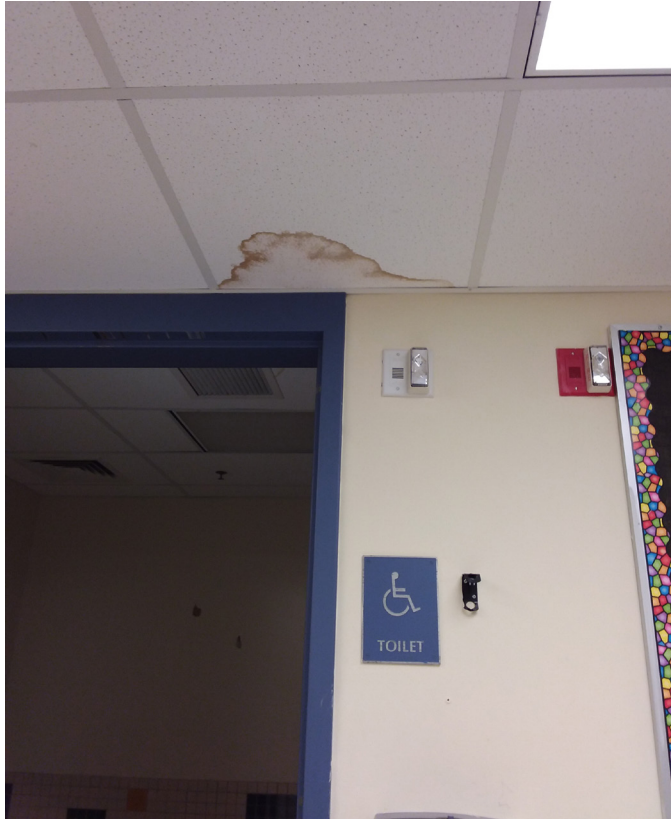
67. Location:

Pre-K / Kindergarten Wing - Corridors

Many areas of water damage present.

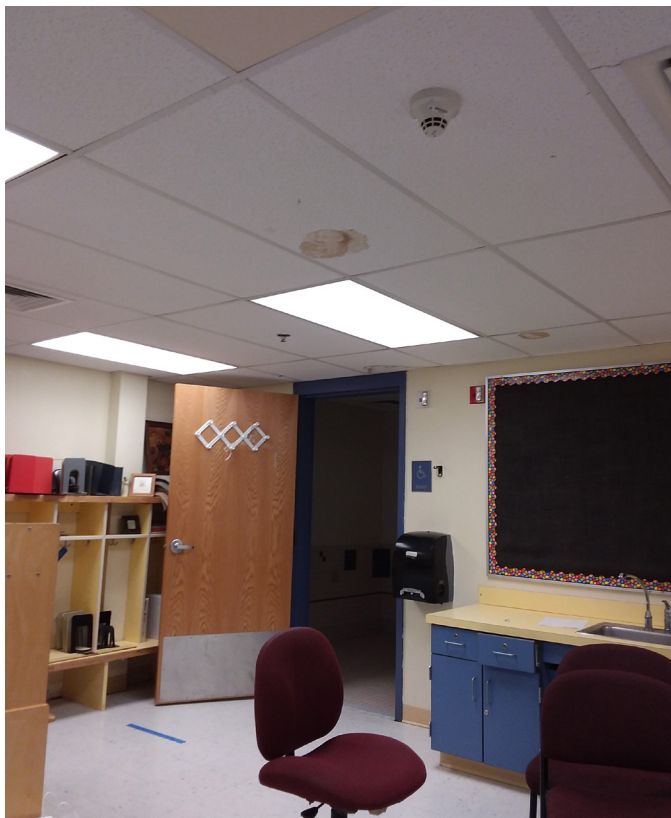
68. Location:

Pre-K / Kindergarten Wing - Classrooms

Areas of water damage present.

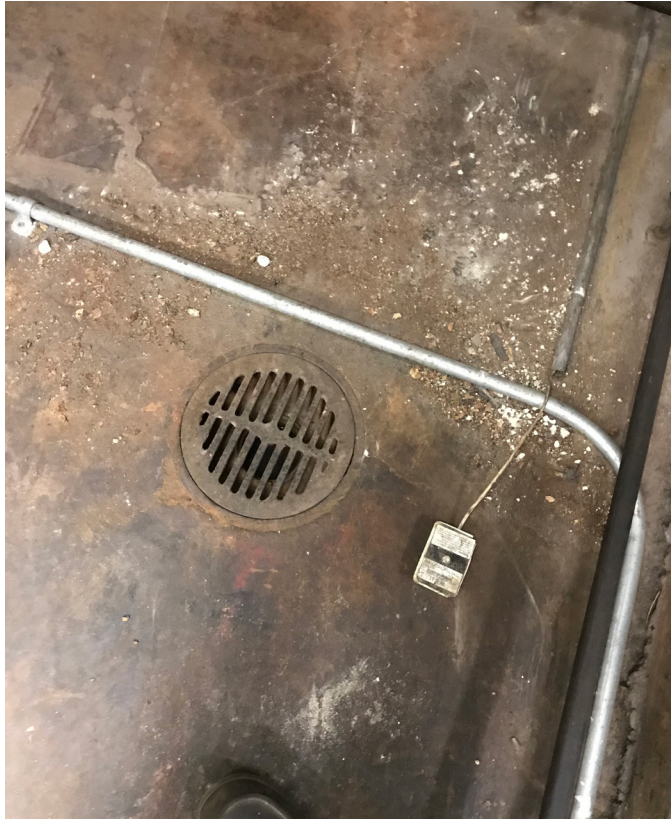
5. Location:

The floor drain serving the boiler room is located next to a leak sensor which is also surrounded by water stains and an apparent water line from when the room floods. According to Facilities Personnel, the room has a tendency to flood when exterior rains are heavy and drainage is backed up. This issue is more prevalent during the winter months. This is problematic not only due to the water entering the room, but also due to the risk of oils getting into the storm sewer system which the drain is possibly connected to.

Boiler Room

Floor Drain with Leak Sensor (see plumbing report)

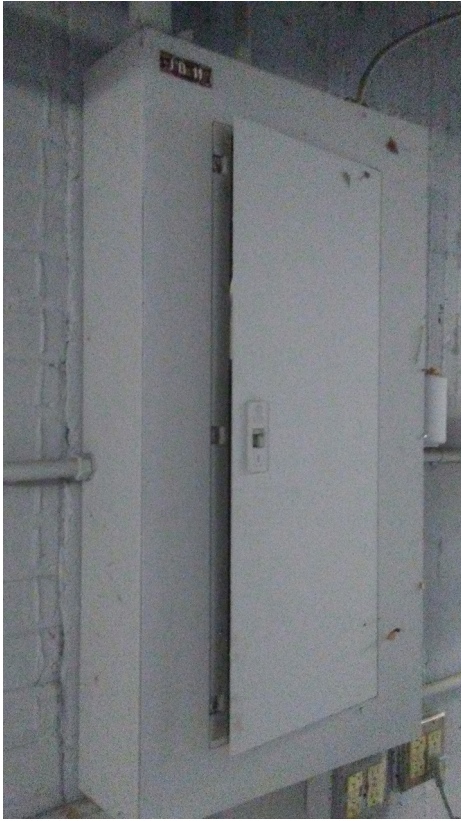
17. Location:

Branch Panel

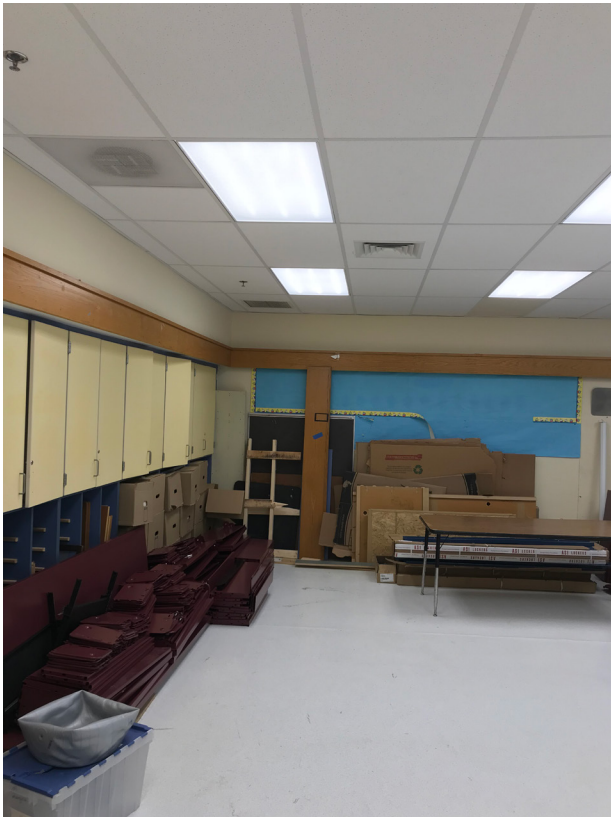
18. Location:

Typical Classroom Lighting

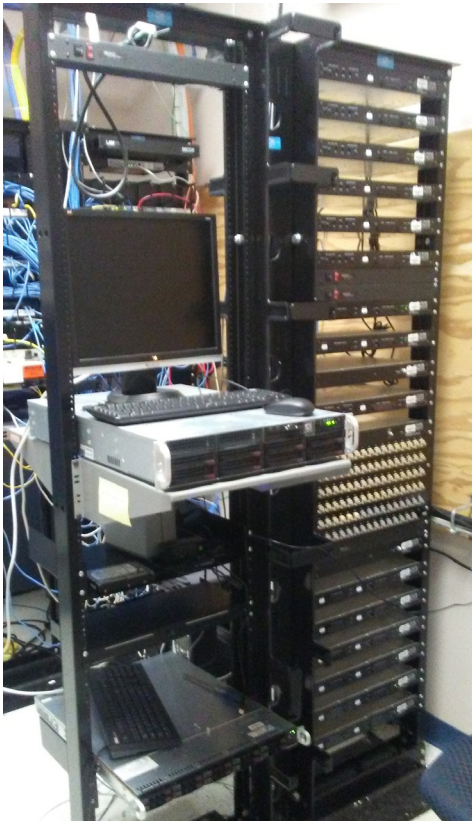
19. Location:

Telecommunications Backboard

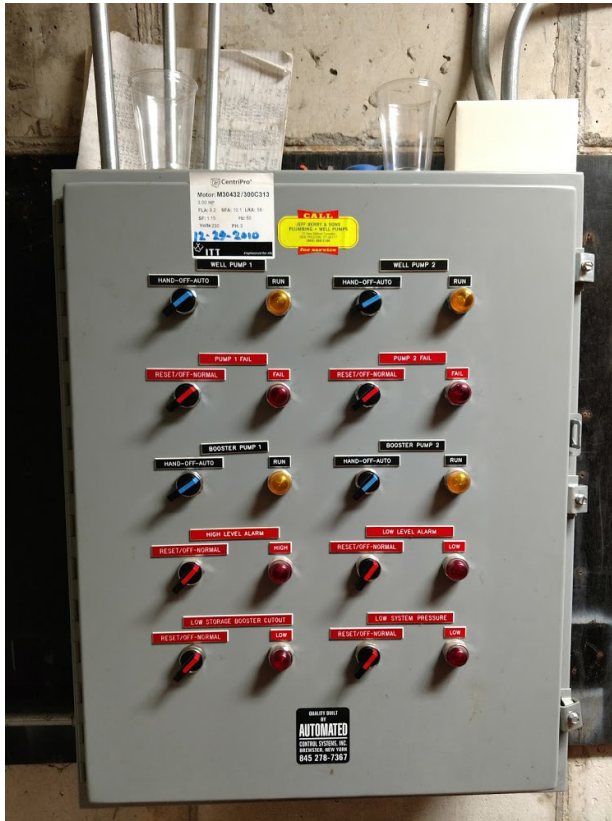
21. Location:

Well Pump Controller

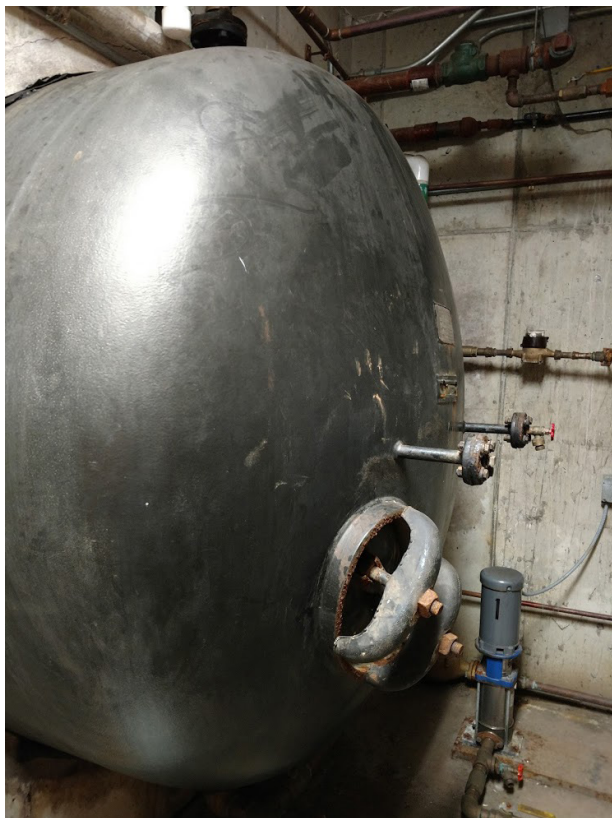
22. Location:

Domestic Water Storage Tank

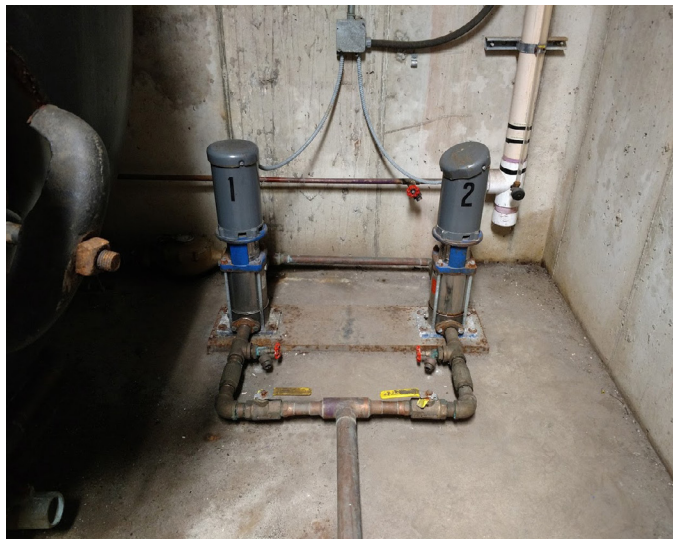
23. Location:

Domestic Water Booster Pump

- Booster pumps are obsolete and replacement should be considered.
- Install system to control chloride/sodium levels within each well. See appendix.
- Confirm that grease separator is cleaned-out.
- Video survey plumbing fixtures with poor drainage for pipe corrosion.
- Numerous roof drains are clogged and ponding is occurring. Maintain as necessary.

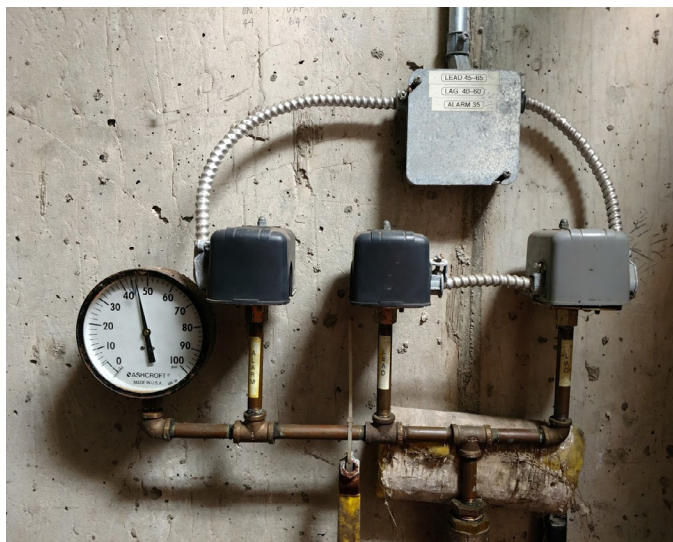
24. Location:

Domestic Water Booster Pump Controls

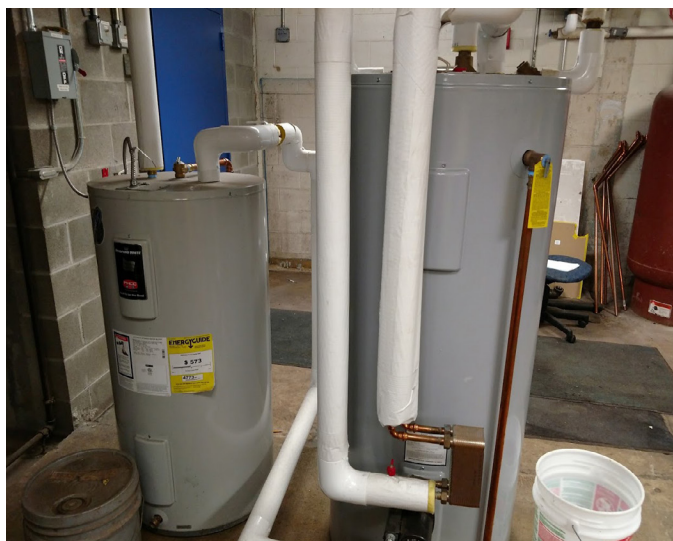
25. Location:

Domestic Water Heaters and Storage Tanks

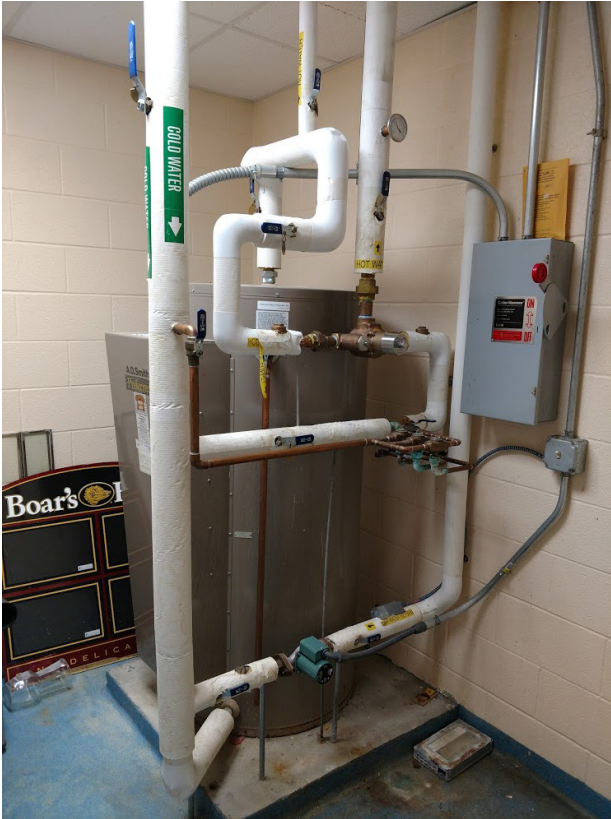
26. Location:

Kitchen Domestic Water Heater and Storage Tank

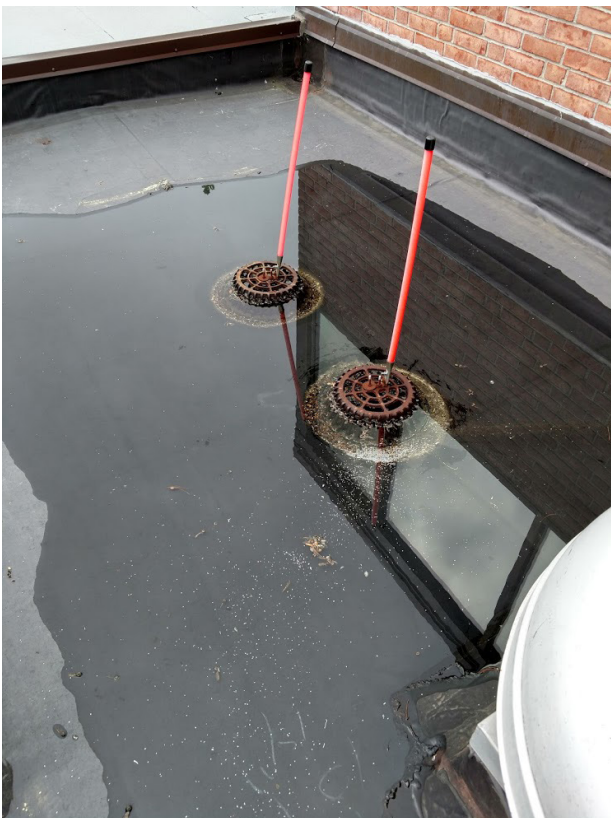
27. Location:

Storm Water Ponding

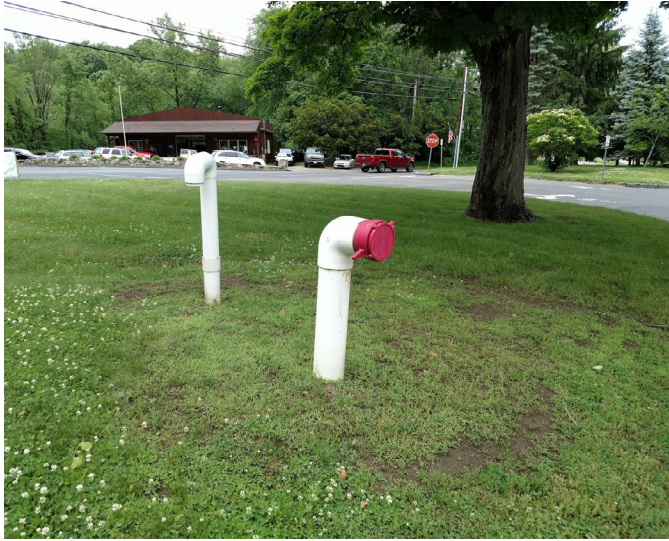
28. Location:

Fire Protection Storage Tank

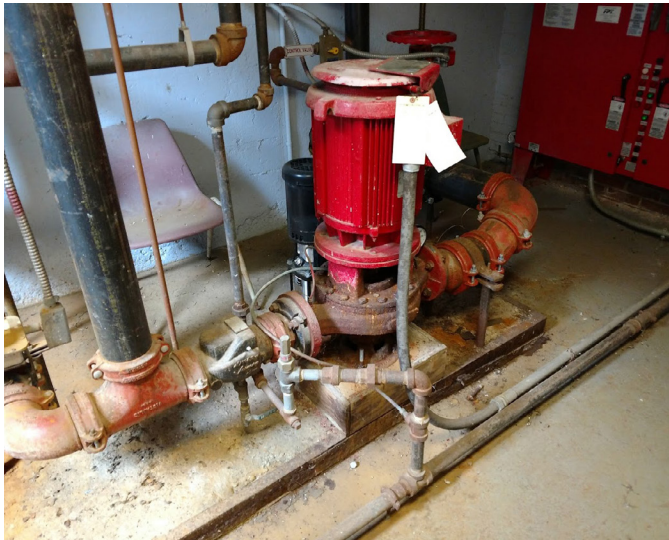
29. Location:

Fire Protection System In-line Fire Pump

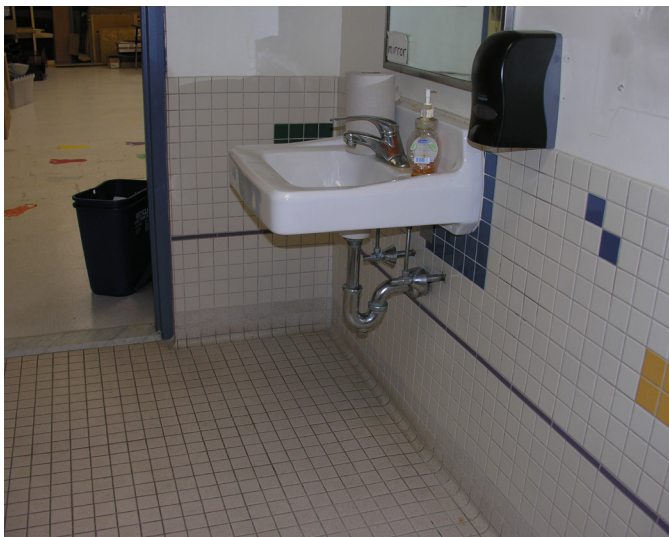
30. Location:

Typical Classroom Bathroom Lavatory

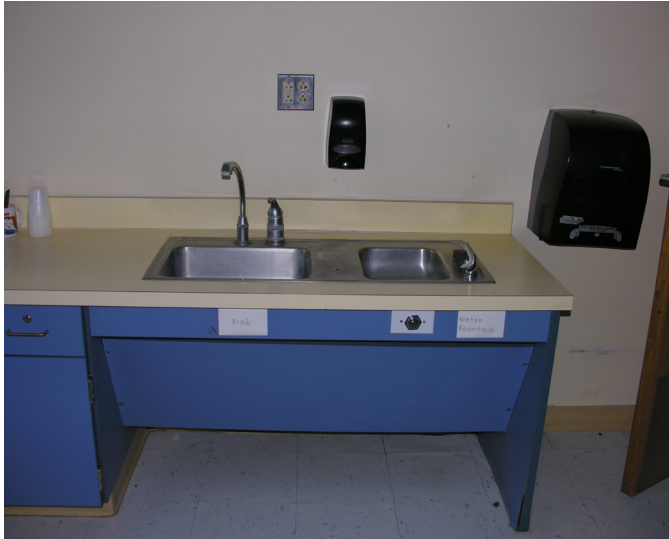
31. Location:

Typical Sink with Bubbler

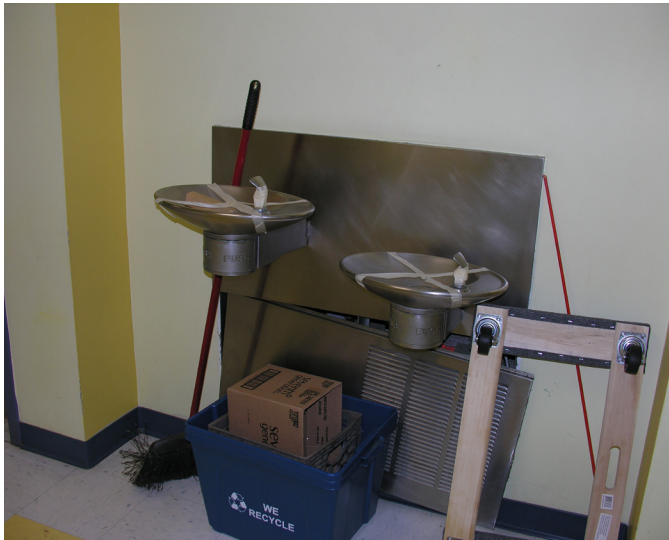
32. Location:

Typical Hi/Low Drinking Fountains - Not in Service
