Facility Survey, Code Analysis and Buildings & Grounds Survey & Master Plan

The Sherman School

Sherman, Connecticut

November 2018

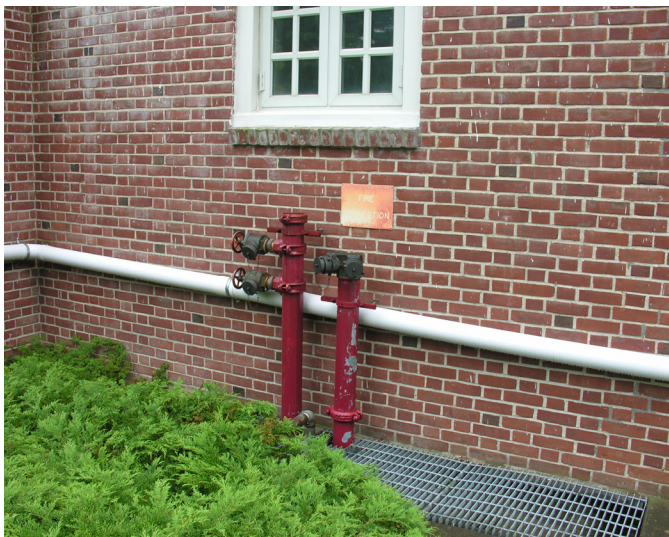
33. Location:

Fire Pump Test Header and Sprinkler System Siamese Connection

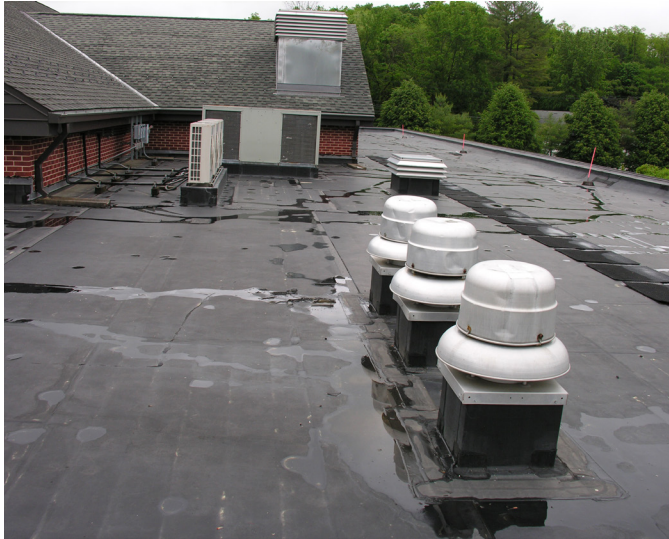
34. Location:

Typical Exhaust Fans

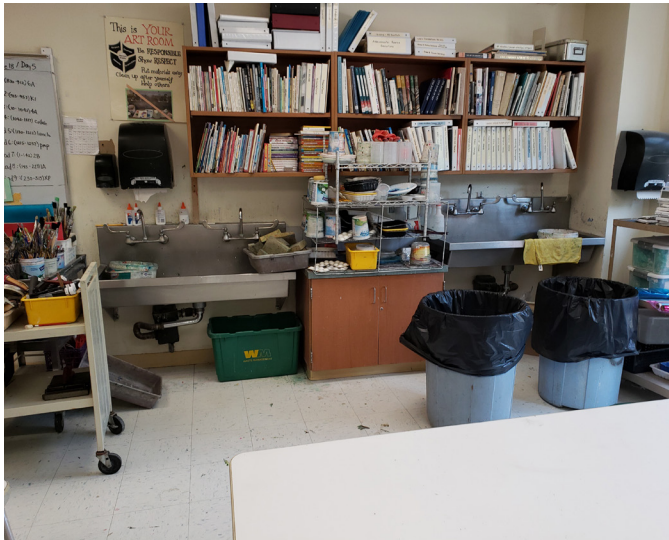
35. Location:

Stainless Steel Sink w/Clay Trap

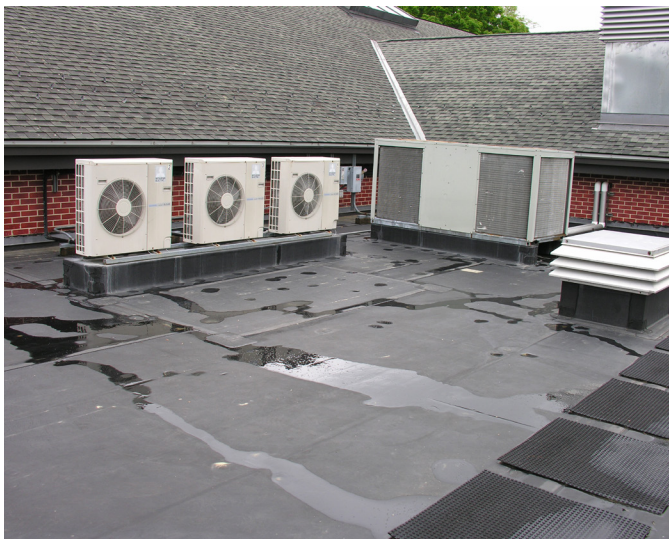
36. Location:

Condensing Units

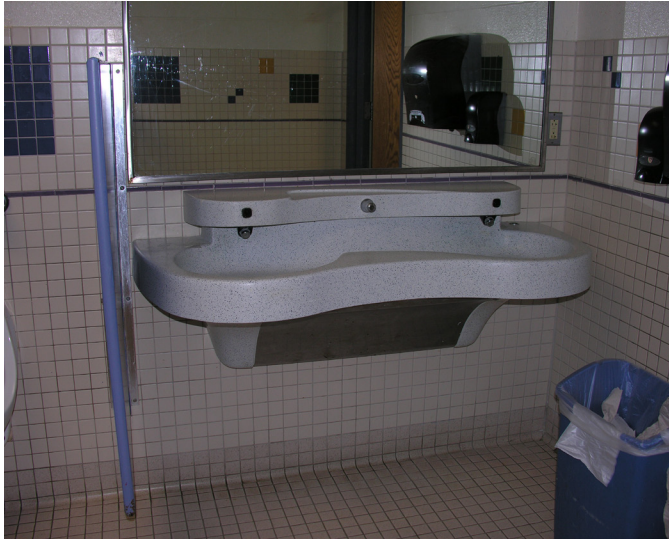
37. Location:

ADA Compliant Gang Lavatory

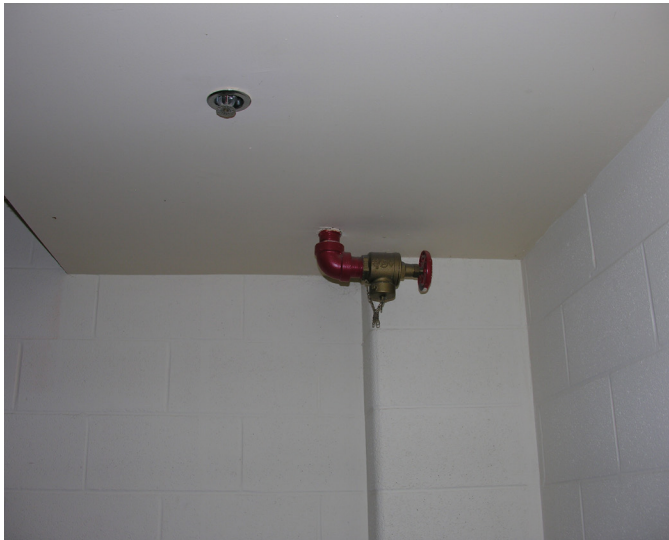
38. Location:

Non-Compliant Fire Hose Valve Located
approx. 7'-0" AFF

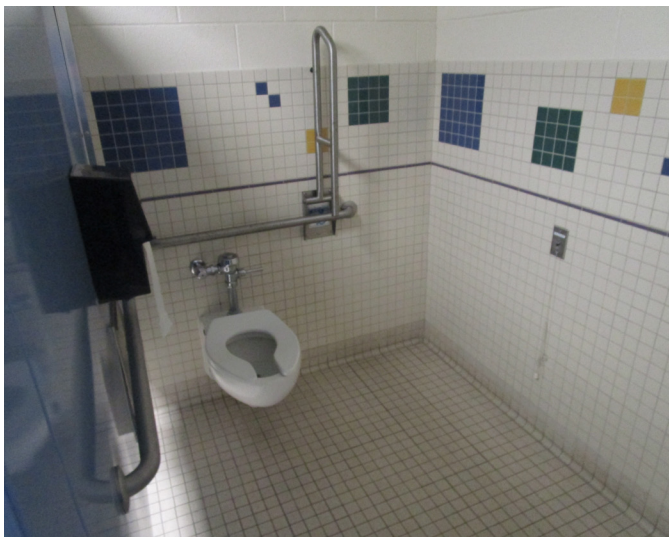
39. Location:

ADA Compliant WC and Stall

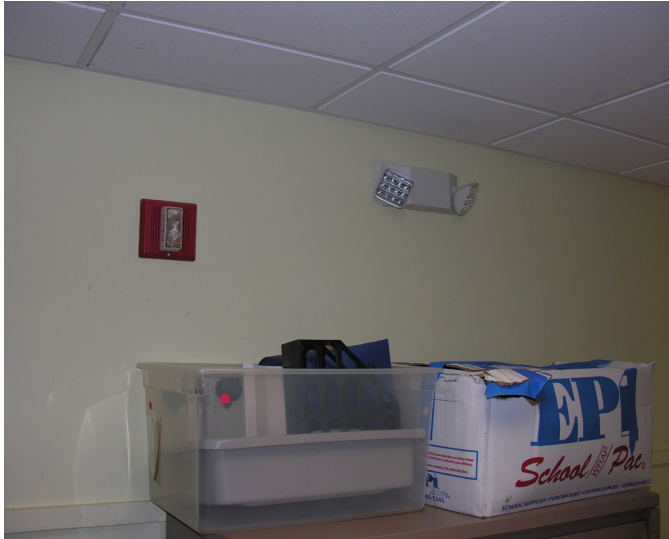
40. Location:

Fire Alarm and Emergency Lighting Devices. EM lighting fixture type varies in the school.

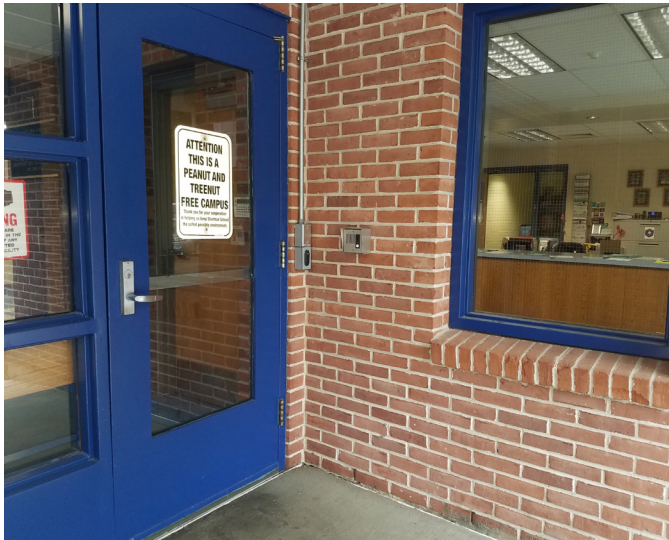
41. Location:

Entry Door w/Key Fob Entry and AIPhone

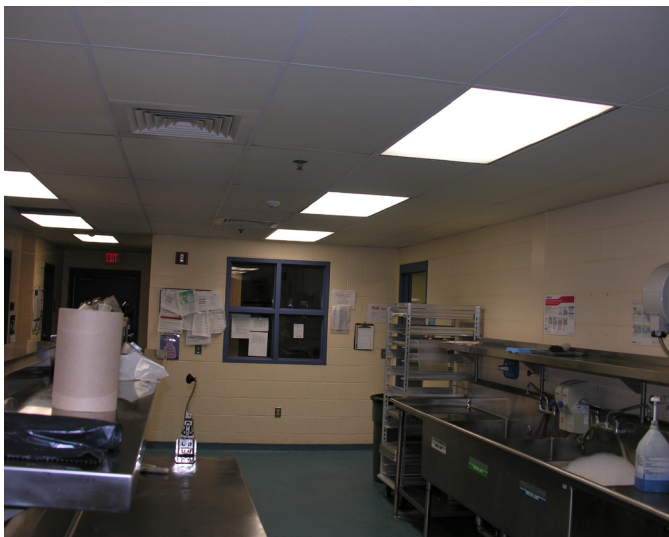
42. Location:

Overview of Kitchen Showing 3-Bay Stainless Steel Sink.

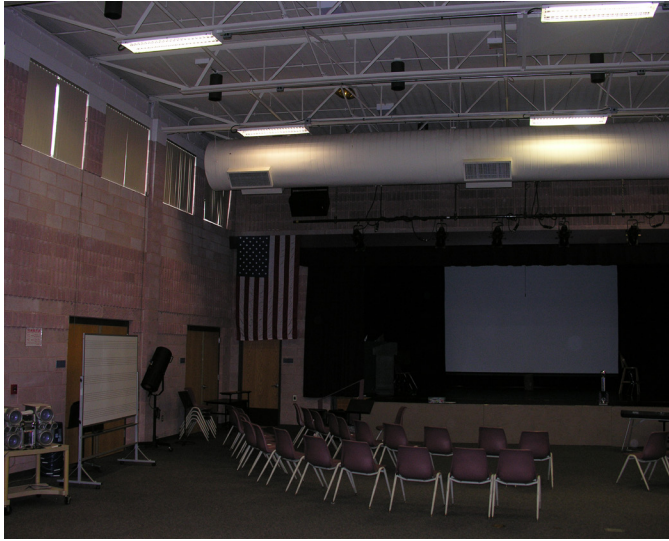
43. Location:

Lighting and HVAC

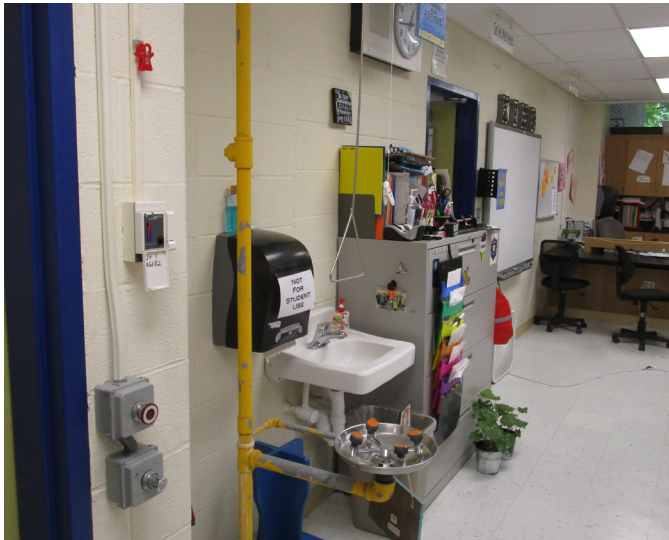
44. Location:

Emergency Shower

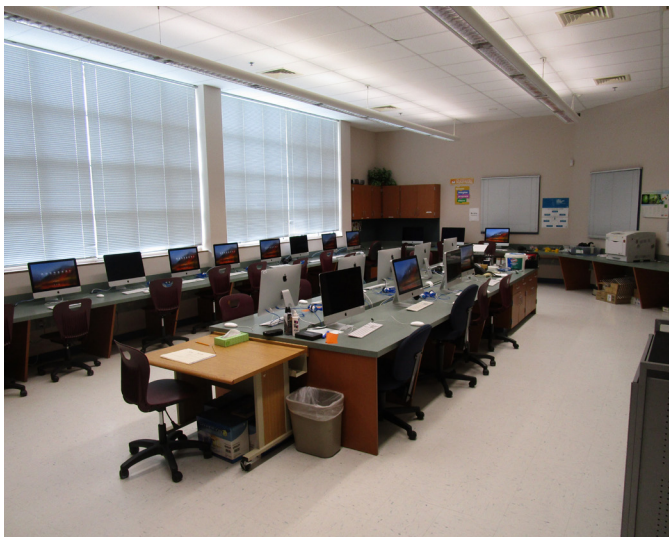
45. Location:

Lighting and Computer Stations

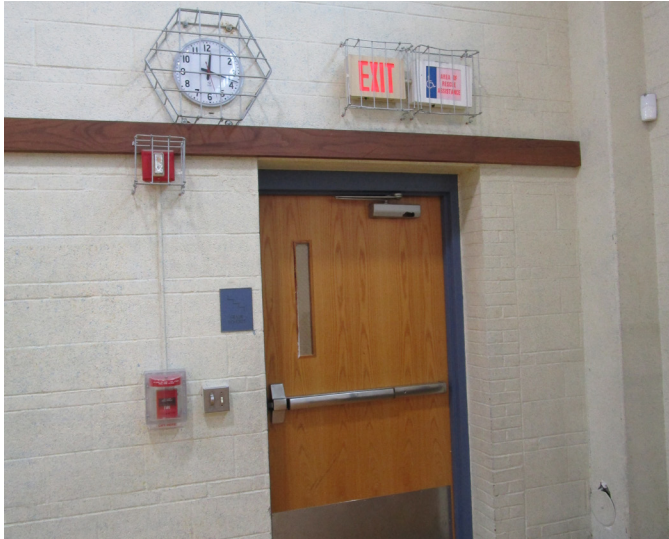
46. Location:

Area of Rescue Signage, Emergency Exit and Fire Alarm Devices

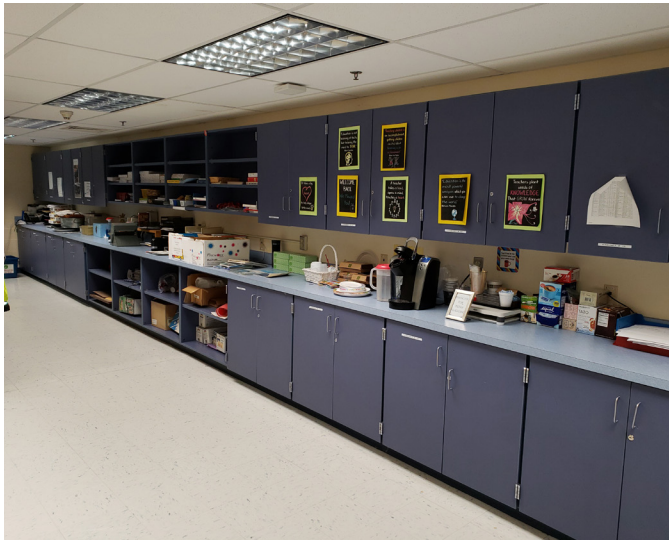
47. Location:

Typical Lighting/Fire Protection

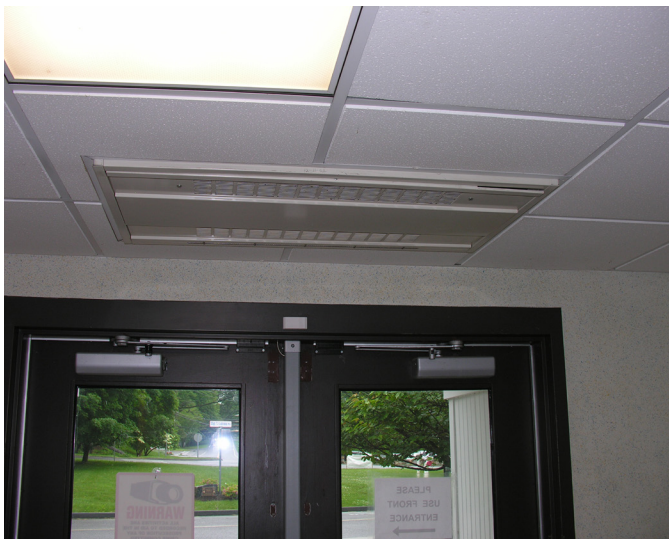
48. Location:

Ceiling Mounted Cabinet Unit Heater

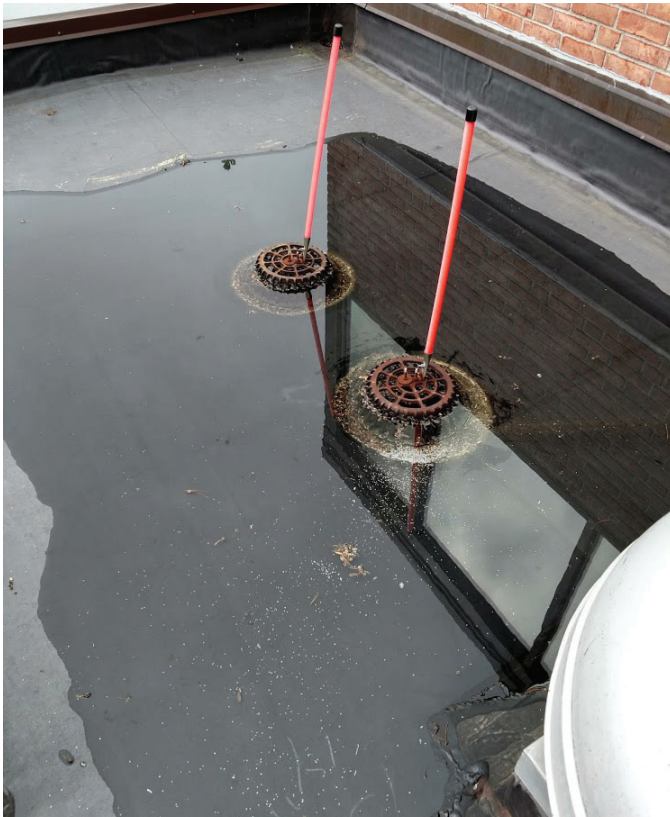
50. Location:

Roof Drains - Ponding water

- Booster pumps are obsolete and replacement should be considered.
- Install system to control chloride/sodium levels within each well. See appendix.
- Confirm that grease separator is cleaned-out.
- Video survey plumbing fixtures with poor drainage for pipe corrosion.
- Numerous roof drains are clogged and ponding is occurring. Maintain as necessary.

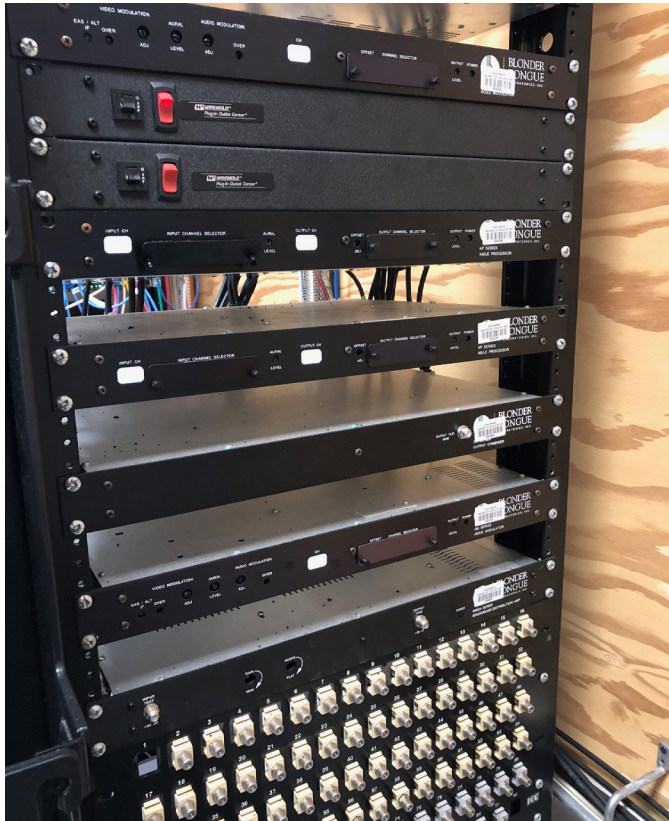
51. Location:

Equipment not in use.

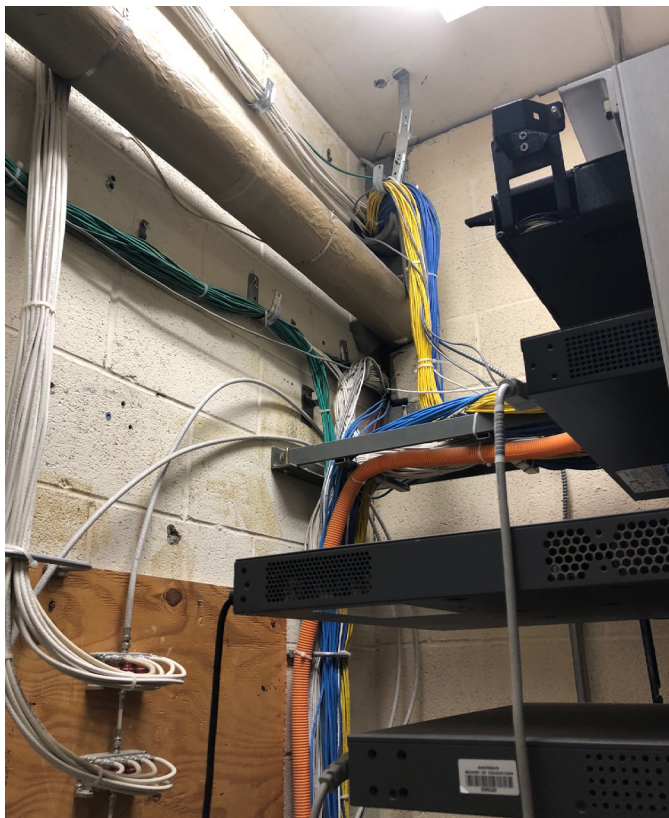
52. Location:

Data wiring and rack. Room lacks air conditioning.

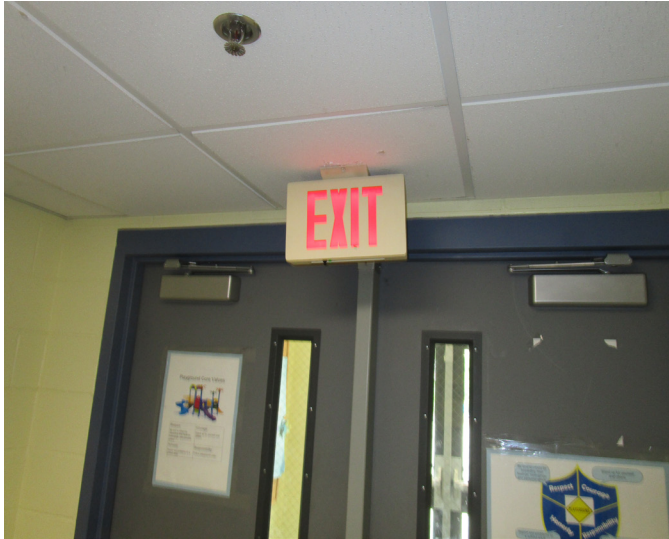
"A" Wing - Lower Level - Corridor Exit Door

The exit signs located within the corridor do not provide the required 6'-8" clearance

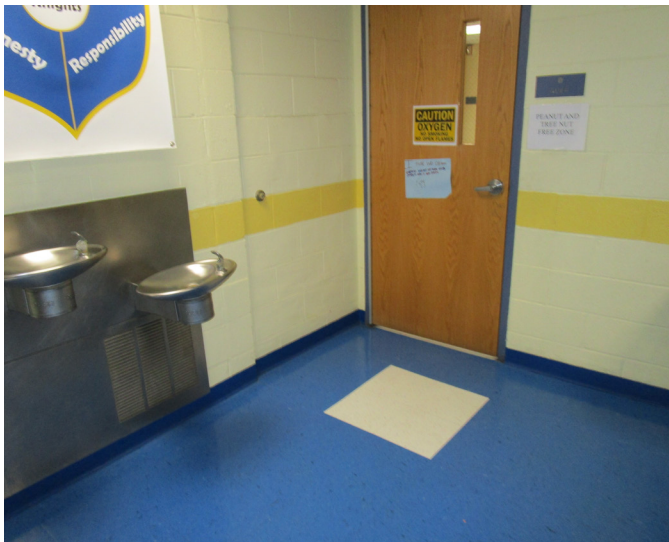
"D" Wing - Main Level - Corridor outside of Nurse's Office

The building's Hi/Low drinking fountains are currently not in service. The drinking fountain installation is considered a protruding object.

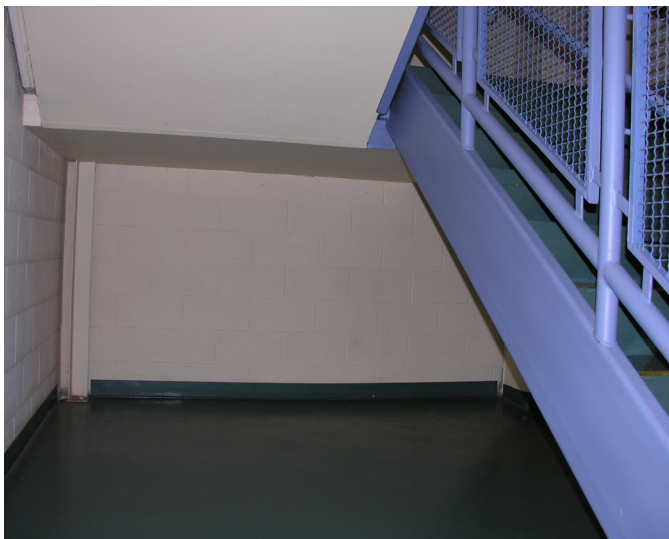
"A" Wing - Lower Level - Stairwell adjacent to the Cafeteria

The headroom height is not provided, causing an unprotected obstruction.

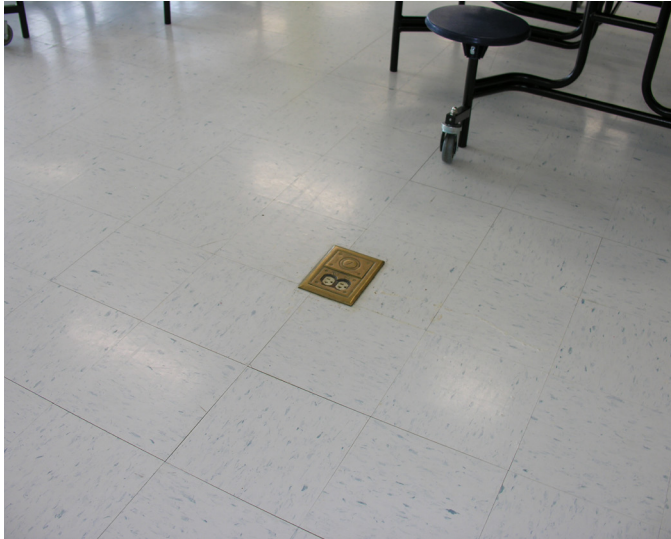
"A" Wing - Lower Level - Cafeteria

The exposed electrical floor box is not protected from infiltration.

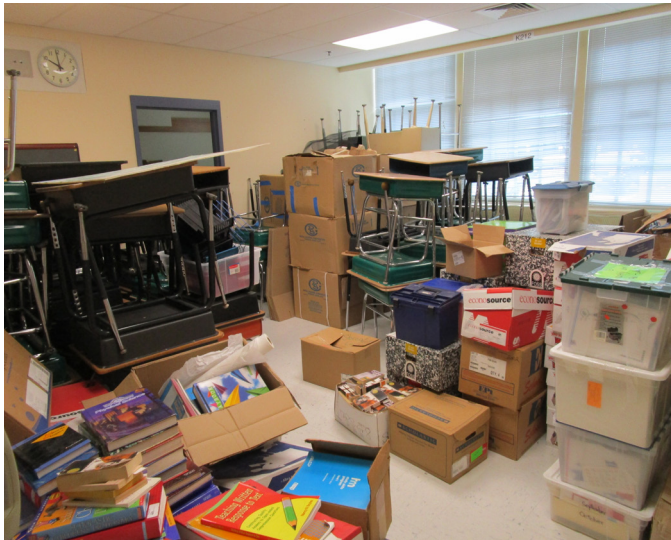
Kindergarten Wing - Room K212

The wing is currently unoccupied and is being used as a storage area. The classroom was not designed as a storage room with required fire ratings for walls and doors.

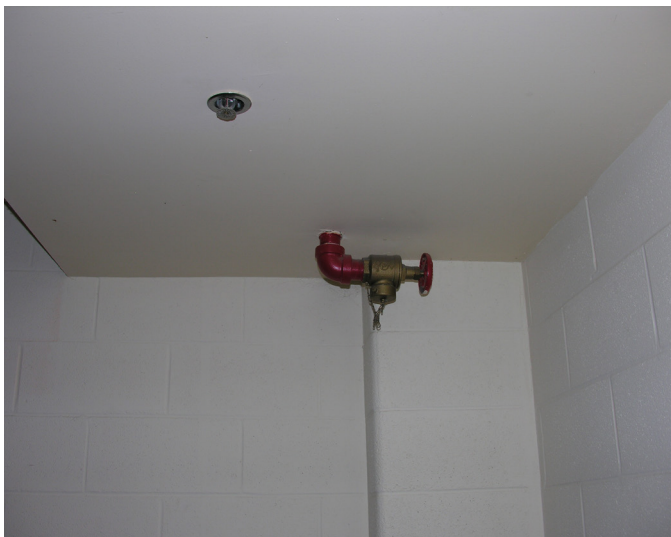
"A" Wing - Lower Level - Stairwell adjacent to the Cafeteria

The fire hose valve is non-compliant being installed at approximately 7'-0" above the finished floor.

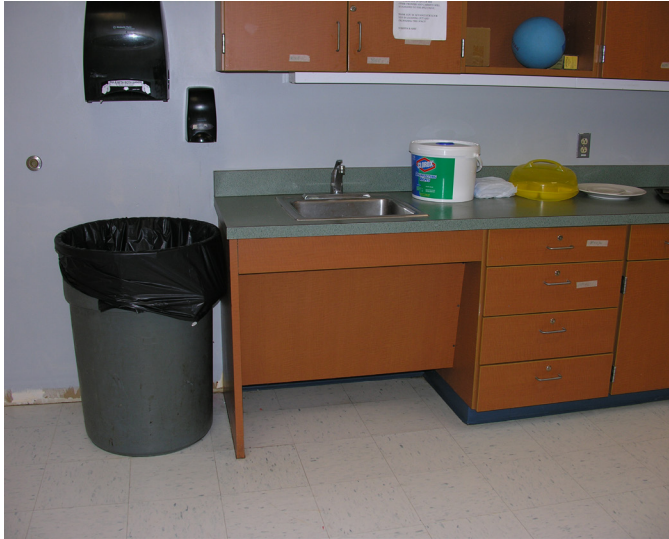
"A" Wing - Lower Level - Faculty Lounge

The receptacle is in a non-compliant location in relation to sink.

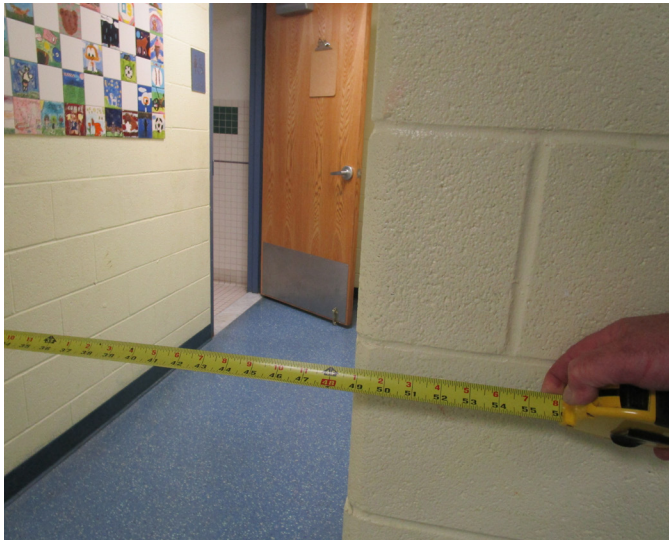
"A" Wing - Lower Level - Girls Toilet Room

The required handicap accessible maneuvering clearance at the entry door has not been provided, therefore the accessible route has not been provided.

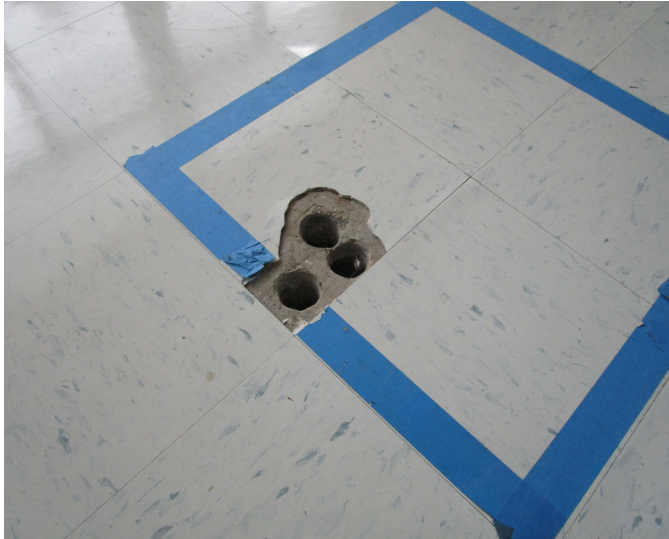
Kindergarten Wing - Room K213

The existing floor slab construction has been core drilled for investigative purposes.

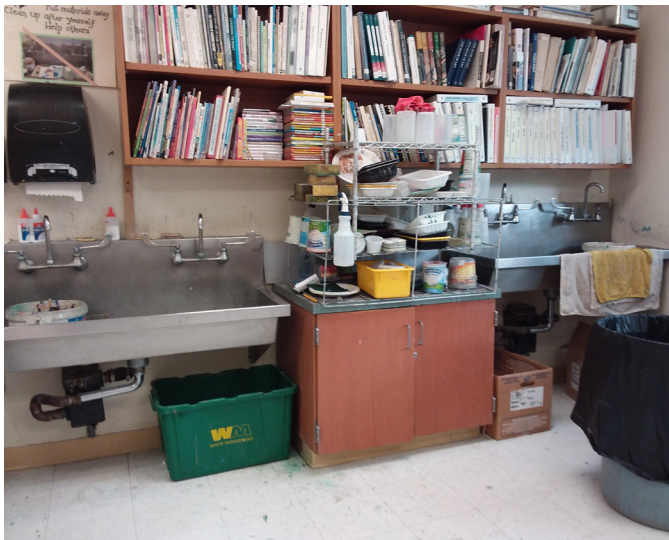
"A" Wing - Lower Level - Art Room 508

The stainless steel sink within the classroom has a compliant clay trap.

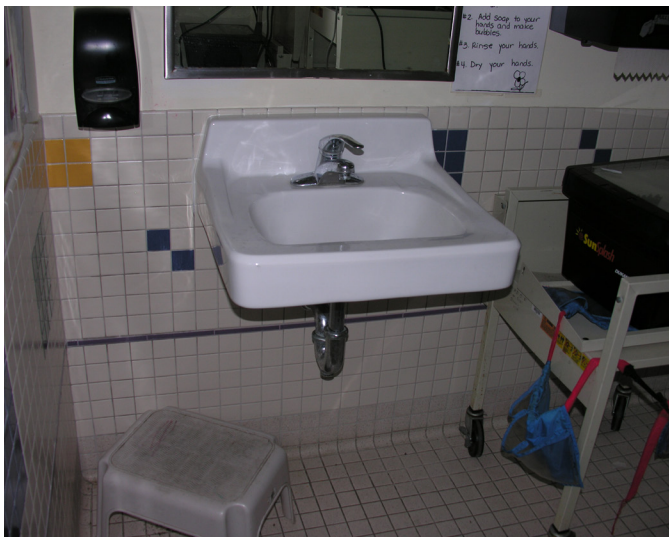
Kindergarten Wing - Toilet Room off of Room K213

Typical Classroom Bathroom Lavatory, Non-Compliant Protection

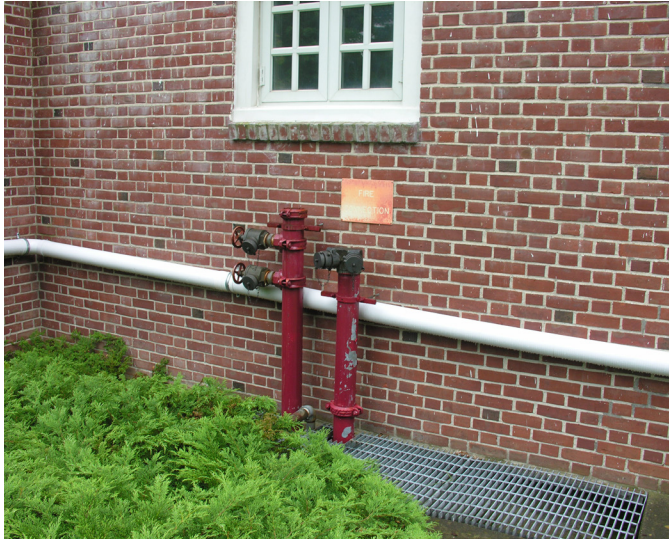
"C" Wing - North Elevation

The fire pump test header and sprinkler system siamese connection are shown. Access to this equipment is limited due to shrubs.

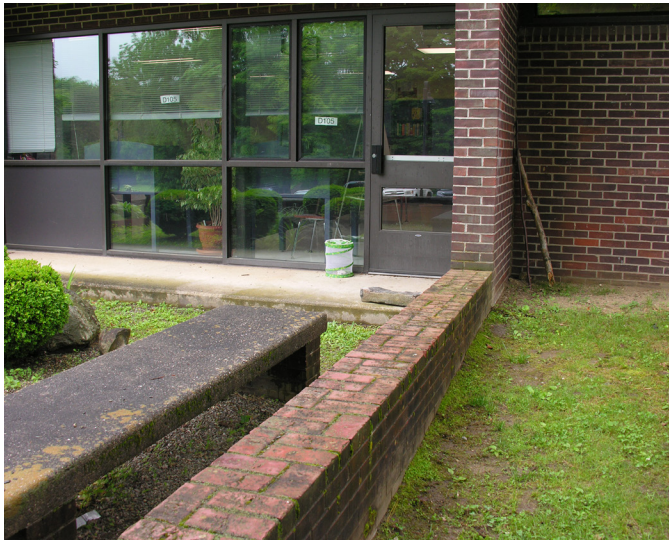
Exterior Exit at Resource Office 105

The designated exit from the Resource Office is not compliant. An acceptable egress path to the public way has not been provided. Refer to Photo #19 for the

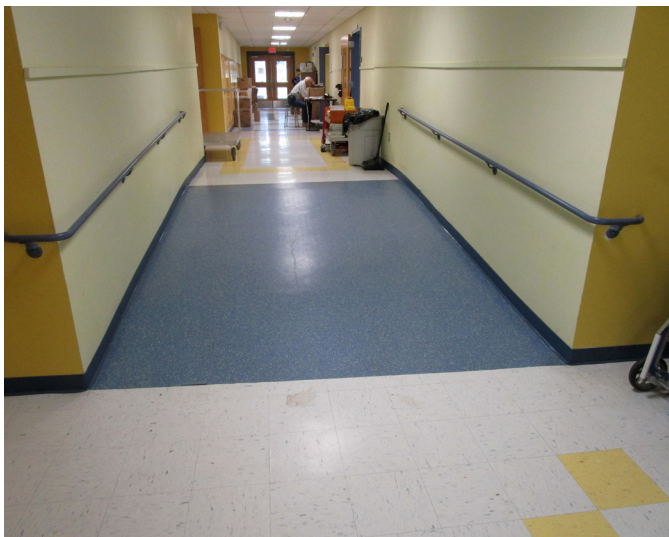
Kindergarten Wing - Ramp at Corridor

The ramp handrail extensions do not continue in the same direction as the ramp.

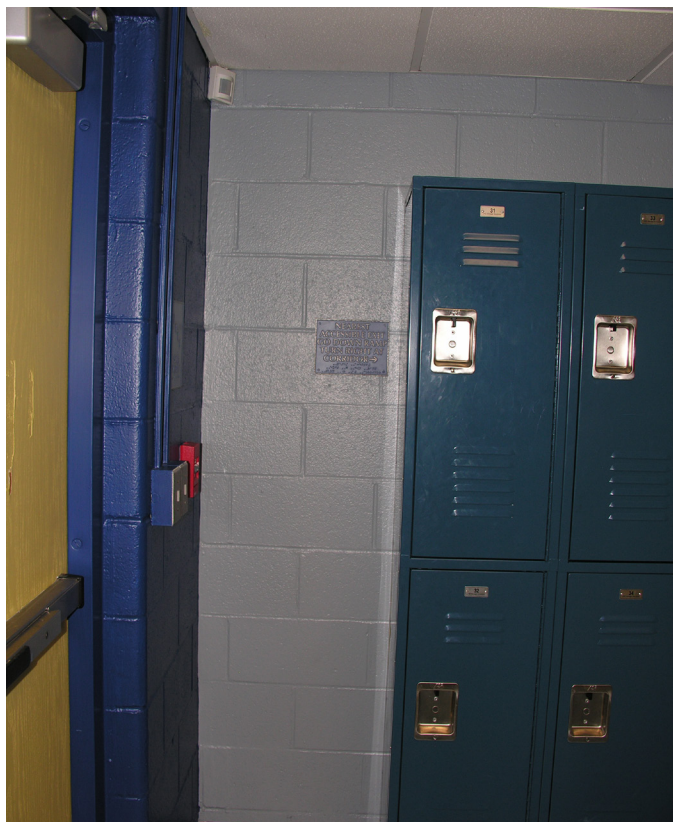
"D" Wing - Lower Level - Corridor
outside of South Stairwell

The non-compliant signage due to
location between masonry wall and
lockers

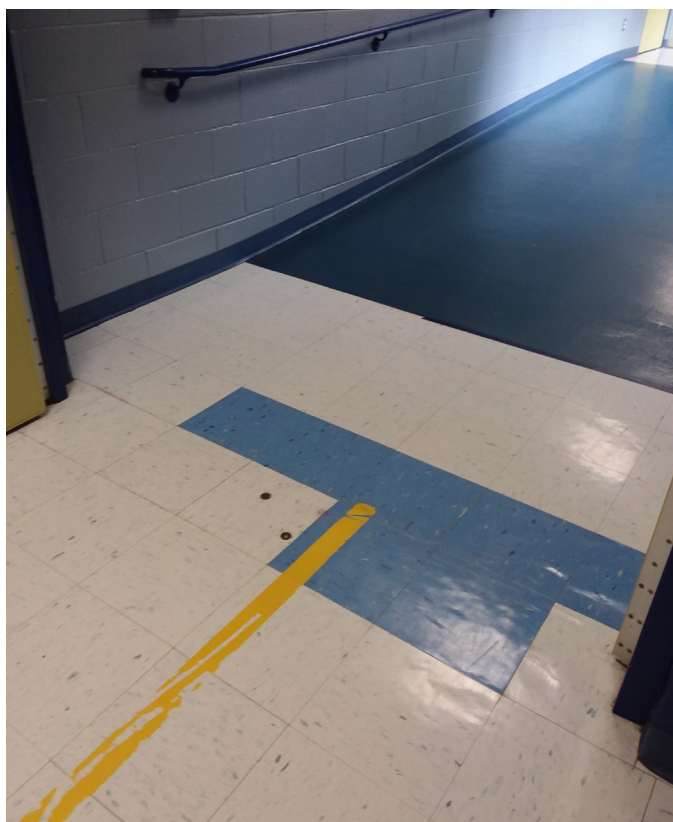
"D" Wing - Lower Level - Corridor at
Double Egress Doors

The ramp lower landing does not
continue in the same direction
unobstructed.

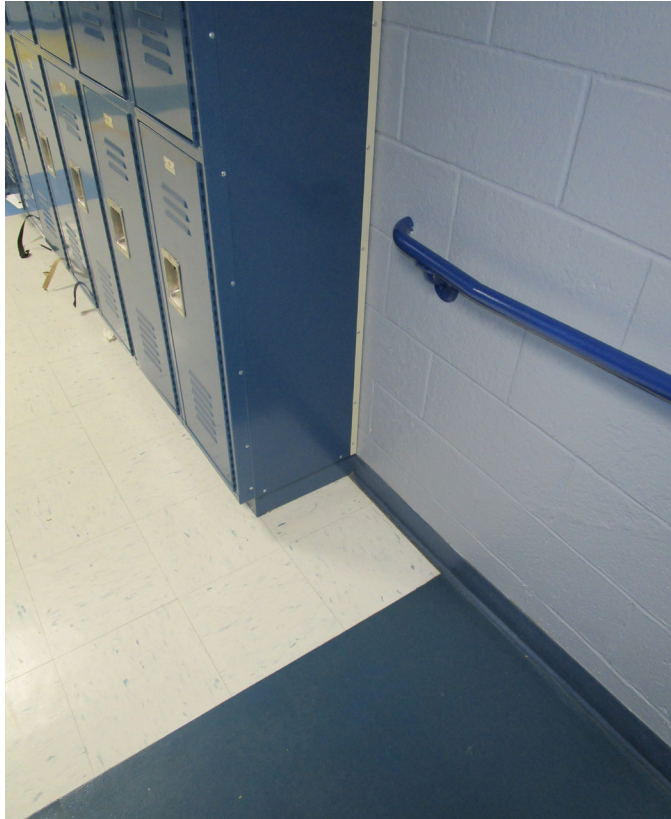
"D" Wing - Lower Level - Corridor

The ramp lower landing does not continue in the same direction unobstructed.

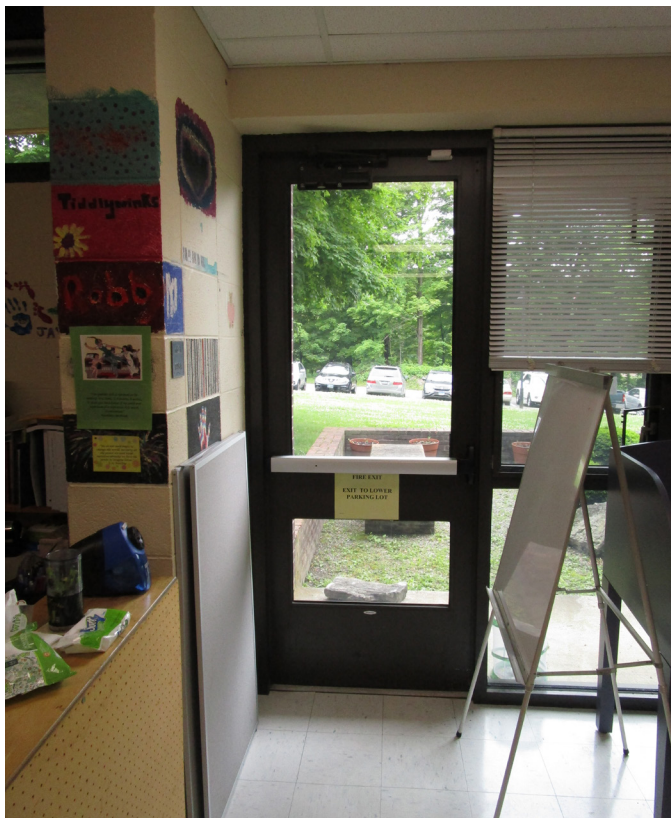
Exterior Exit at Resource Office 105

The designated as a "fire exit" to the building's exterior from Resource Office. The evacuation plan for the room also designates this as the main exit from the space. Refer to Photo #14 for view from the building exterior.

- All exits shall be marked with an approved exit sign, see photo #19.
- Re-roofing applications need to comply with the minimum continuous insulation standard

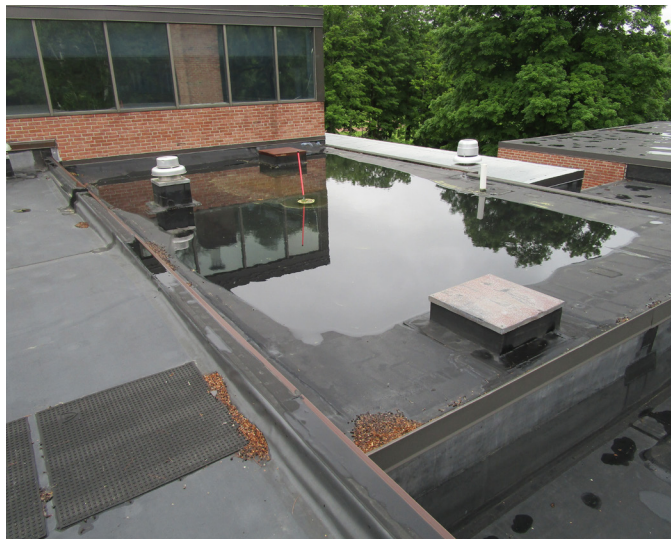
Roof - Area D

An overflow drainage system has not been installed due to the age of the existing roofing system. The overflow system would notify building staff that there was a clog at the roof level.

- Window & door replacement for the original building need to comply with a minimum insulating value
- Re-roofing need to comply with the overflow roof drainage provision, see photo #20.

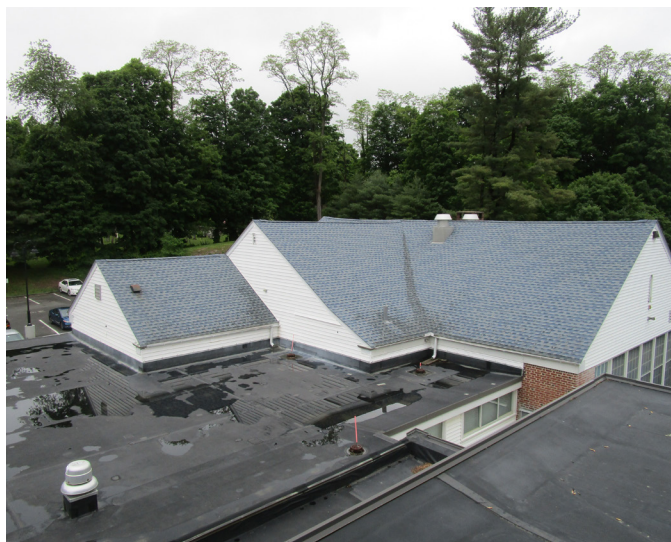
Roof - Area C

The roof construction may not be provided with the proper ventilation. The roof eaves / soffits are not vented and the gable ends are minimally vented.

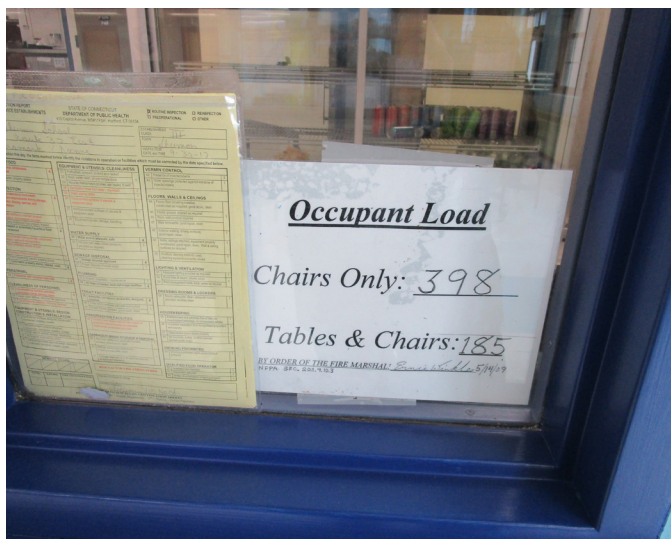
"A" Wing - Lower Level - Cafeteria

The assembly area is properly marked with a posted occupant load sign. All assembly areas require a posted occupancy sign.

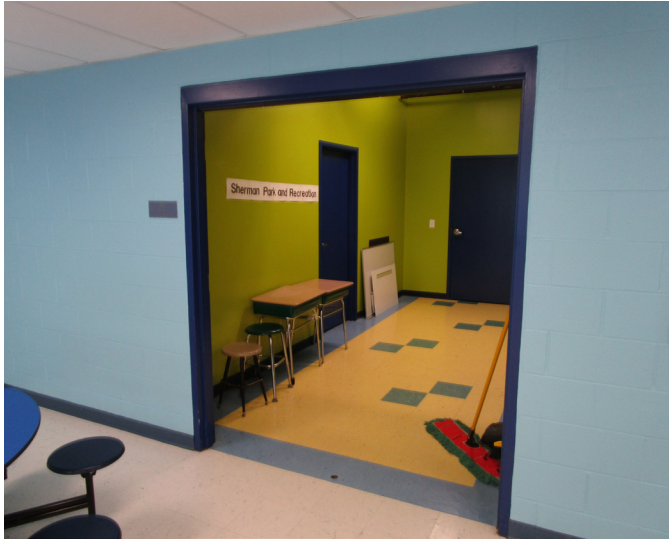
Lower Level - Parks and Rec - off of the Cafeteria

This tenant can not be located by the general public. The signage for the room needs upgrading.

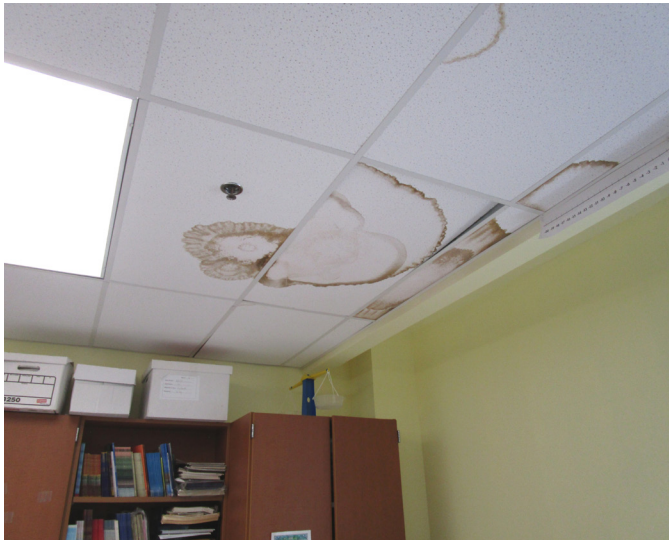
Resource Office B206

All water leaks need to be monitored and remediation performed as soon as possible to avoid contamination.

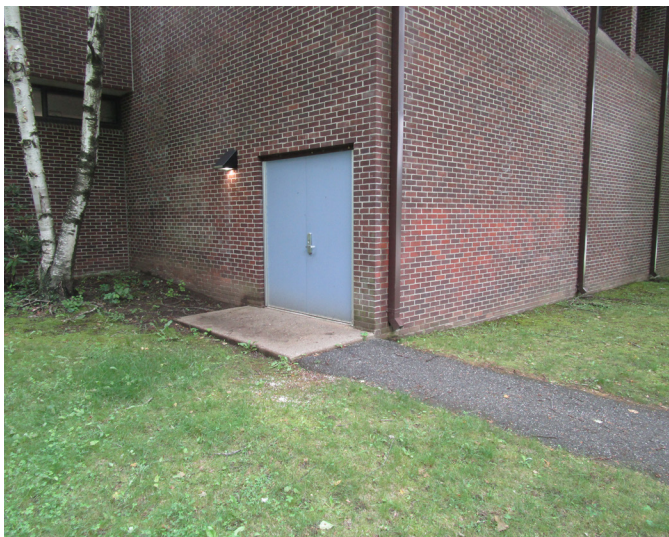
Exit from South Stair Well - Area "D"

The door leaf will block the access to the walkway when egressing the stair. This stair has an area of refuge at the Main Level but not at the Lower Level.

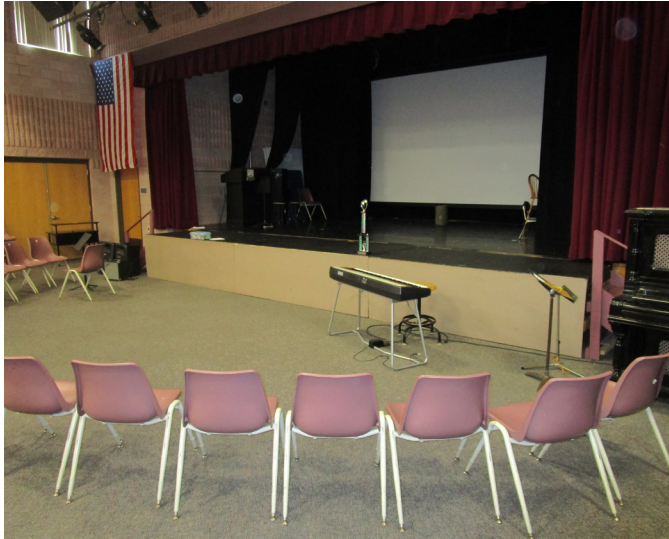
Area "B" - Lower Level - Multi-Purpose Room

The raised platform was added onto after the original construction. The raised platform was of wood framed construction. Typically the floor structure would be protected and/or sprinklered. Wood framing is not consistent with the original construction type for the building.

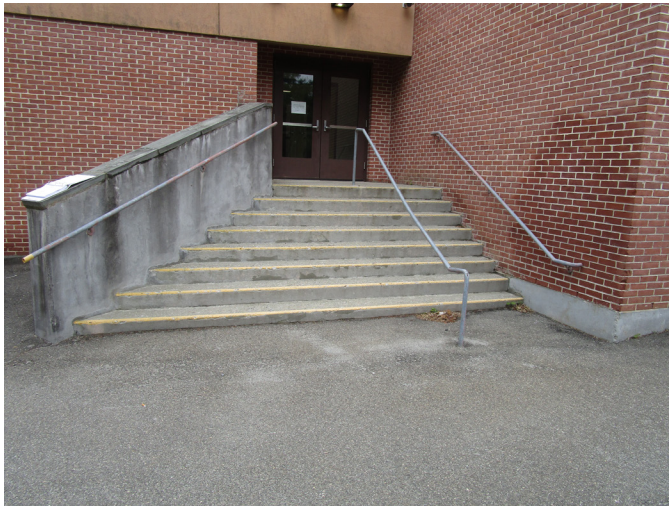
Area "B" - Lower Level - Exterior Exit Stair

The handrails for this stair need to be upgraded for height. Handrail ends need to be returned to the wall or pavement

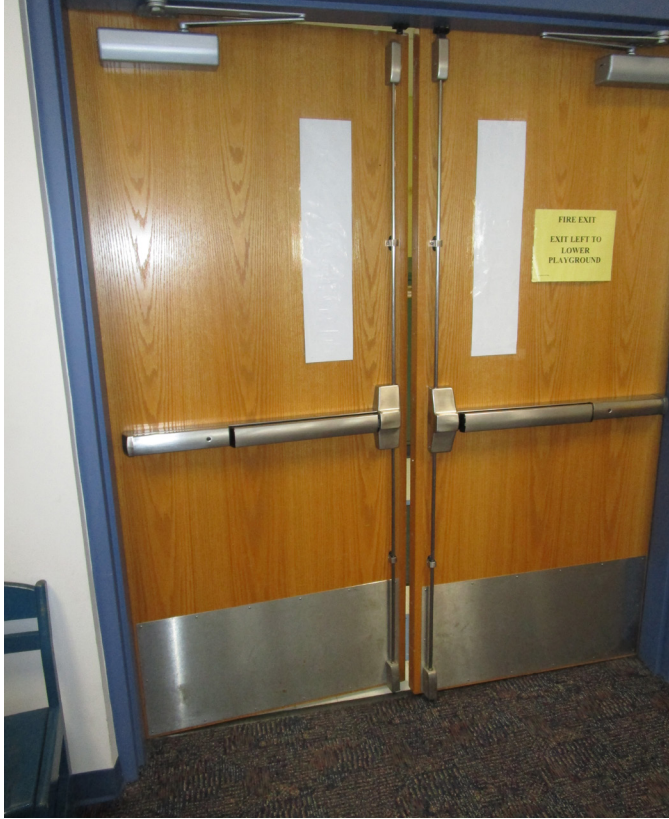
"A" Wing - Main Level - Media Center

The exit doors from the Media Center do not close properly. The smoke barrier at the exit access corridor is therefore compromised.

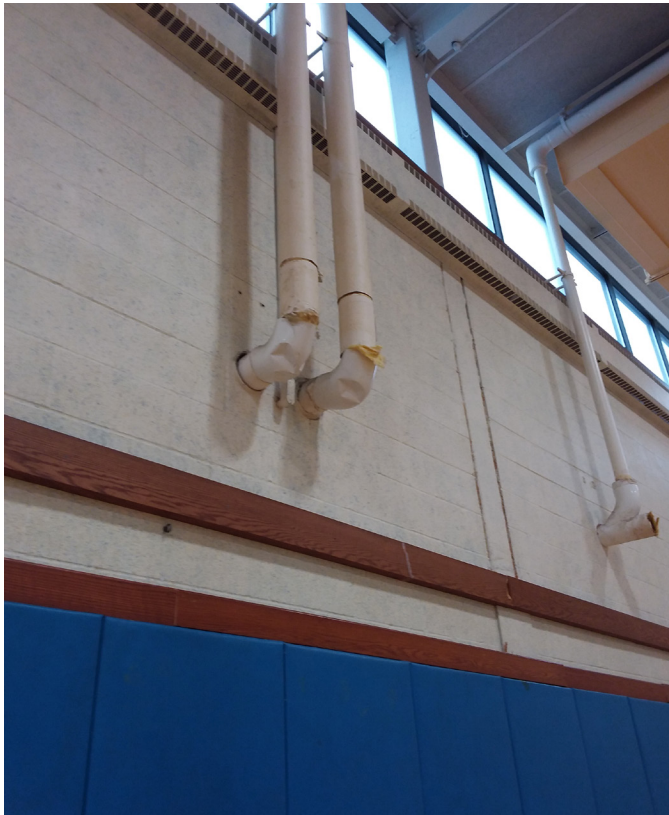
Pipe Penetration

All piping through rated wall should be sealed with UL rated sealant

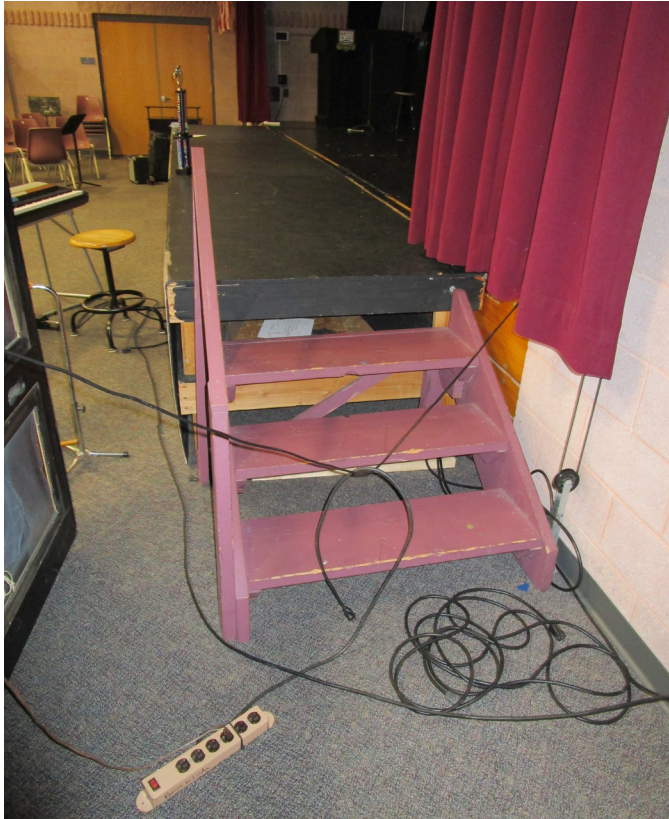
Area "B" - Lower Level - Multi-Purpose Room

Open risers are not permitted. The handrails are not compliant. The slip resistance for the stair treads is not evident. The stair construction may not meet the structural capacity for this application.

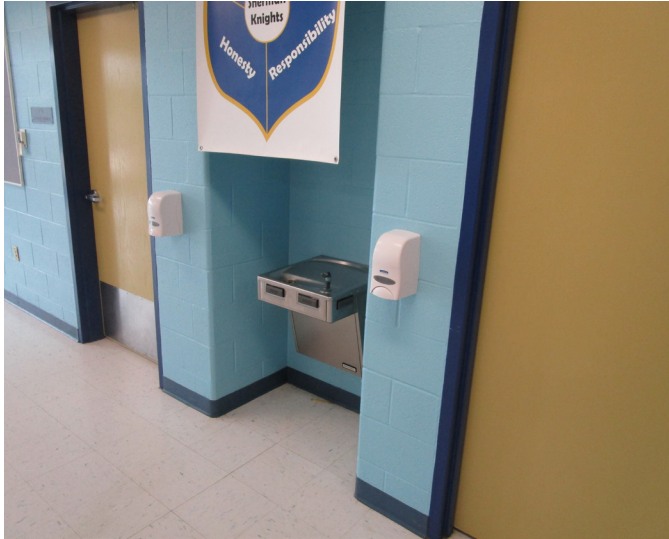
Cafeteria - Lower Level

Provide headroom clearances at drinking fountain.

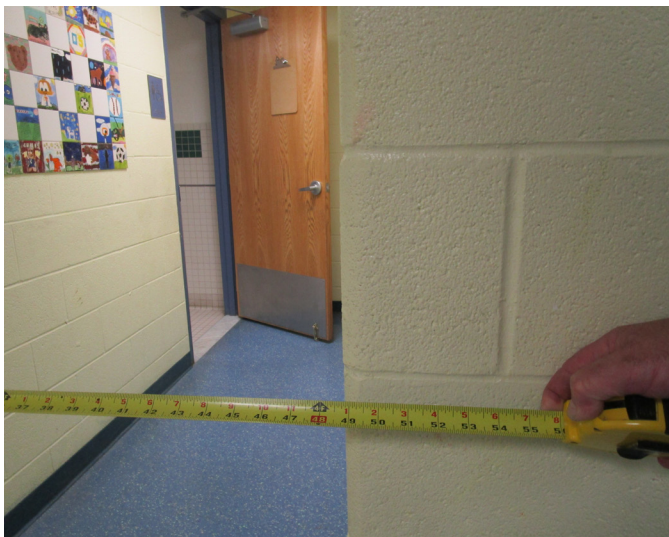
Accessible Girls Toilet Room - Lower Level

The maneuvering clearance at the toilet room entrance door has not been provided.

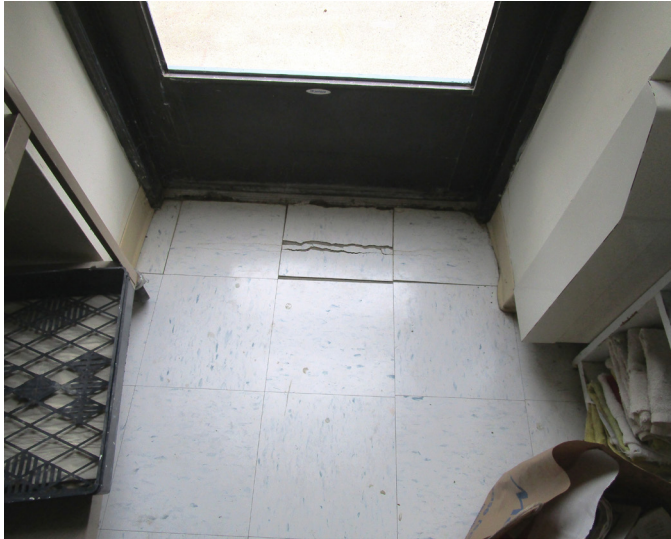
Art Classroom Exit Door - Lower Level

151		404.2.5	Doors	Thresholds	Thresholds, if provided at doorways, shall be ½ inch (13 mm) high maximum. Raised thresholds and changes in level at doorways shall comply with 302 and 303. EXCEPTION: Existing or altered thresholds ¾ inch high maximum that have a beveled edge on each side with a slope not steeper than 1:2 shall not be required to comply with 404.2.5.	Yes	Fail	4	4

The required maneuvering clearance at the exit door has not been provided. The door threshold height is an issue due to settlement.

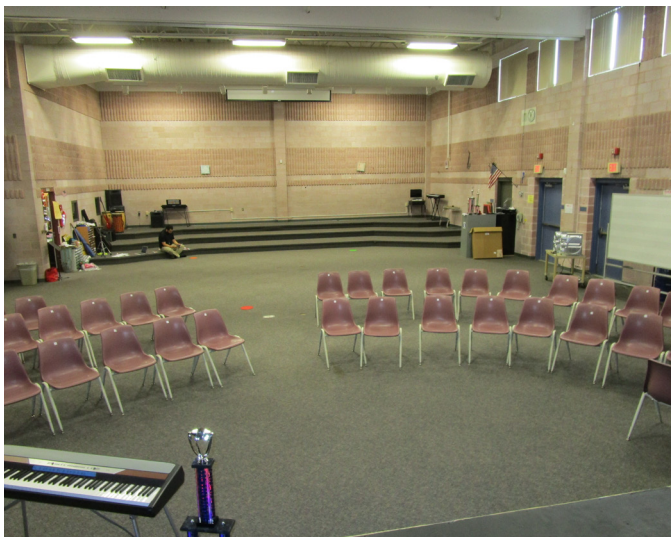
6. Location:

The risers at the back of the Music Room are not accessible.

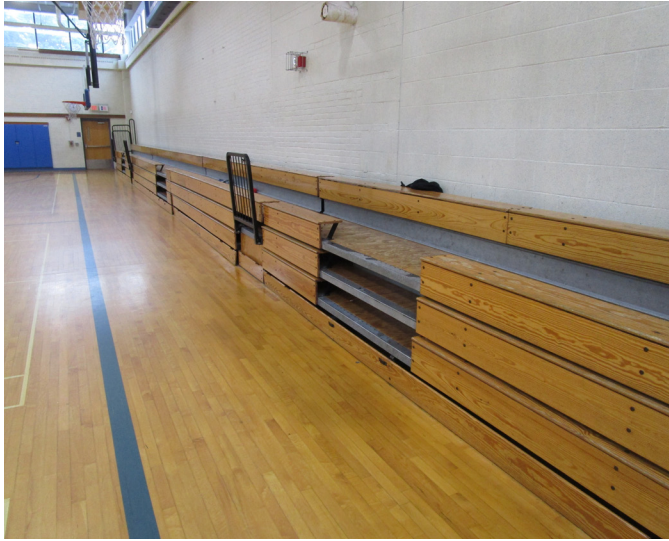
7. Location:

Accessible seating in conjunction with companion seating is not available and/or identified.
