Facility Survey, Code Analysis and Buildings & Grounds Survey & Master Plan

The Sherman School

Sherman, Connecticut

November 2018

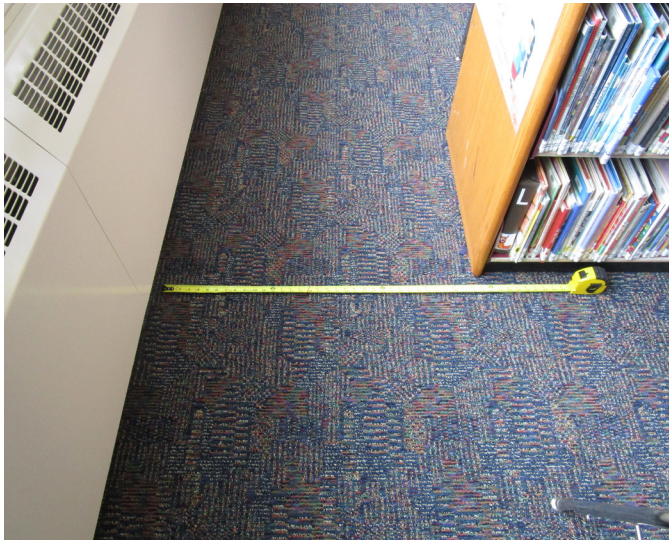
8. Location:

The clear width at the end of the aisle is not wide enough.

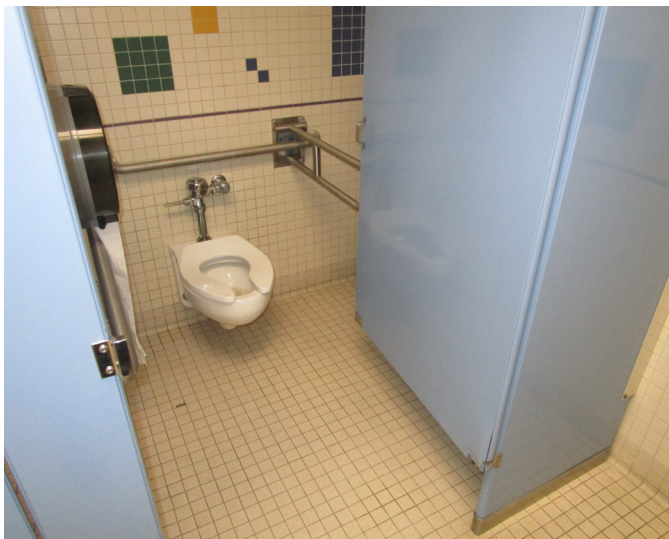
9. Location:

The stall door swings into the clear space required.

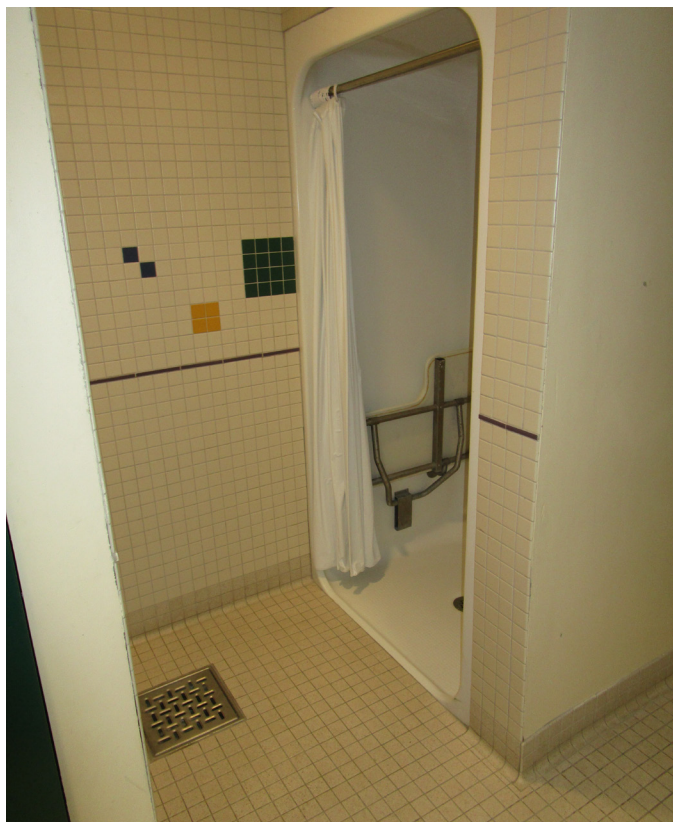
10. Location:

The clear floor space behind the seat wall has not been provided.

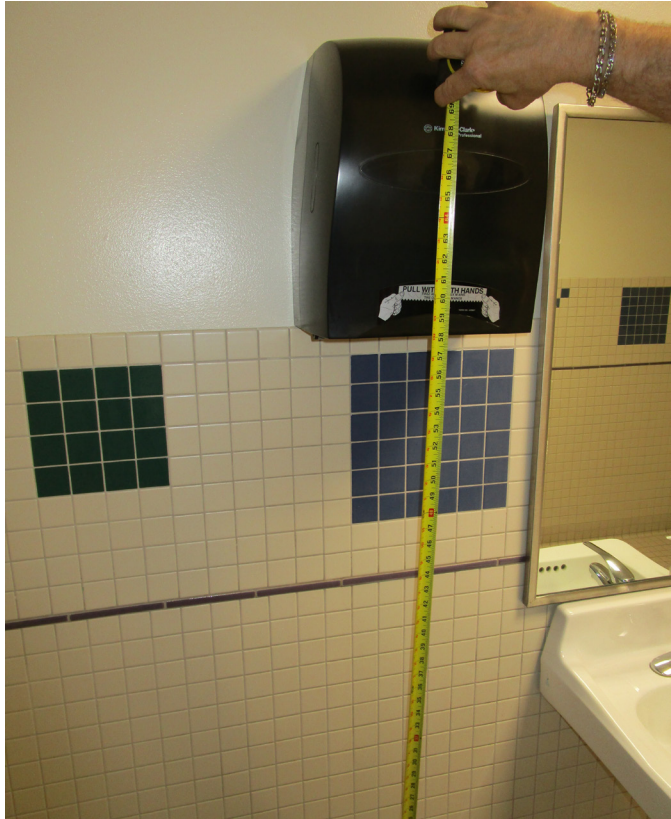
12. Location:

A compliant height for the paper tower dispenser has not been provided.

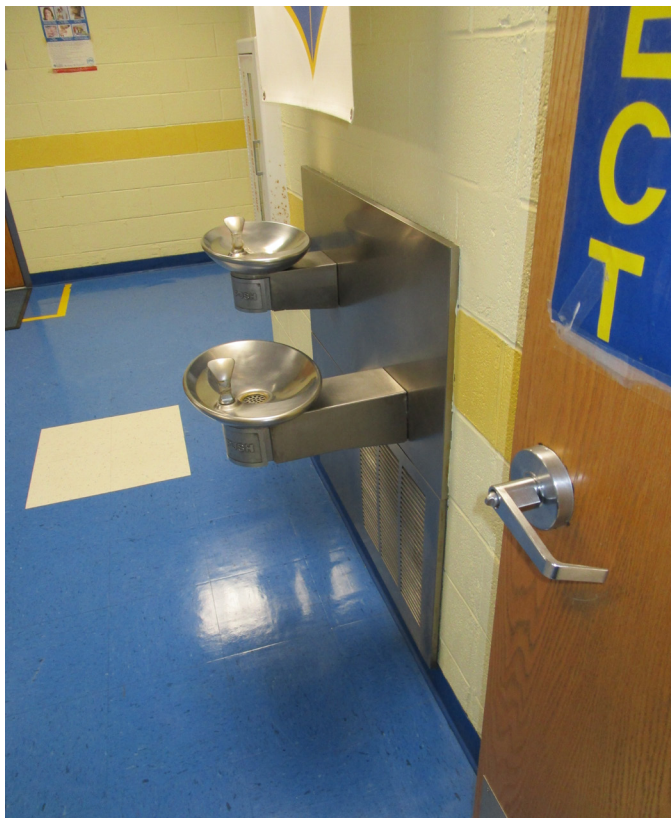
13. Location:

The drinking fountains are placed incorrectly, they are protruding objects which are located within the required door clearance area.

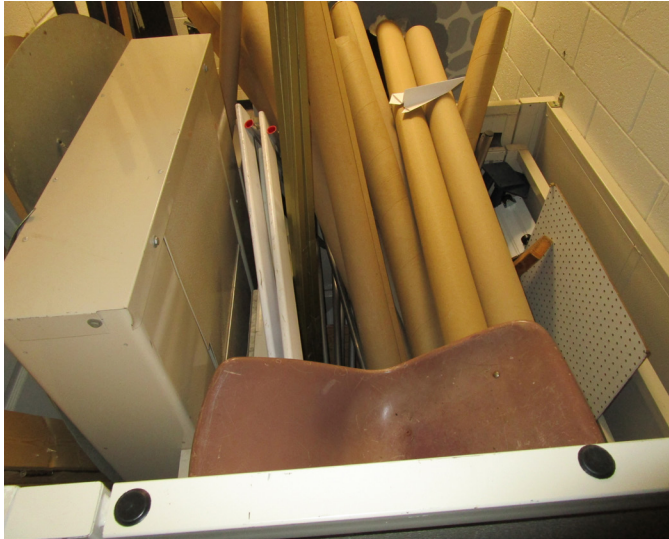
14. Location:

The compliant lift is currently used as a storage area.

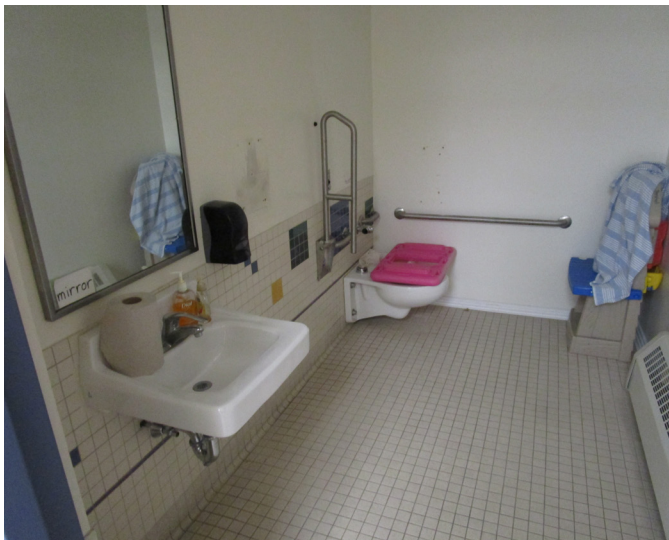
15. Location:

The grab bars are not continuous behind the toilet. The drain pipe for the sink is not insulated.

Install vertical grab bar at all toilets, typical.

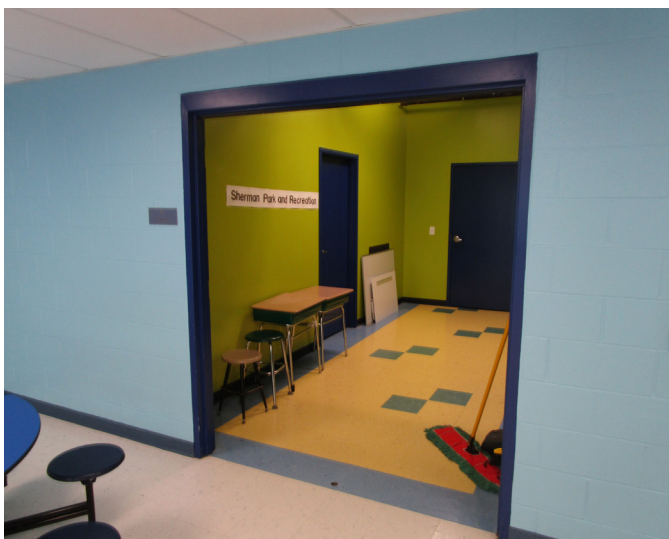
16. Location:

Compliant signage for the new town department office has not been provided.

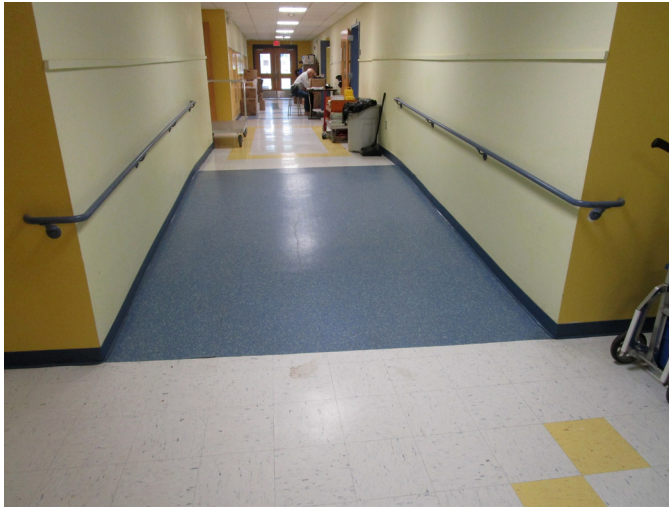
17. Location:

The handrail extensions need to continue in the same direction as the ramp for 12" minimum.

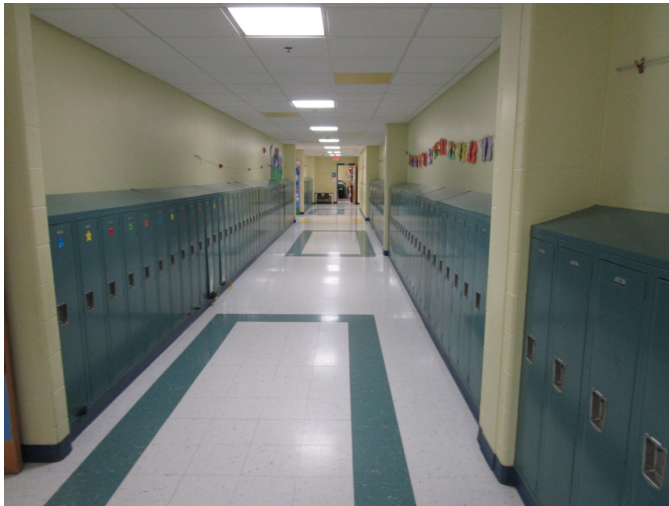
18. Location:

Accessible lockers have not been provided and/or designated within the school.

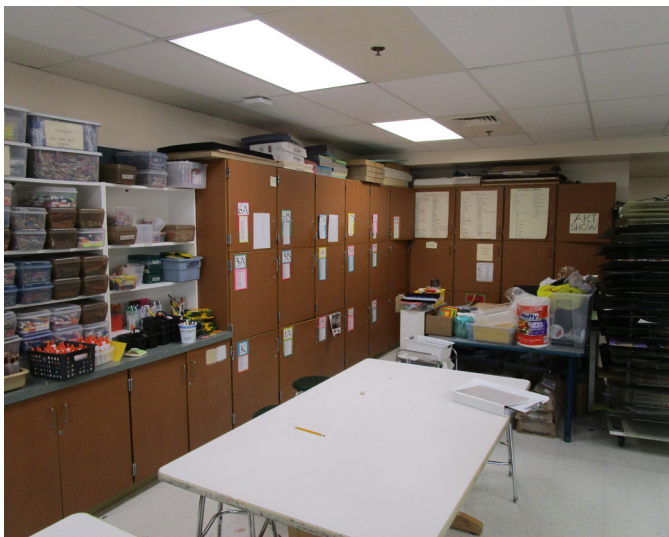
19. Location:

Accessible storage areas and counter work areas within the art classroom have not been provided.

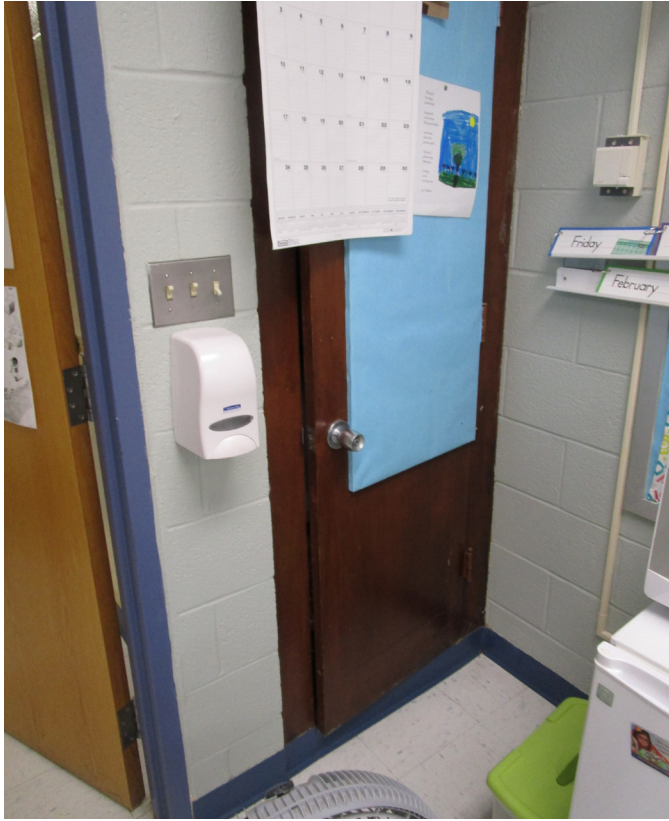
20. Location:

Closet door handle hardware has not been updated

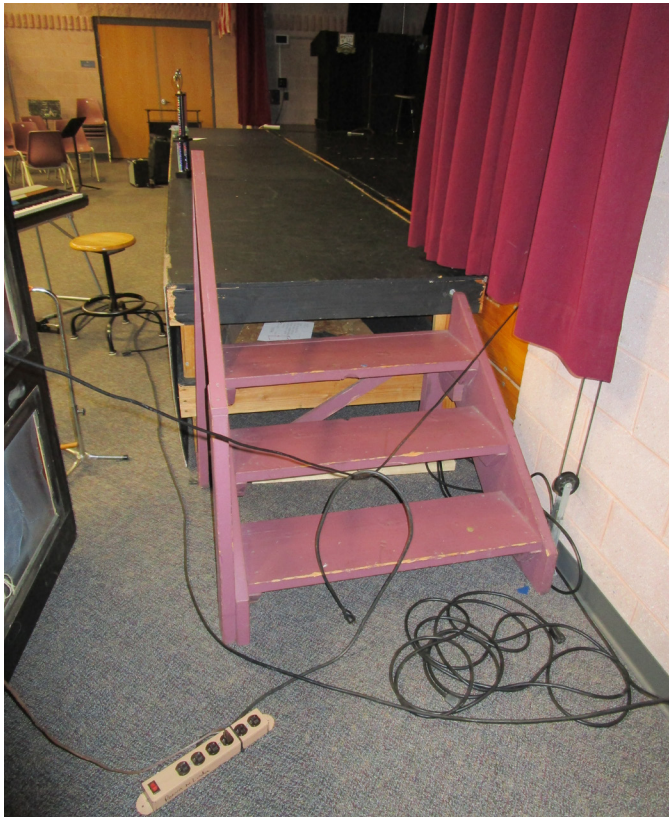
21. Location:

The stairs to the platform are non-compliant.

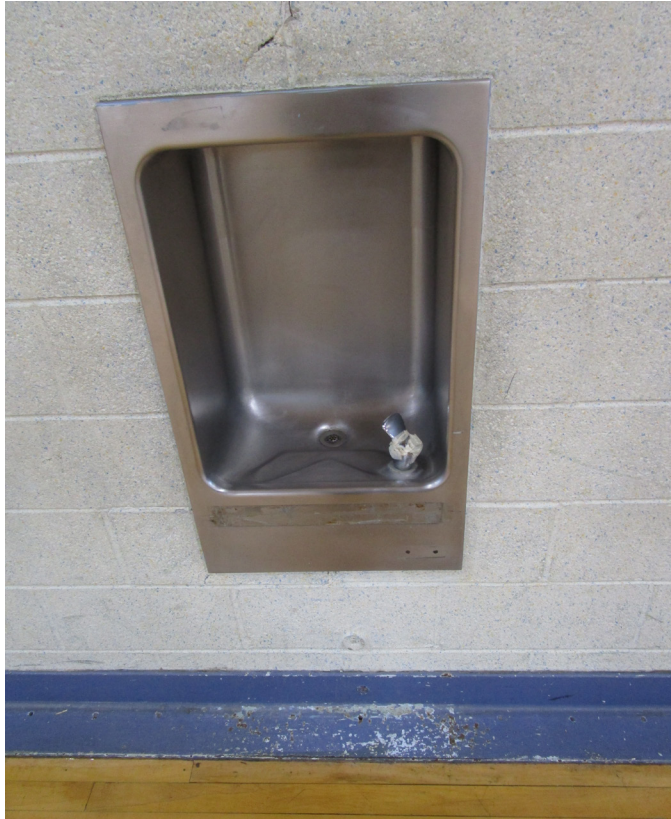
22. Location:

The drinking fountain is not provided with the high/ low operating feature.

- Assembly Areas - Update book stack access and clearances within the Library, eliminate and/or replace stairs to the raised platform at the Multi-Purpose Room, provide access to the risers to the tiered Music Classroom and add companion seating and a compliant drinking fountain within the Gymnasium.

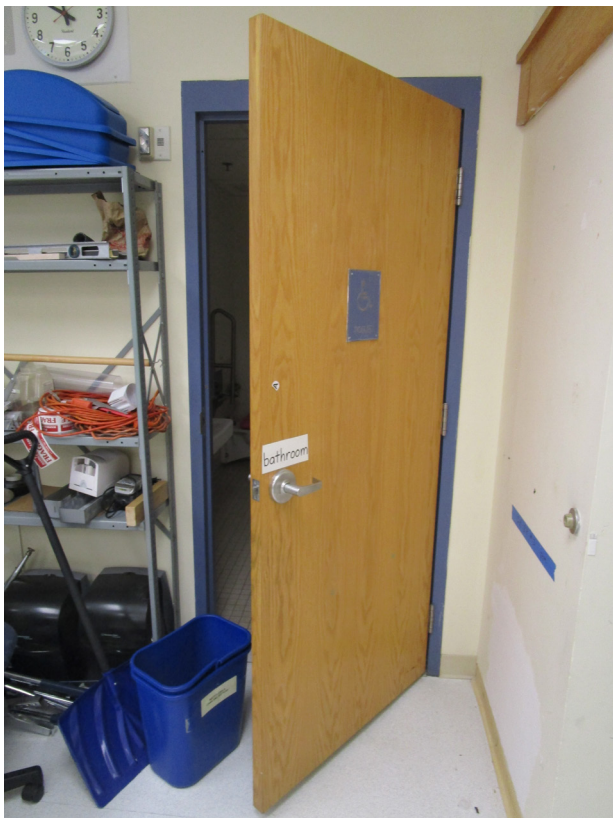
23. Location:

If the door is fully opened the signage cannot be located. The handicap accessible sign needs to be properly located.

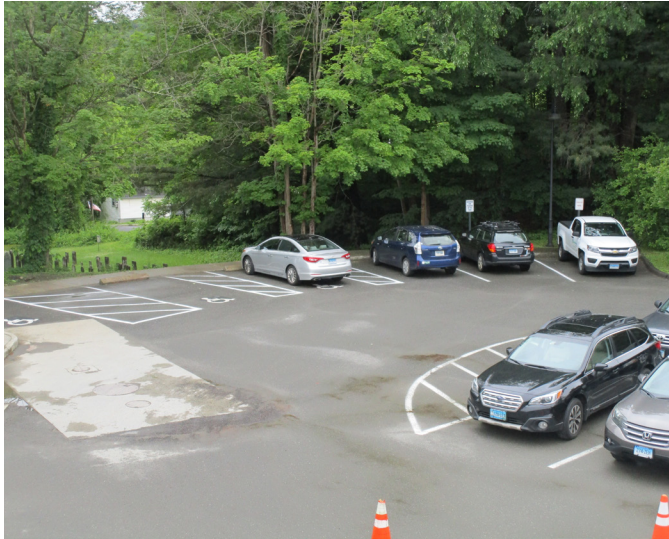
24. Location:

The existing handicap parking area requires upgrades; accessible signage, aisle widths, compliant accessible spaces, van accessible space, parking striping and layout.

Although not pictured, the lower school parking lot lacks accessible parking spaces.

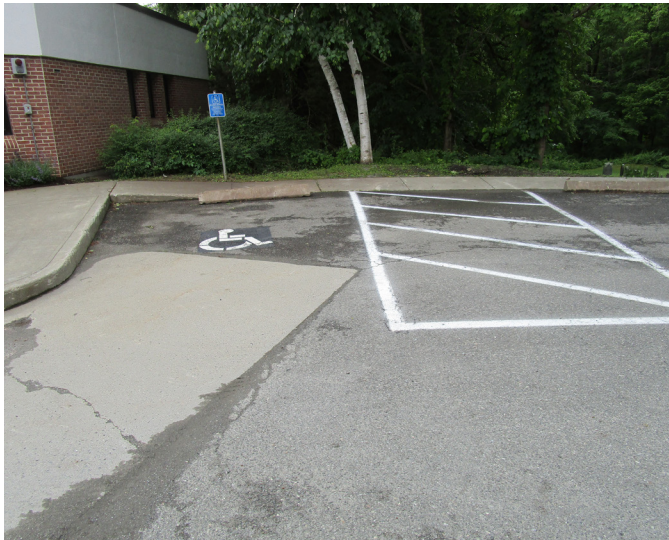
25. Location:

The parking space has been designed as a van accessible parking space. The handicapped parking sign does not designate this as a van accessible space. The wheel stop location will not prevent the accessible route from being blocked.

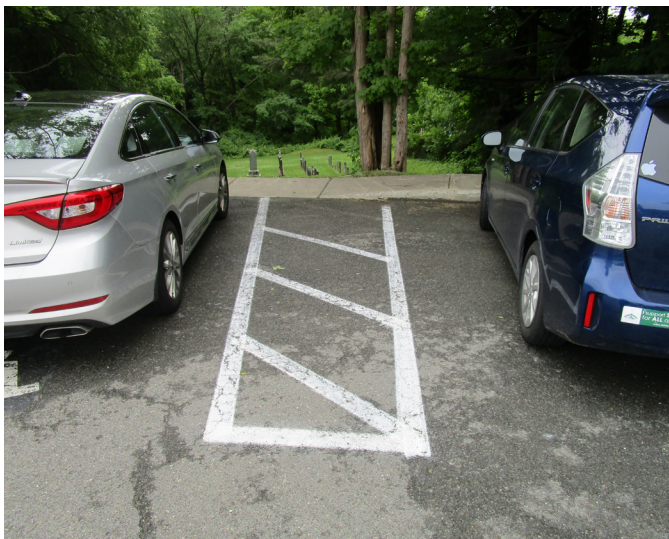
26. Location:

The handicap parking space is not designated with a handicapped parking sign. The aisle is in conflict with a curb ramp.

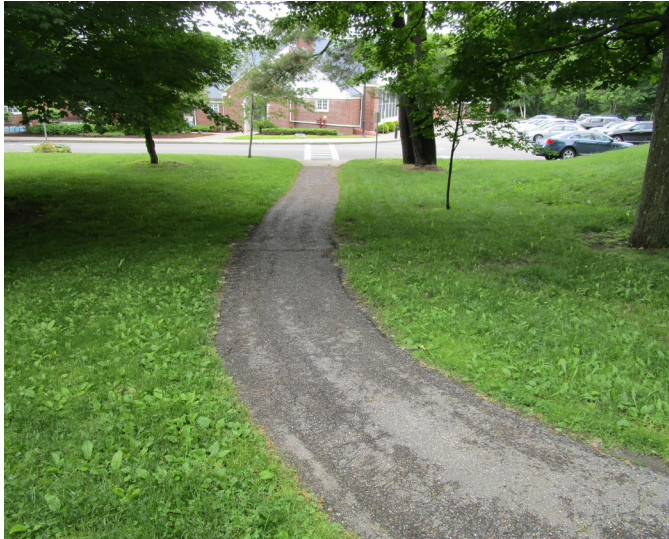
27. Location:

Access from the main road is compromised by the lack of a curb ramp at the school side walk. Refer to Photo #35.

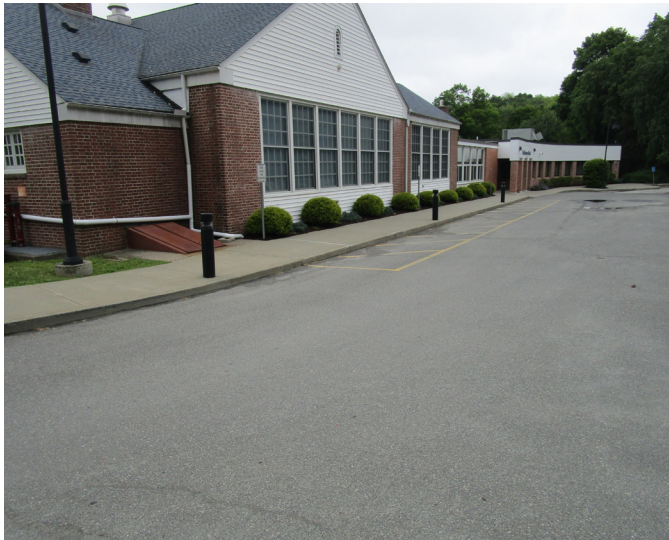
28. Location:

The bus loop / drop off area is not provided with a curb ramp to access the accessible route. Currently the area is designated as a fire lane.

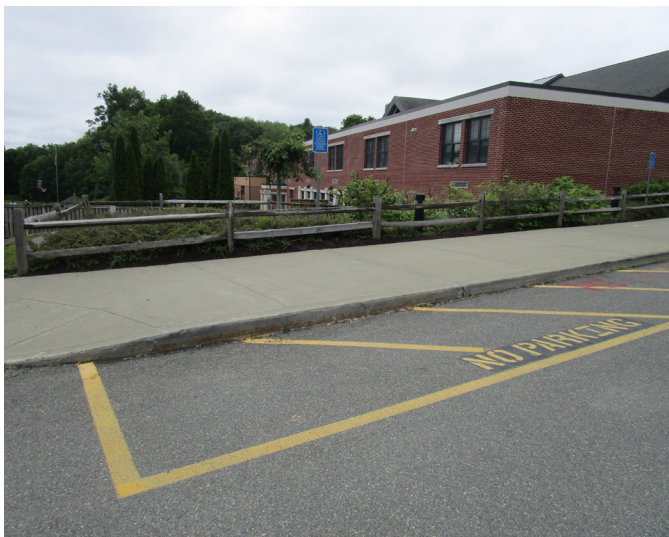
29. Location:

The slope of the drop off area and the adjacent side walk compromise accessibility. Currently the area is designated as a fire lane despite the handicap accessible signage.

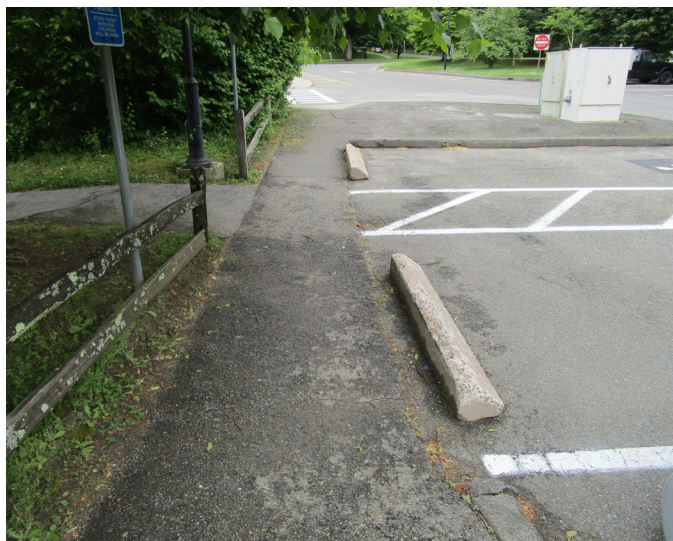
30. Location:

If a car is parked up to the existing wheel stop the handicap accessible route will be blocked.

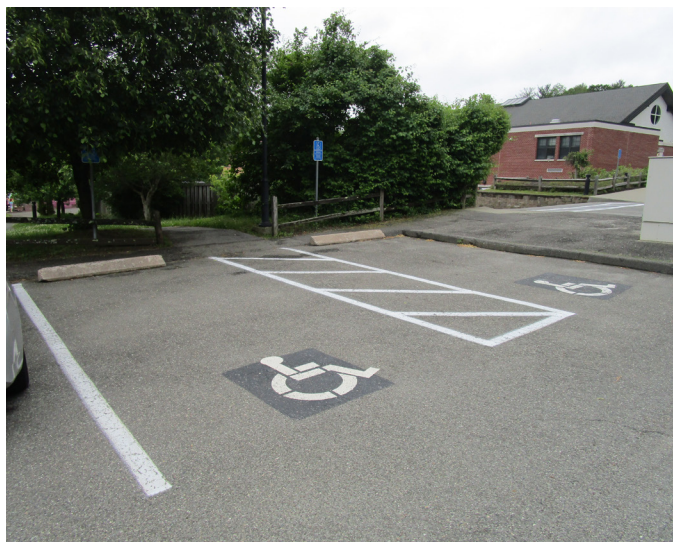
31. Location:

The cross slope of the existing handicap accessible parking is too steep. The handicap parking signage is not evident through the trees.

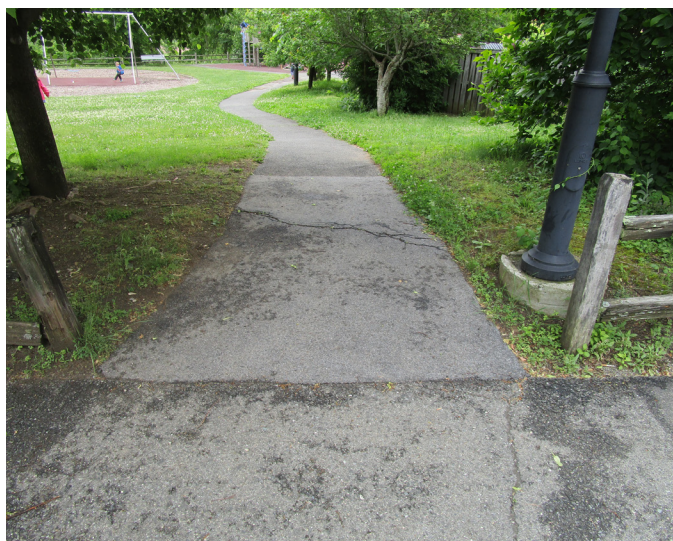
32. Location:

The slope of the accessible walk from the parking area to the east side of the building is too steep. Refer to Photo #31

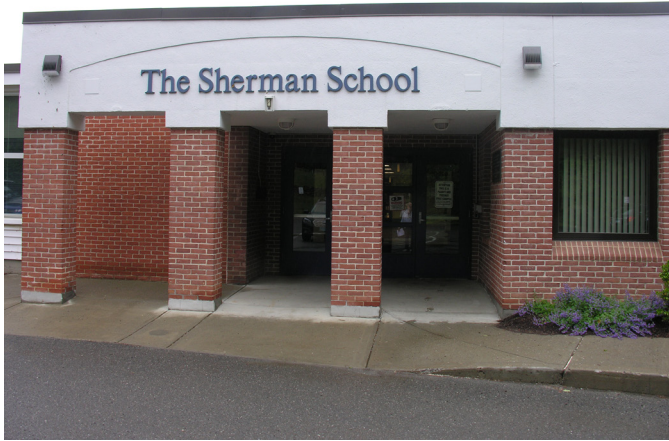
33. Location:

Accessible signage needs to be provided for the accessible main entrance and the other accessible entrances. Directional signage needs to direct the public to the accessible entrances and away from other entrances.

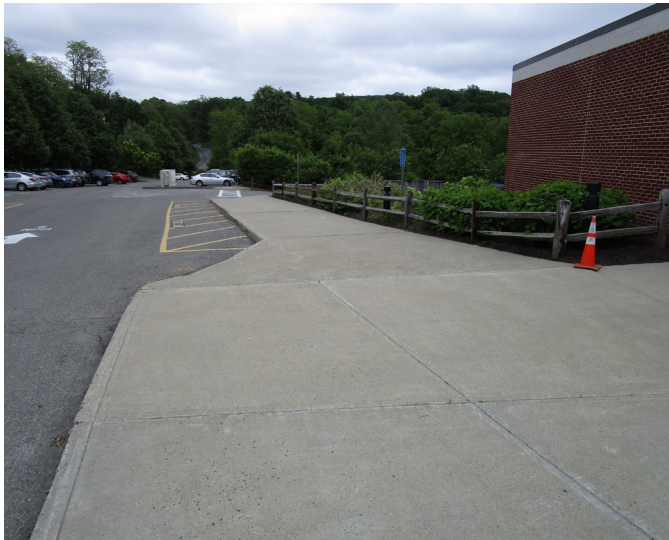
34. Location:

The slope of the driveway, parking lots and the drop off area do not allow for proper accessibility.

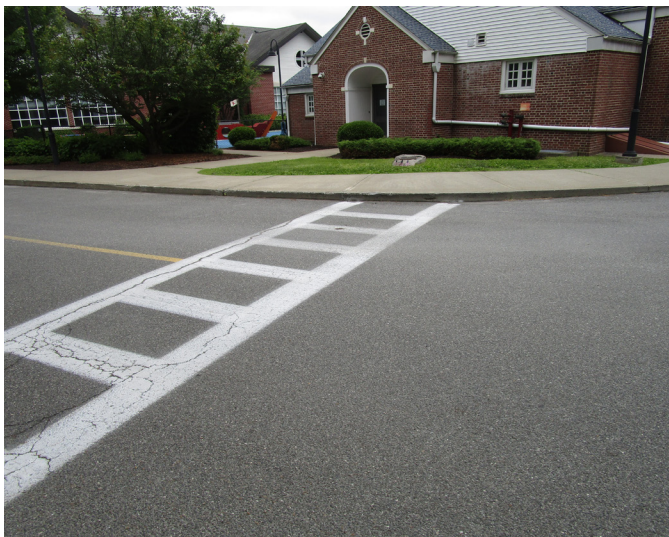
35. Location:

A curb ramp and tactile warning need to be provided at the cross walk. Refer to Photo #27.

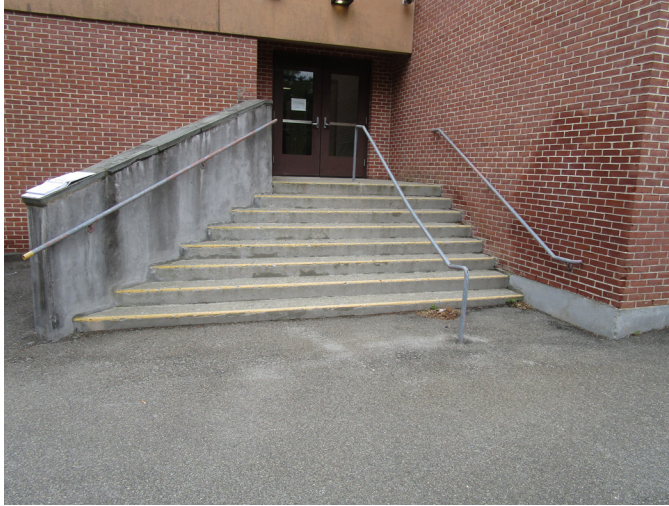
36. Location:

The top of the existing handrails are too low. The handrail on the left does not return to a wall or the walk. The first stair riser is lower than the remaining risers.

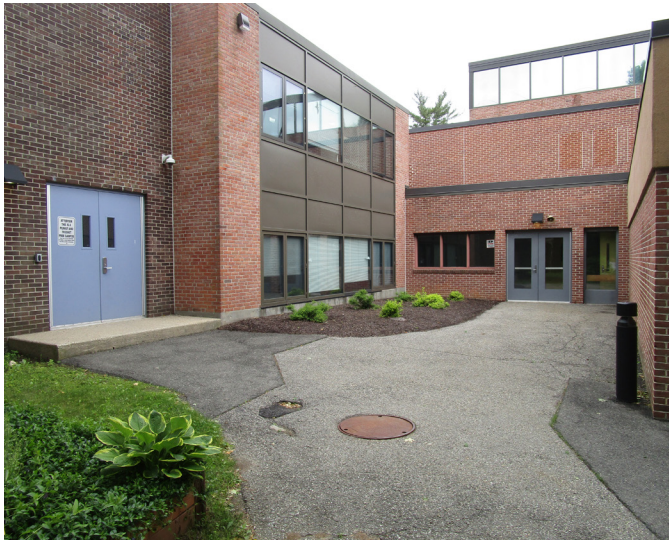
37. Location:

The slope of the exit to the public way is too steep for accessibility. Accessible signage is not provided to direct the public to the accessible entrance.

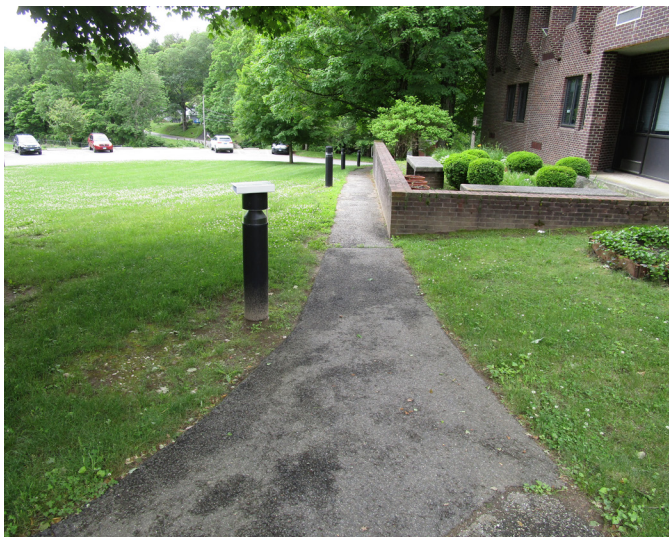
38. Location:

The walk way does not provide the minimum width at the brick knee wall. An accessible exit from the Enrichment Lab would use this walkway. Refer to Photo #45, Enrichment Lab Door.

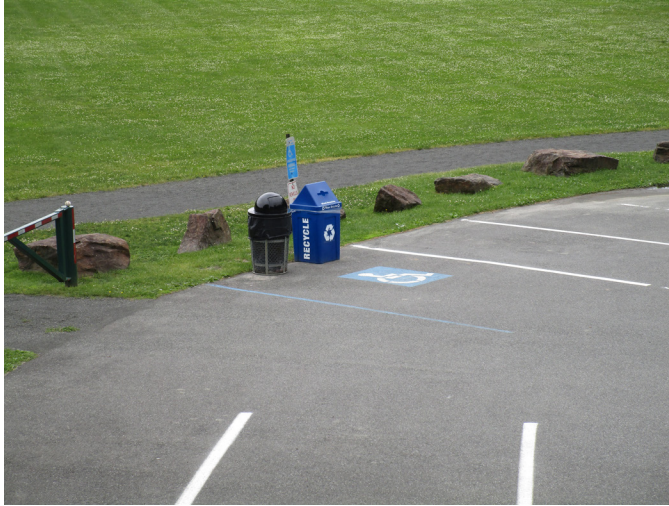
39. Location:

The handicap accessible parking space
requires upgrading for accessibility.

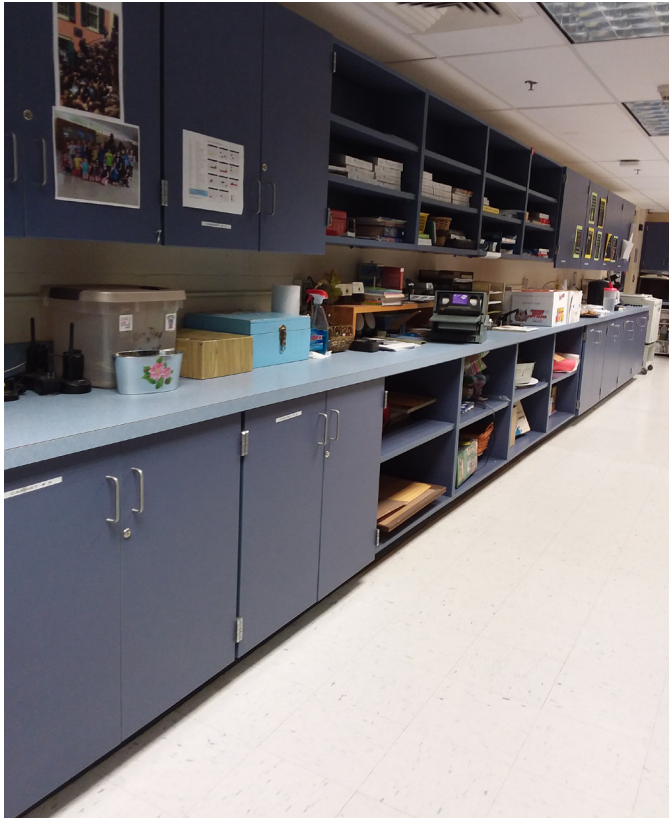
40. Location:

An accessible work space has not been
provided along the counter space.

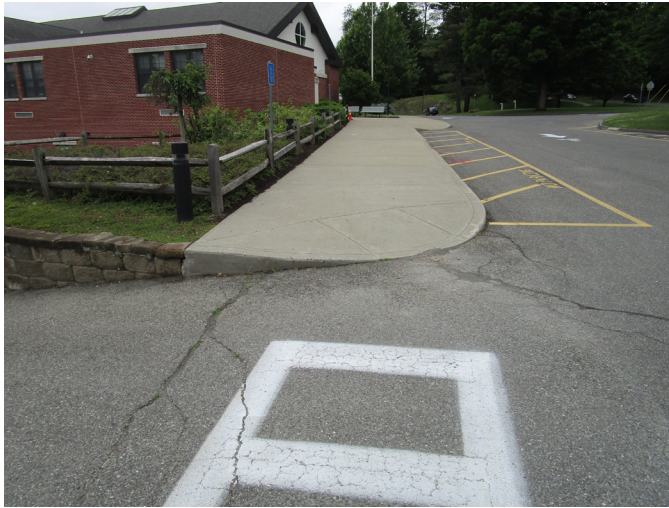
41. Location:

The diagonal curb ramp requires tactile warning, a proper relationship with the cross walk and proper slope for an acceptable site accessible route.

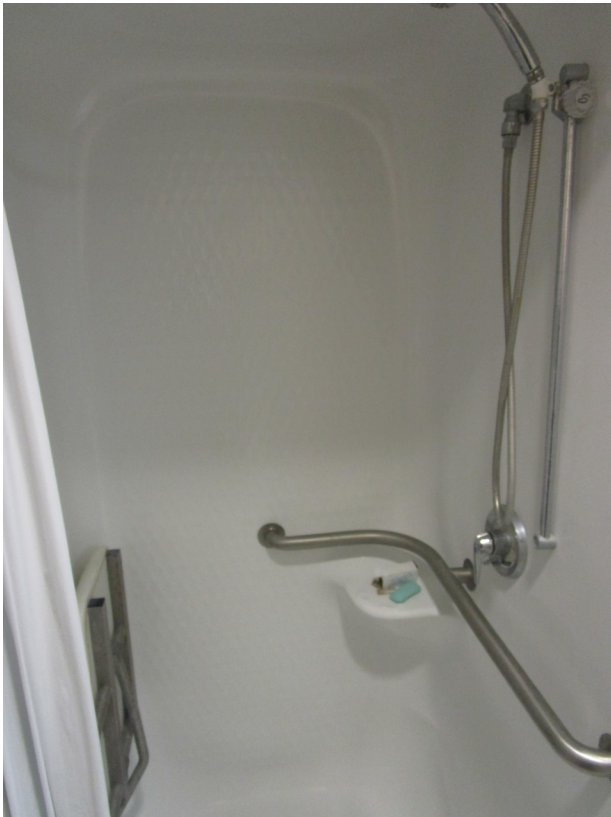
42. Location:

The vertical grab bar has not been provided.

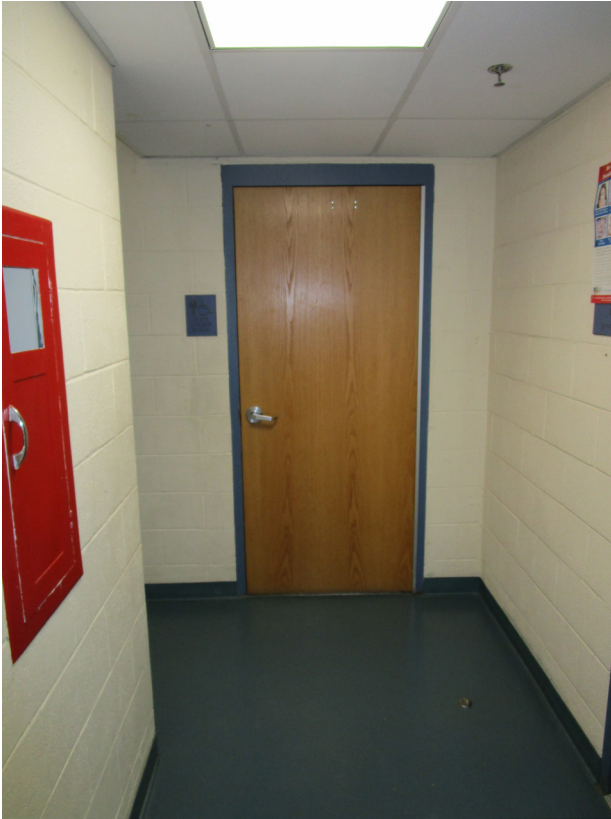
43. Location:

The door maneuvering clearance has not been provided at the entrance door to the Boys Locker Room

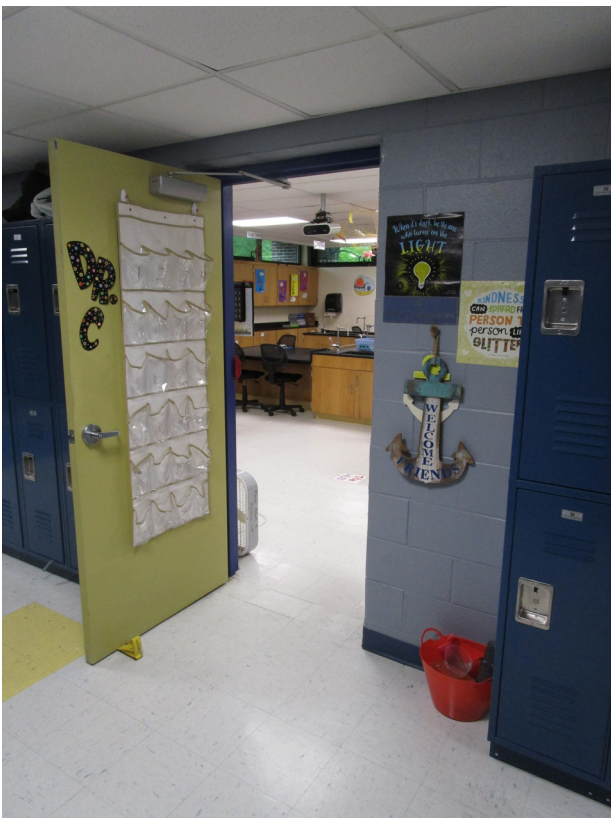
44. Location:

Accessible classroom signage is not evident.

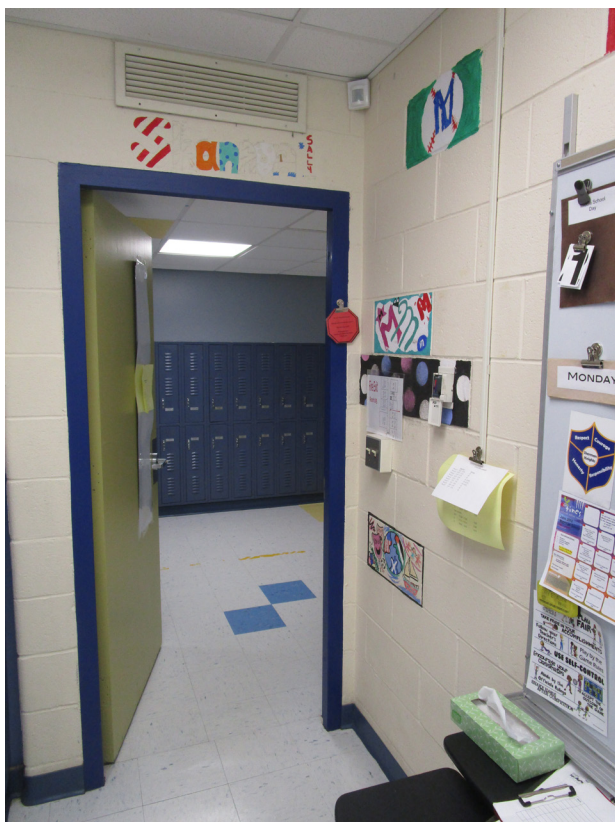
The door is marked and shown as the primary exit for this space. The designated exit is not an accessible exit leading to the public way.

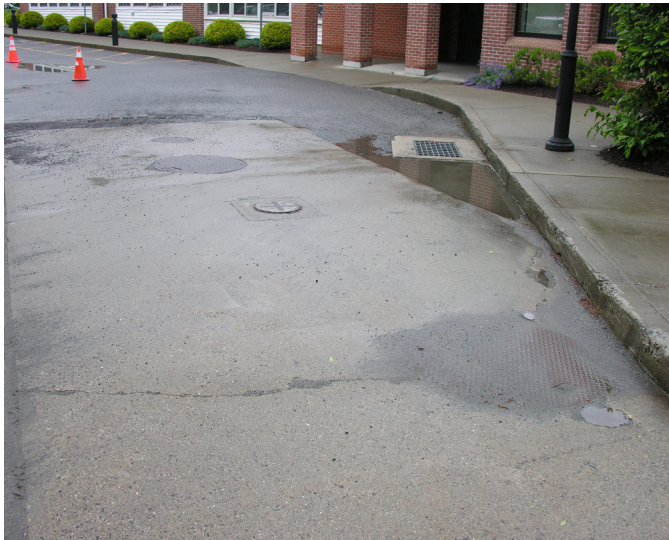
2. Location:

Ponding at Storm Drain / Fuel Oil Tank Location

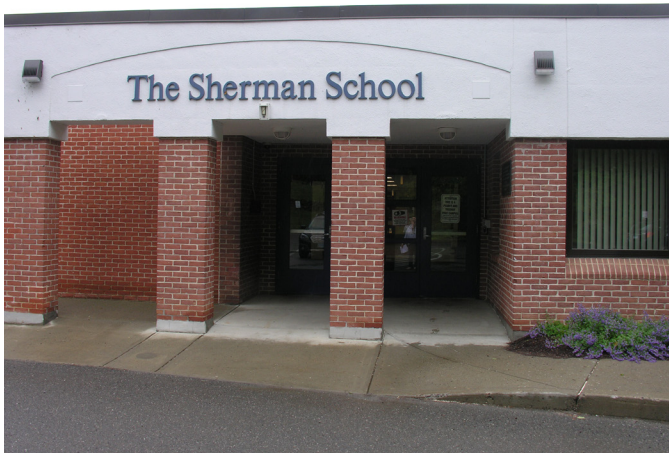
3. Location:

Entrance Ramp not in Compliance -
Tactile Missing

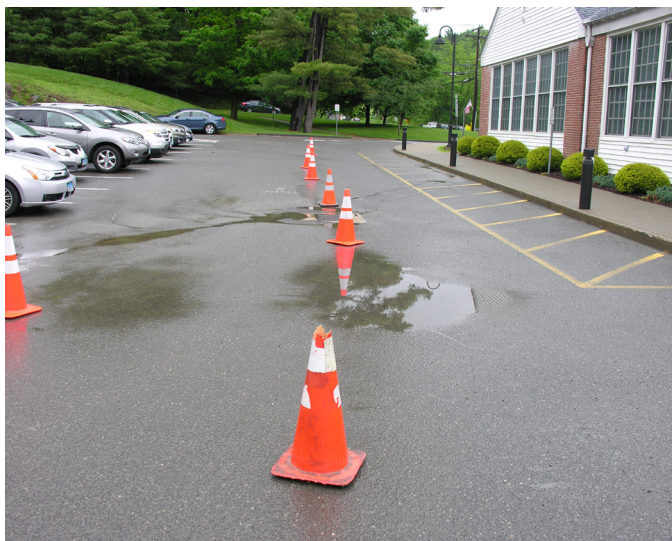
4. Location:

Ponding / Non-Compliant Drop-off

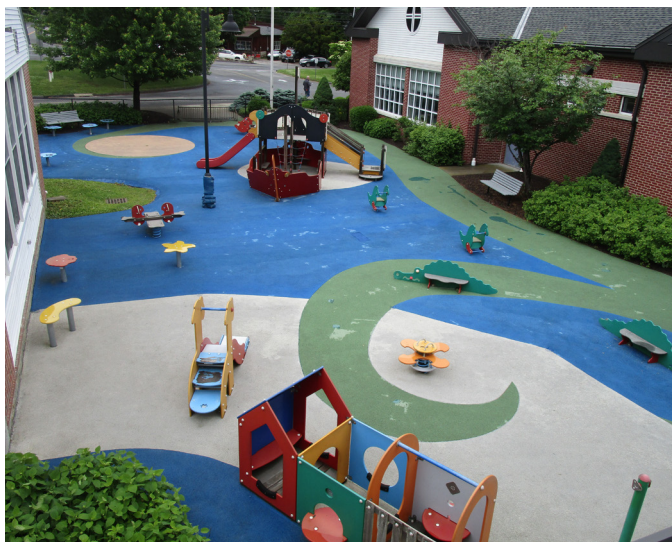
5. Location:

Wood/Composite Play-scape , Worn Rubberized Mat

Wood play elements in poor condition.

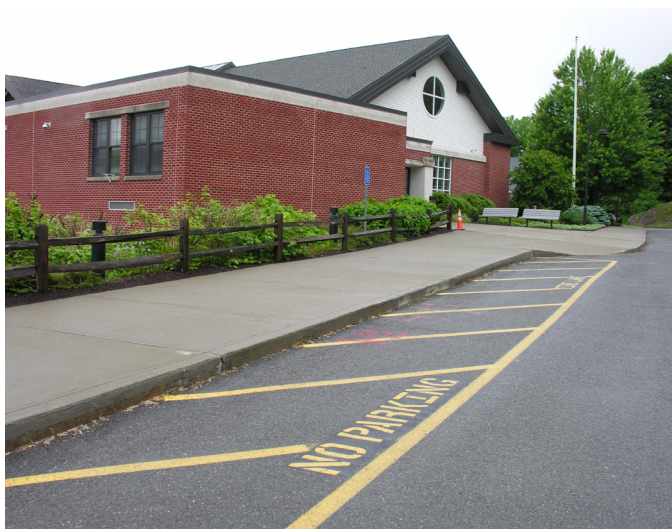
6. Location:

Non-Compliant Drop-off Area

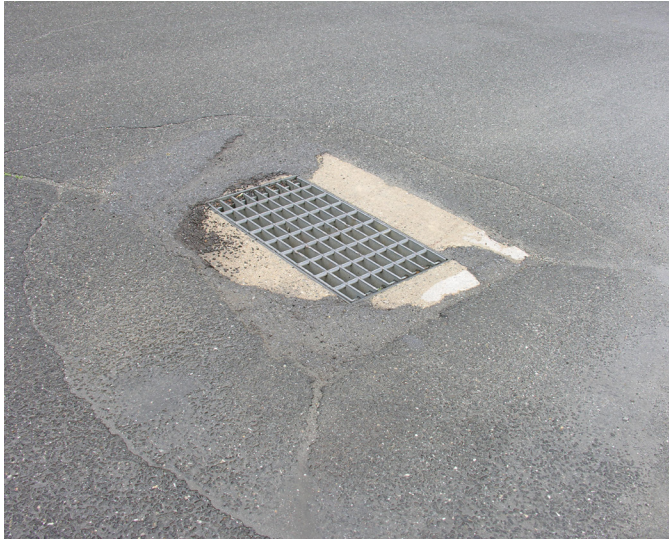
7. Location:

Patched Storm Drain

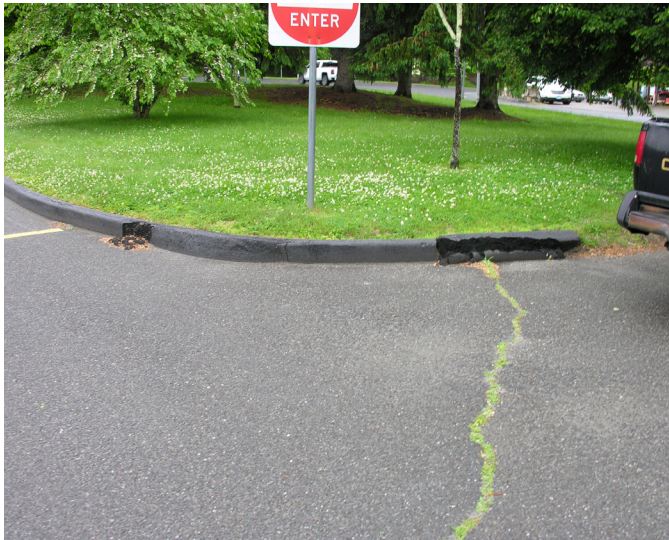
8. Location:

Damaged Bituminous Curbing

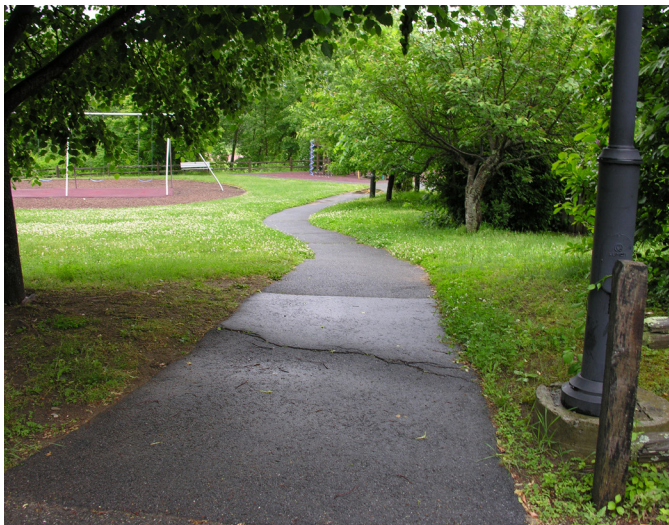
9. Location:

Damaged Bituminous Walkway / Non-Compliant Pitch / Railings

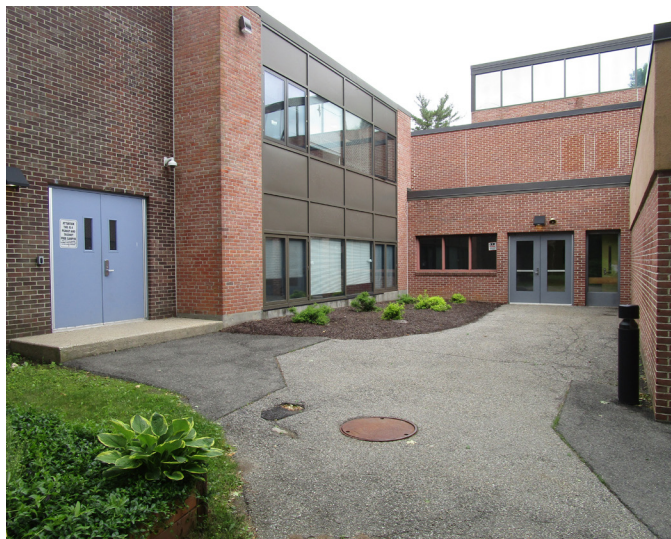
12. Location:

Damaged Bituminous Walkway

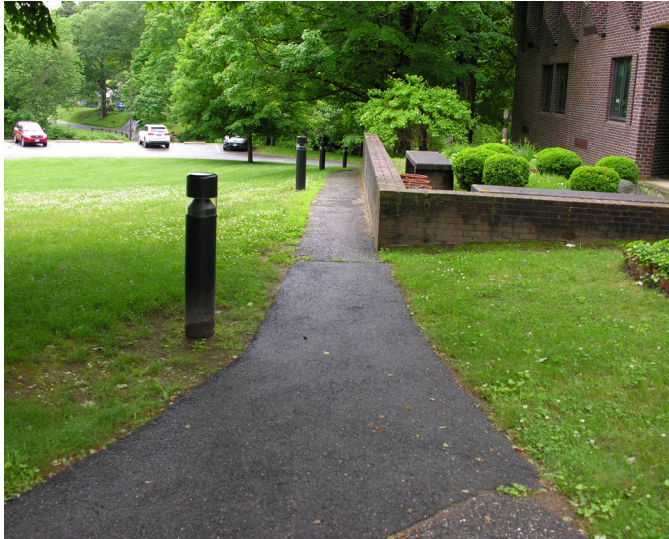
13. Location:

Egress Accessible Ramp Non-Compliant
Handrails Required

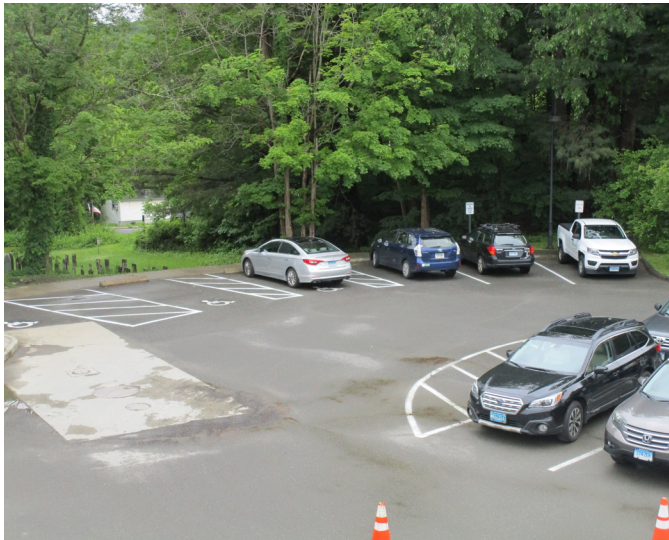
14. Location:

Van Accessible Handicap Space Required

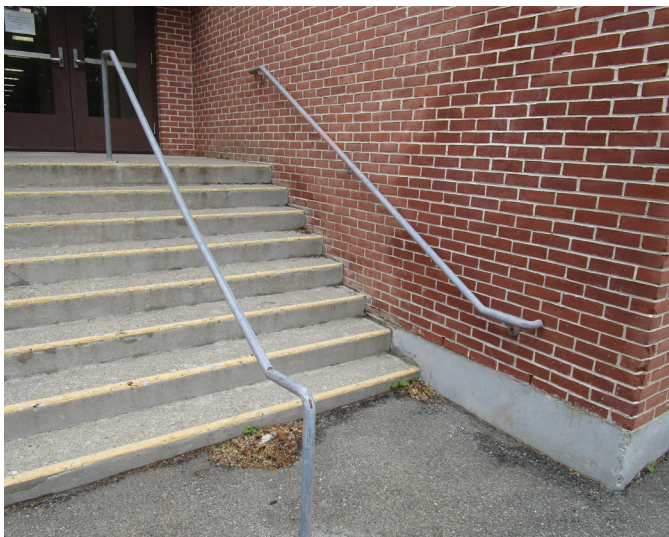
15. Location:

Handrails not in Compliance
